**Accident Investigation Board
Denmark**

HCLJ510-000433

Accident to Bombardier DHC-8-400,
registration LN-RDK,
at Aalborg Airport (Denmark),
on 9 September 2007

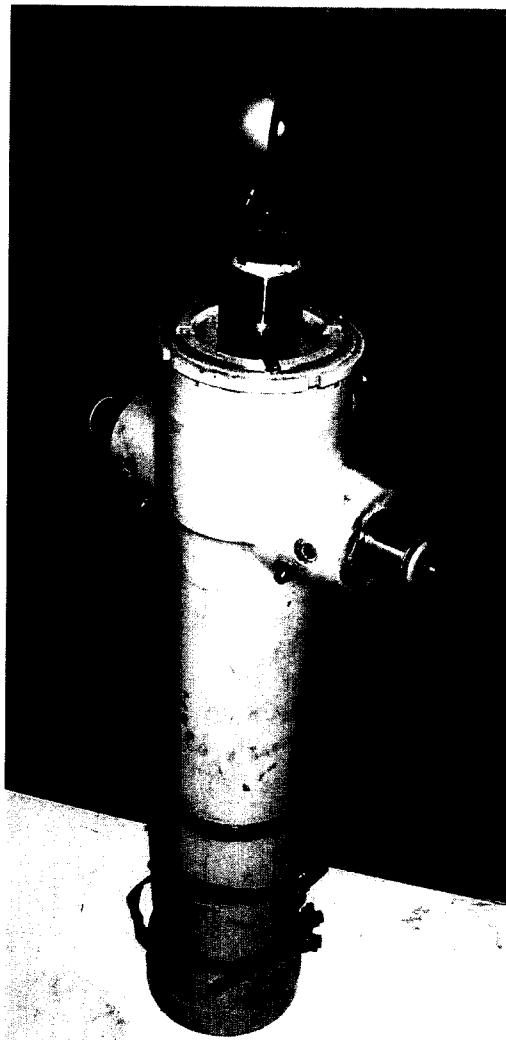
Figure 1: View of right MLG retract actuator with piston rod and rod end.

Figure 1 shows a reconstructed photo of the actuator, piston rod and rod end. Figure 2 shows close up views of the piston rod female thread and rod end male thread in “as found” condition.

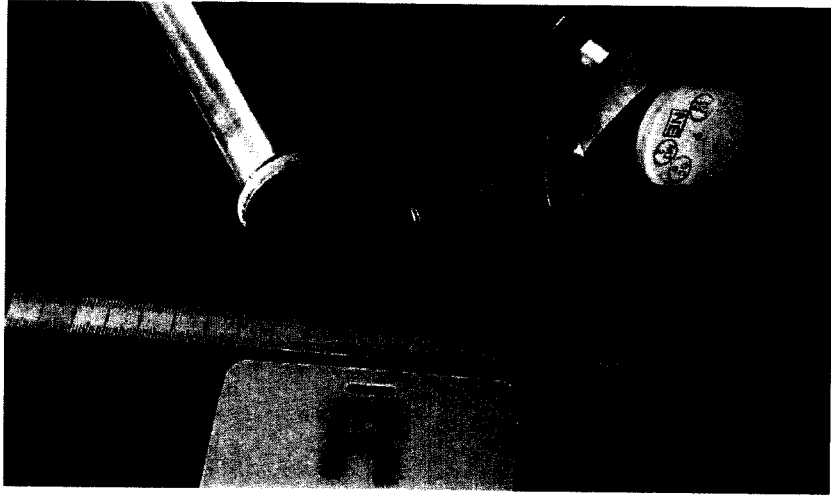
Figure 2: Threaded parts of piston rod and rod end in “as found” condition.

- Rod end was separated.
- Piston rod internal threads were noticeably stripped out to the depth of the rod end engagement.
- The retraction/extension actuator piston rod revealed the presence of internal corrosion.

- The bearing surfaces were adequately lubricated.
- The jam nut was present and lock-wire was intact, but without the manufacturer's originally installed lead seal.
- The threads were clogged with what appeared to be corrosion.

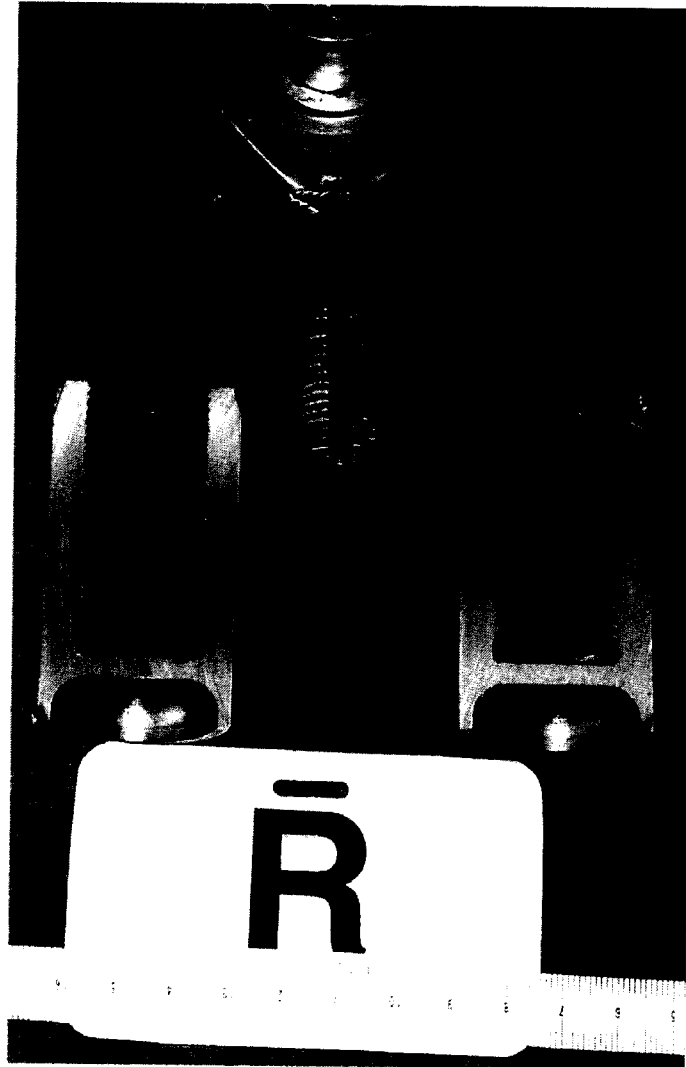
Figure 3: Longitudinal sectioning of piston rod end.

The threaded end of the piston rod was sectioned longitudinally as shown in figures 3, 4 and 5. Figure 6 shows a section of the piston rod before and after cleaning. It was evident that the female threads were severely damaged and partly destroyed by corrosion. Figure 10 shows the appearance of threads in the non-engaged part of the thread. The contour of the non-engaged threads appears intact but upon closer view it was evident that corrosion had also occurred in these parts.

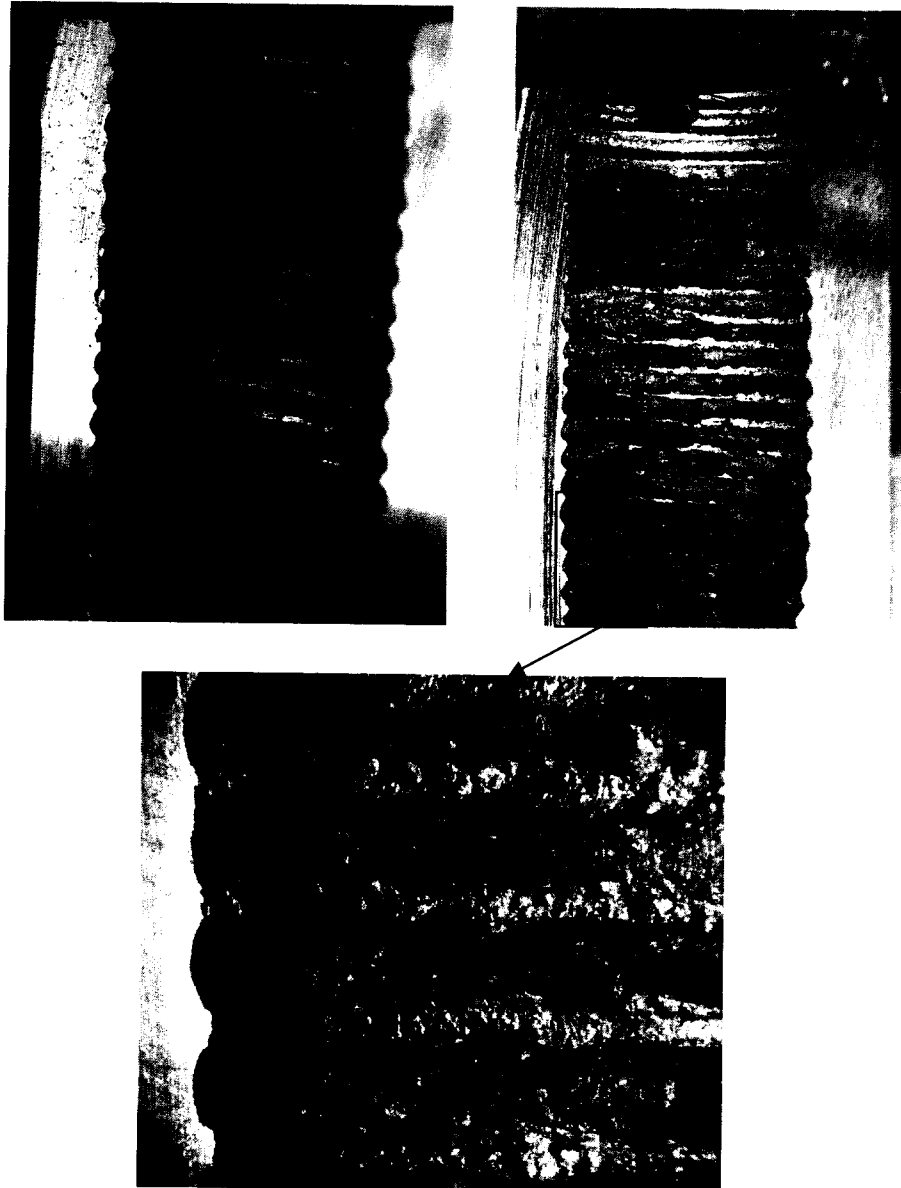
Figure 6: Part of piston rod in cleaned condition. Note the severe corrosion of thread tops and bottoms.

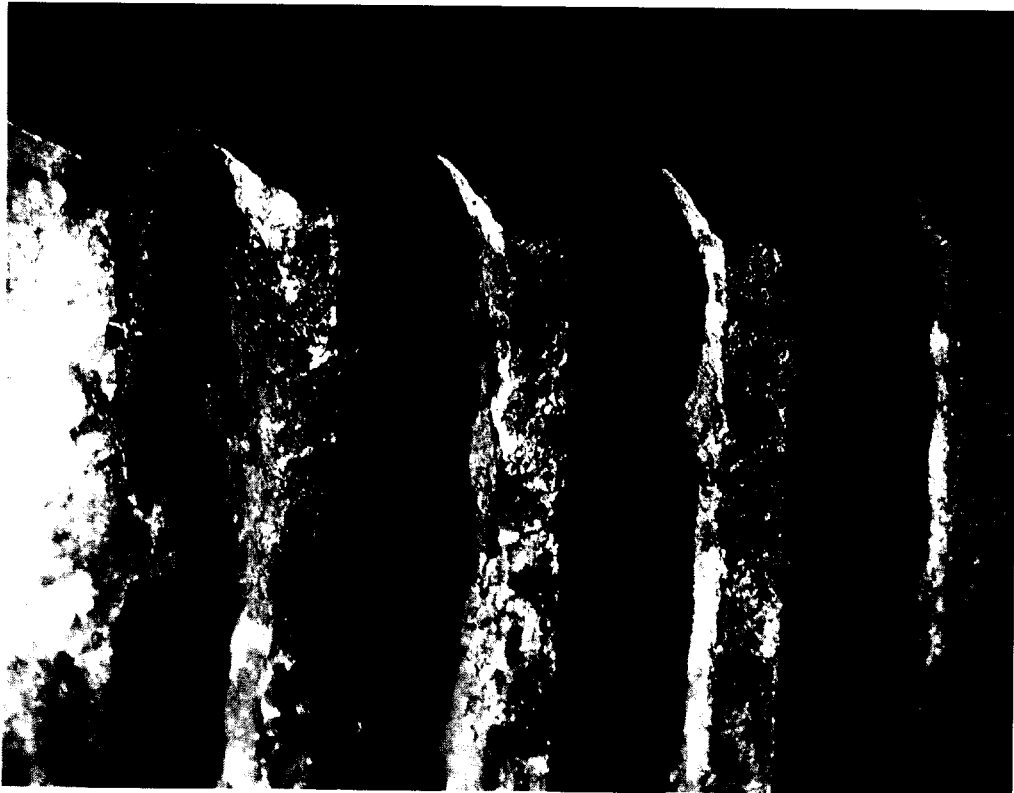
Figure 10: View of threads near bottom of piston rod. The arrow points to the last engaged thread.

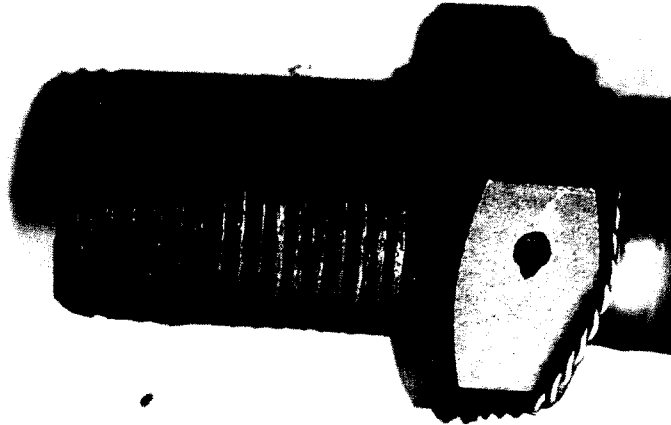
Figures 17 and 18 show the appearance of the rod end male thread. The thread valleys were filled with a dry powder-like product and metallic ligaments. A longitudinal cut in the male thread is shown in Figure 19.

Figure 17: Right MLG actuator rod end in “as found” condition.

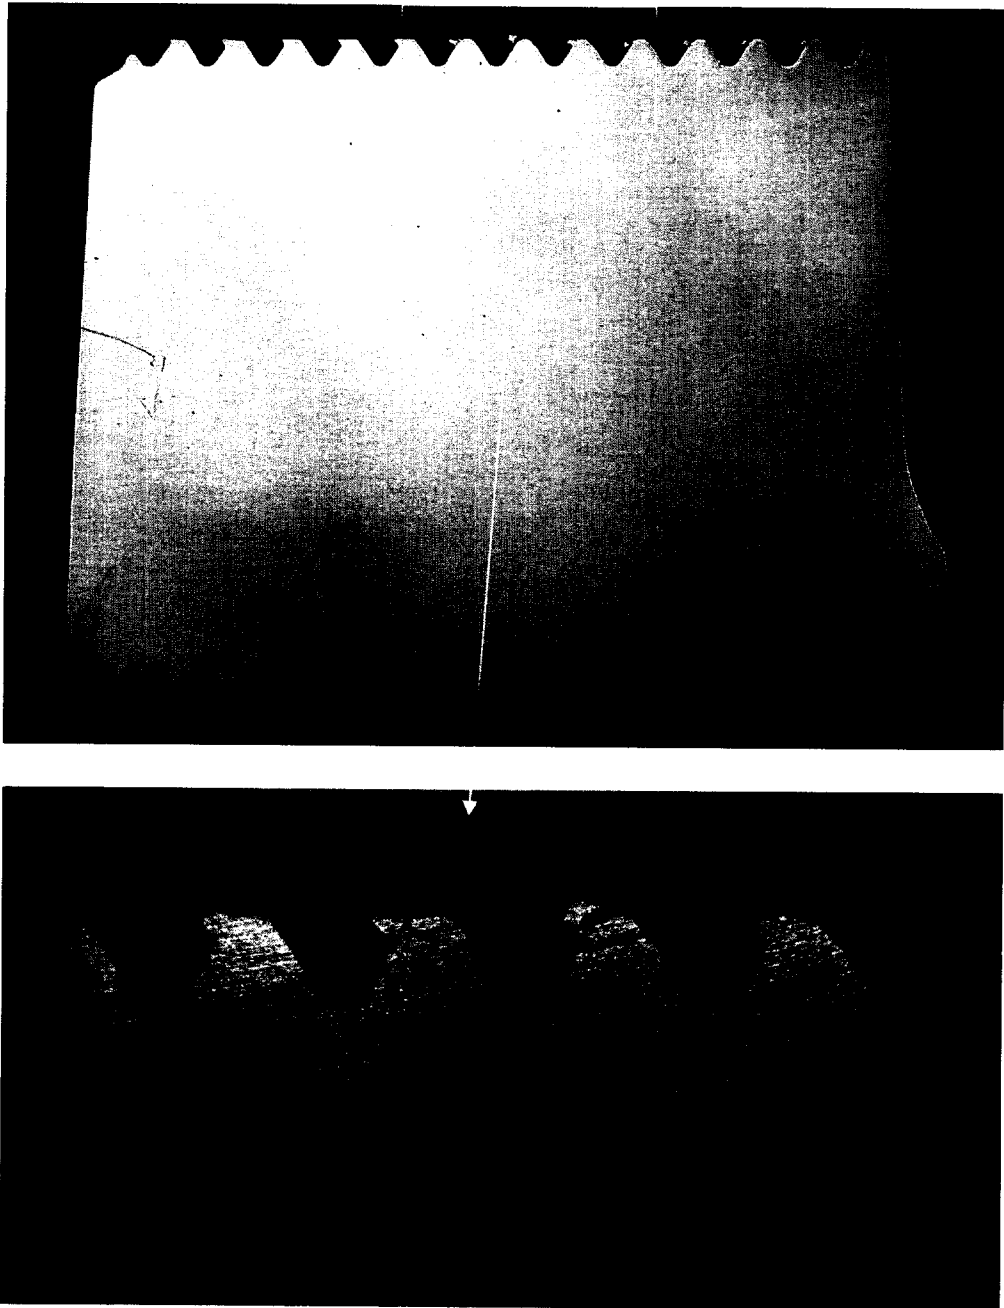
Figure 19: Longitudinal section of male thread showing some deformation/wear near top (example at arrow) and sheared off metal at the thread tip corners.

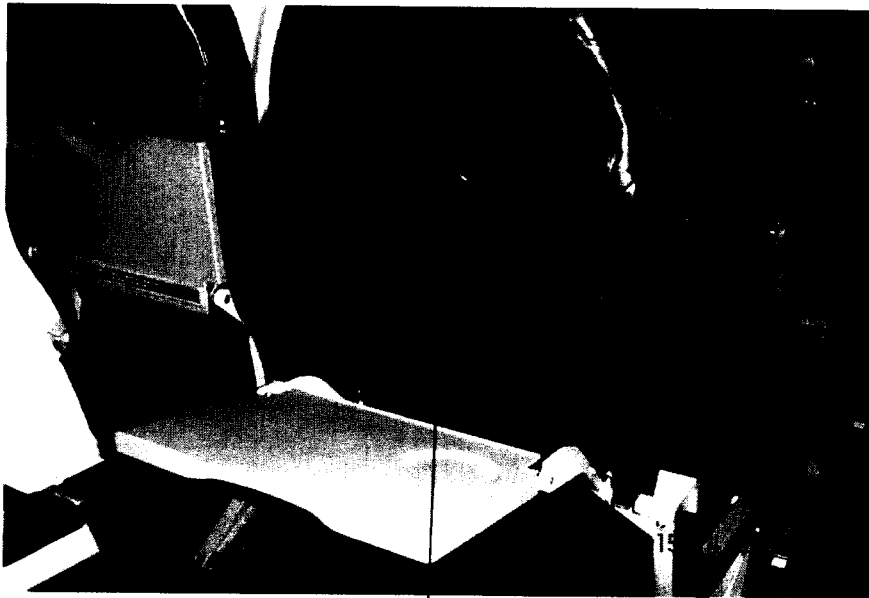
The latch of the meal tables was found slack and easy to move. The latch could rotate both to the left and to the right. All latch pins was found moved towards the aisle and therefore the tables could have been released during the emergency evacuation.

Figure E: Latch moved toward the aisle

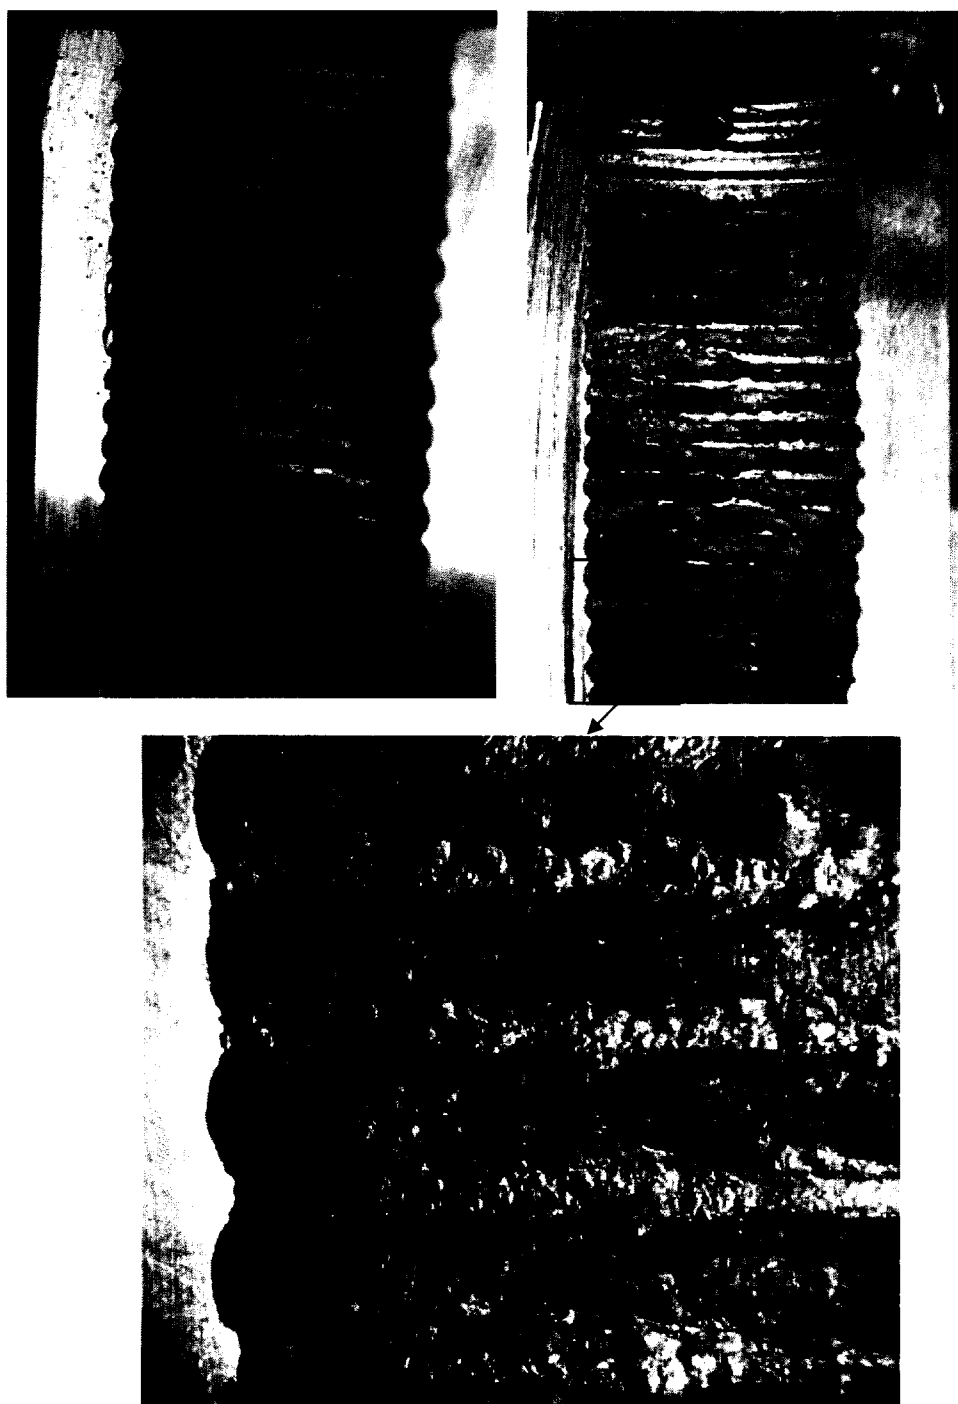
Figure 6: Part of piston rod in “as received” and cleaned condition. Note the severe corrosion of thread tops and bottoms.

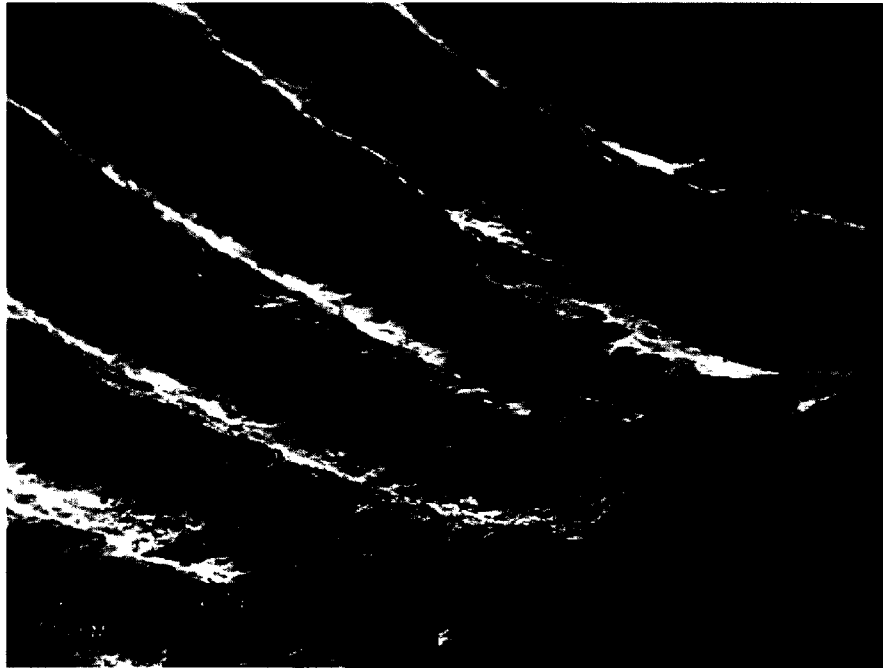
Figure 7: Scanning electron microscope image and metallographic section of severely corroded threads.

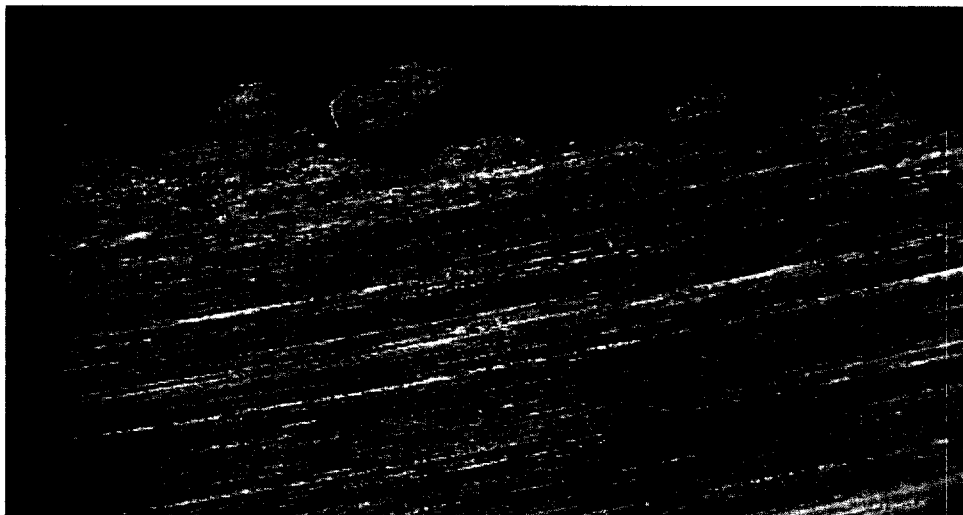
Figure 8: Metallographic section of severely corroded threads in Figure 7. Note that 2 of the threads are completely undermined by corrosion.

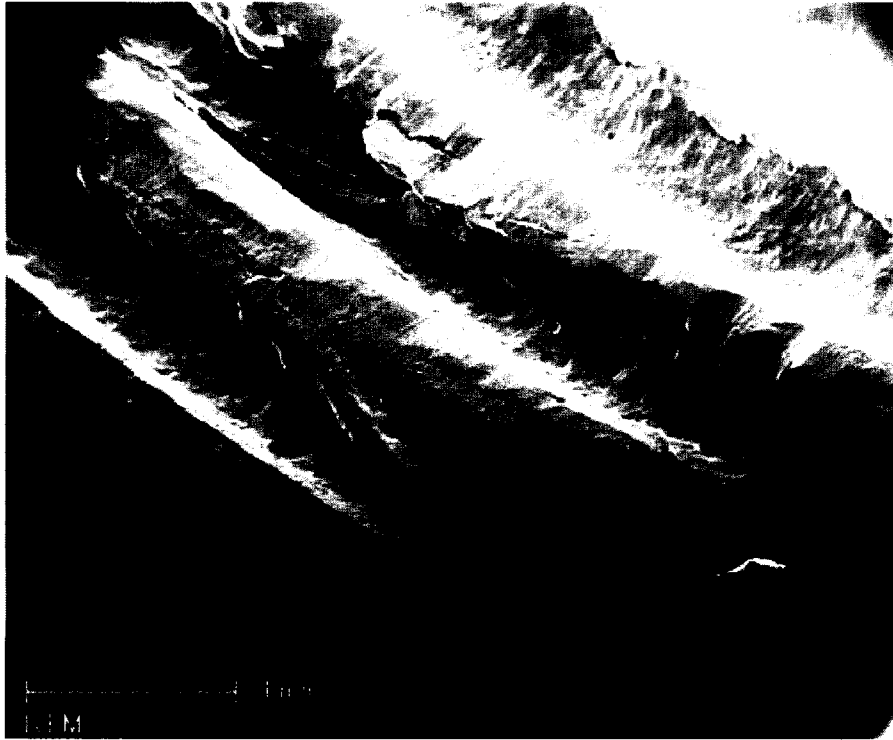
Figure 9: Scanning electron microscope image of threads at mouth of piston rod, showing shearing off of thread tops during final disengagement.

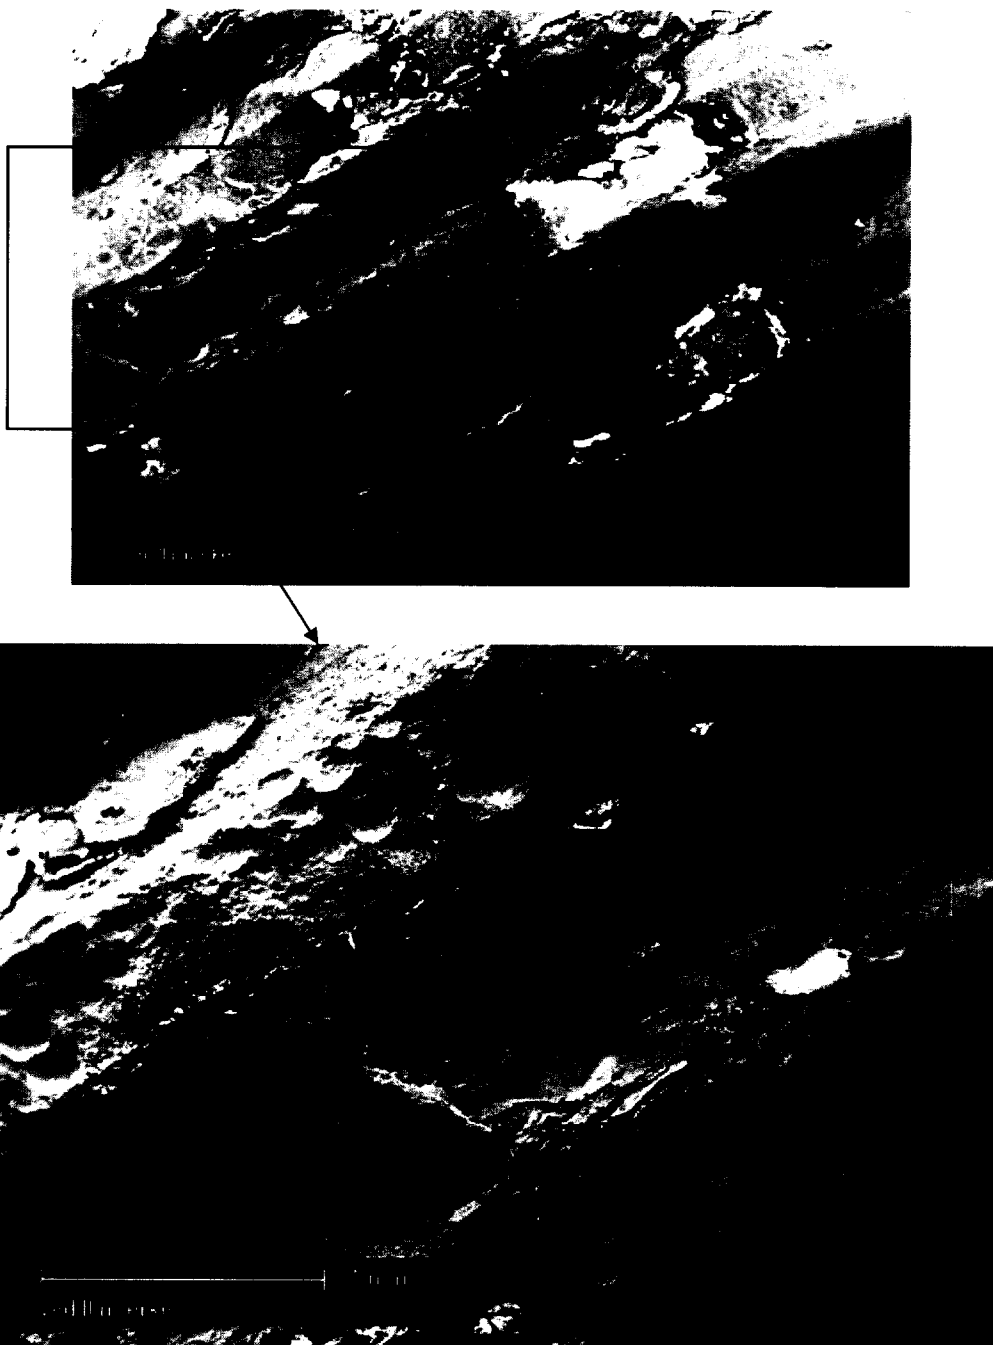
Figure 11: Scanning electron microscope images of non-engaged threads. Note the corrosion attacks in the thread tops.

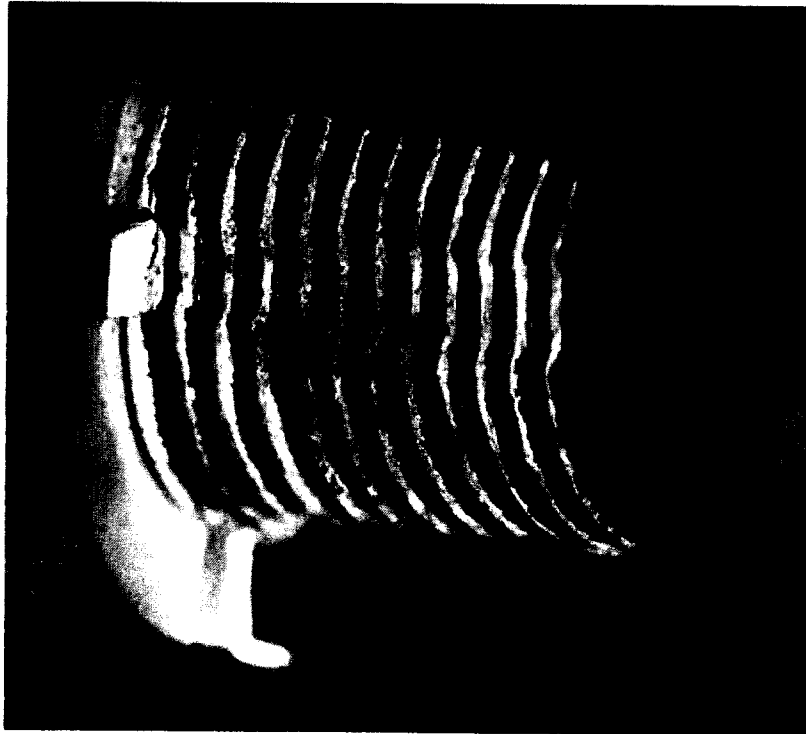
Figure 12: View of threads near piston rod mouth showing significantly less metal loss in the key way area.

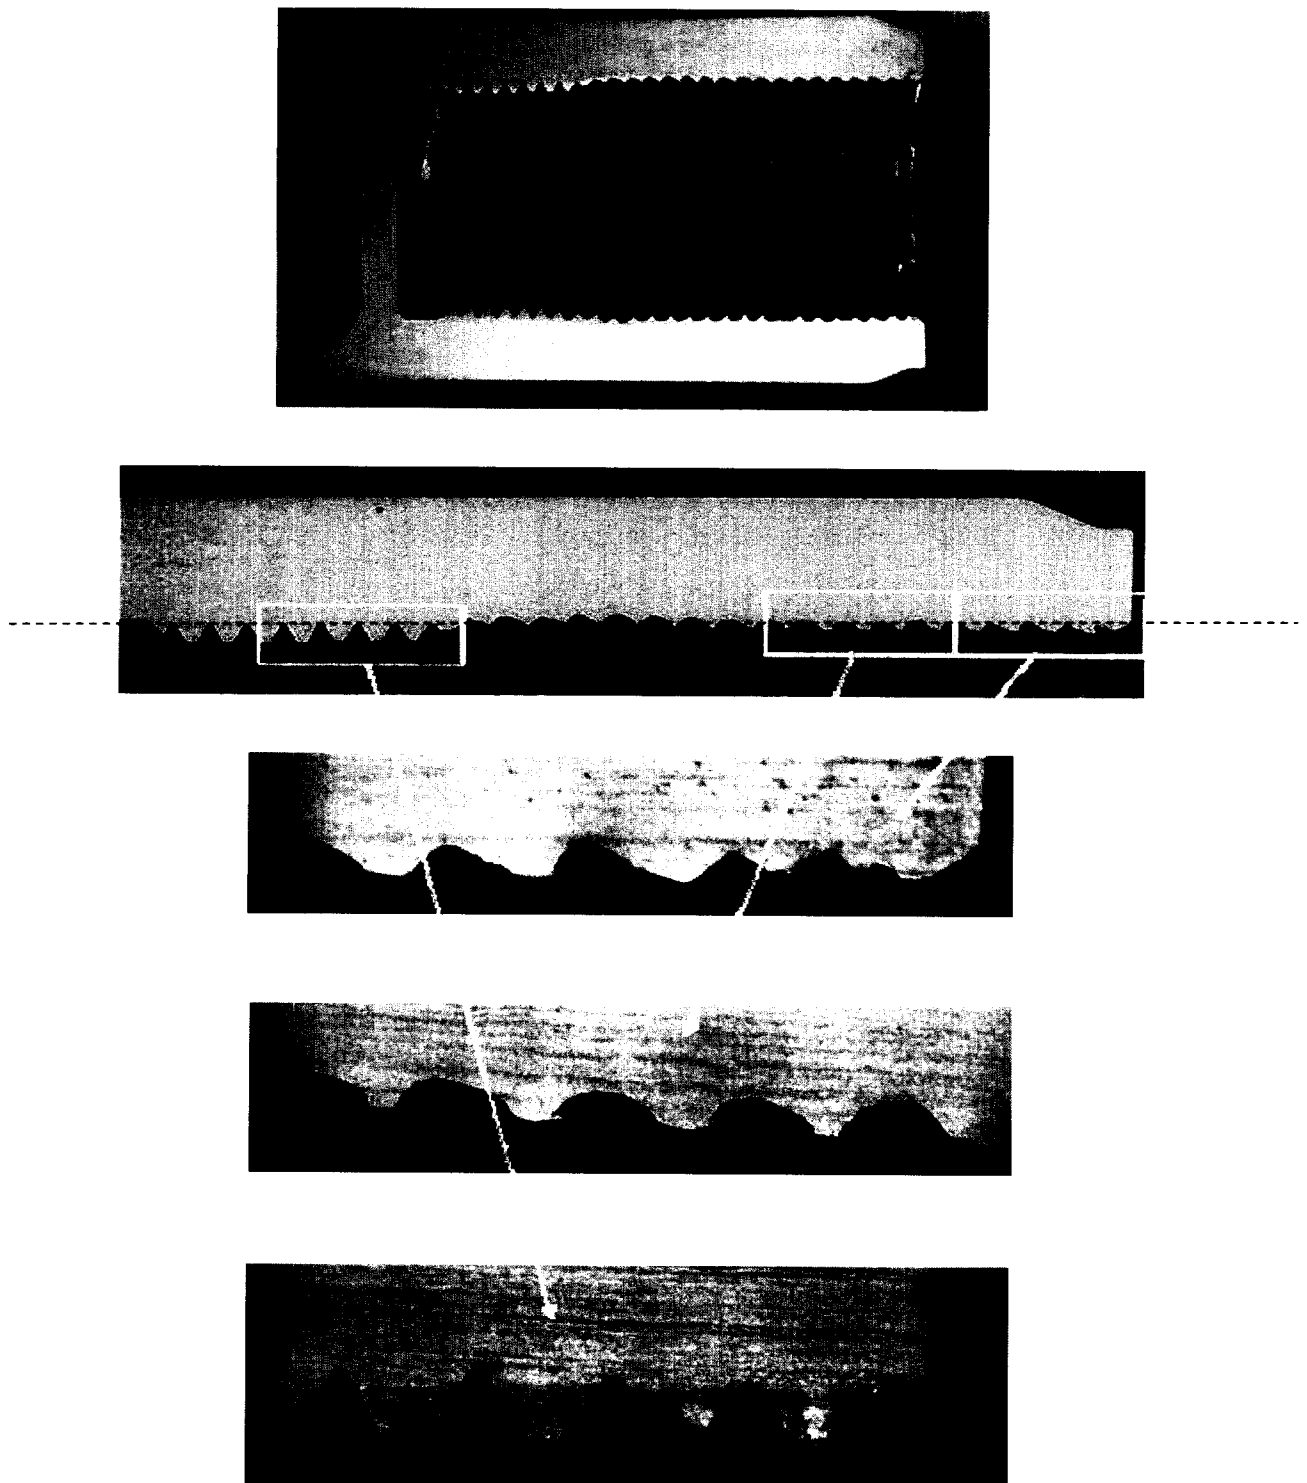
Figure 14: Illustration of the thread condition along the bore of the piston rod end. The super imposed dashed line shows the nominal thread depth.

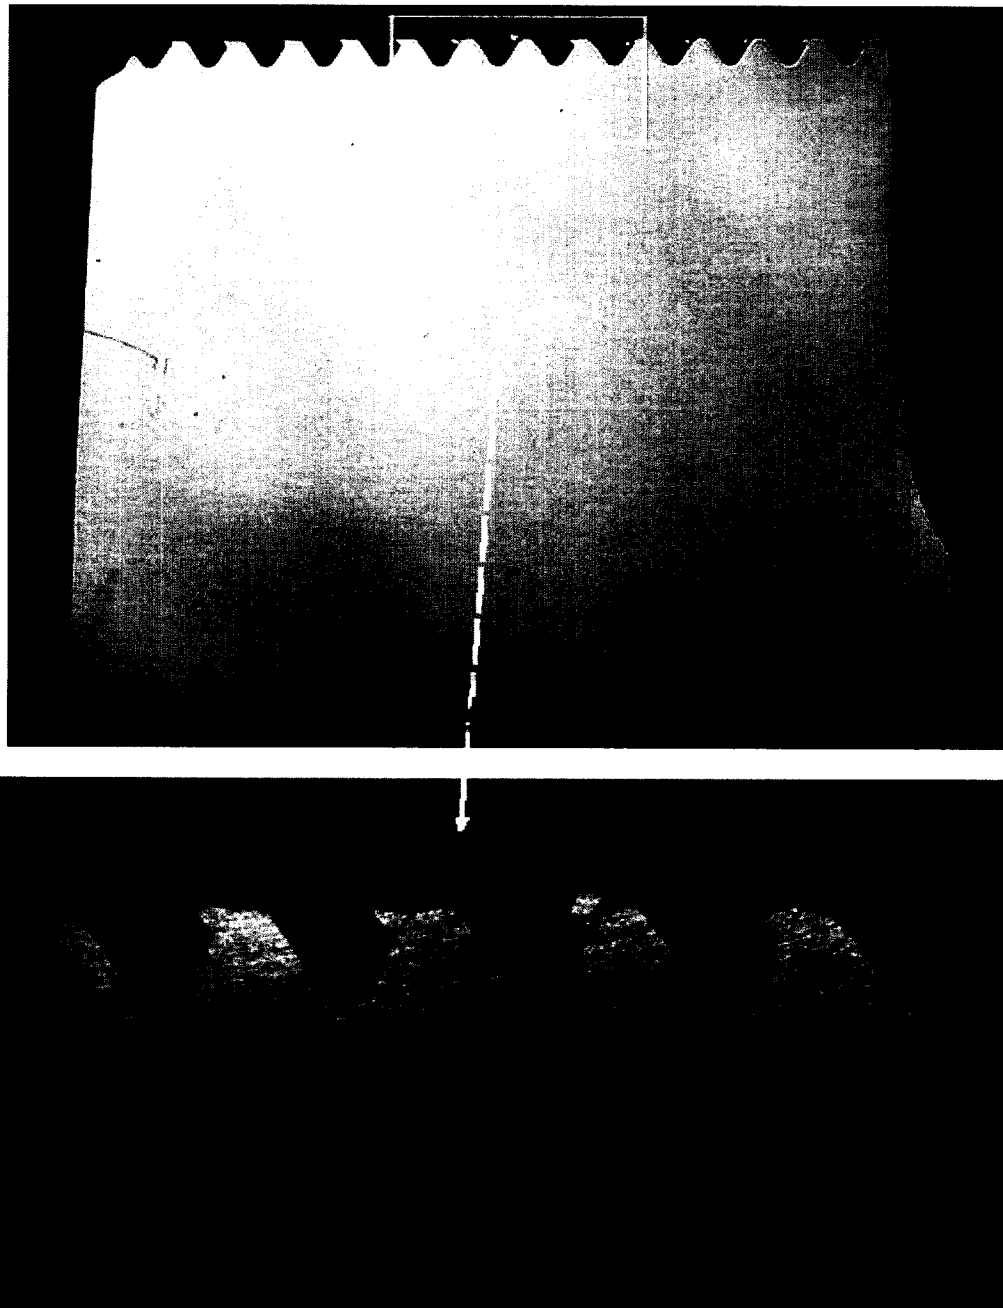
Figure 19: Longitudinal section of male thread showing some deformation/wear near top (example at arrow) and sheared off metal at the thread tip corners.

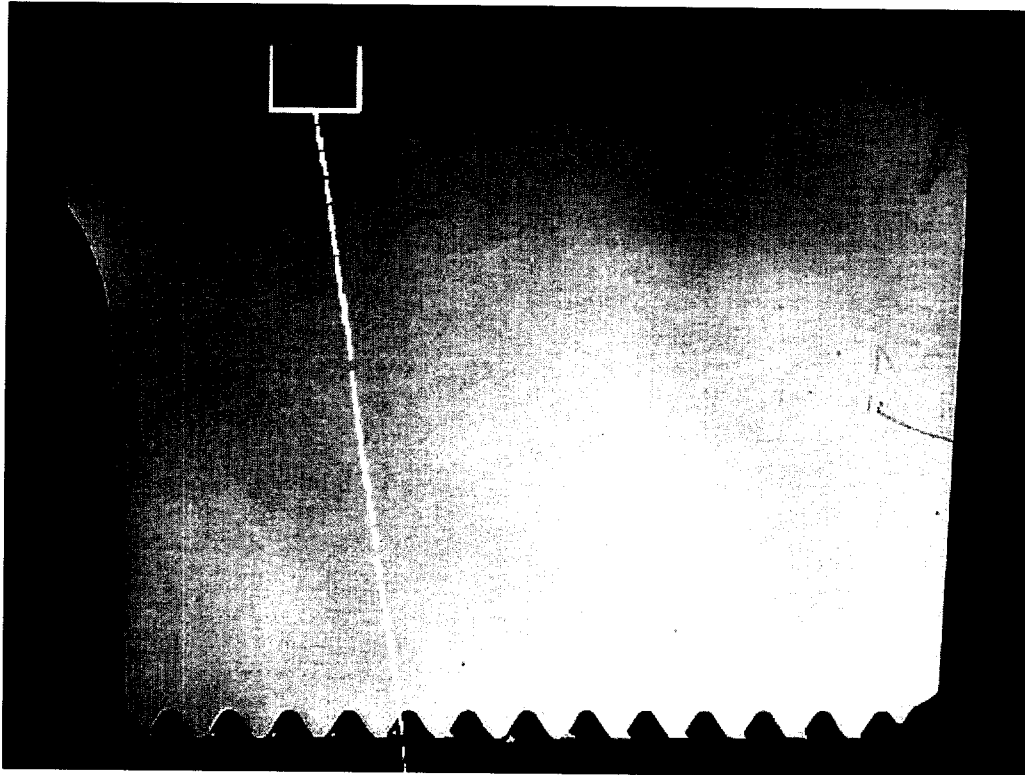
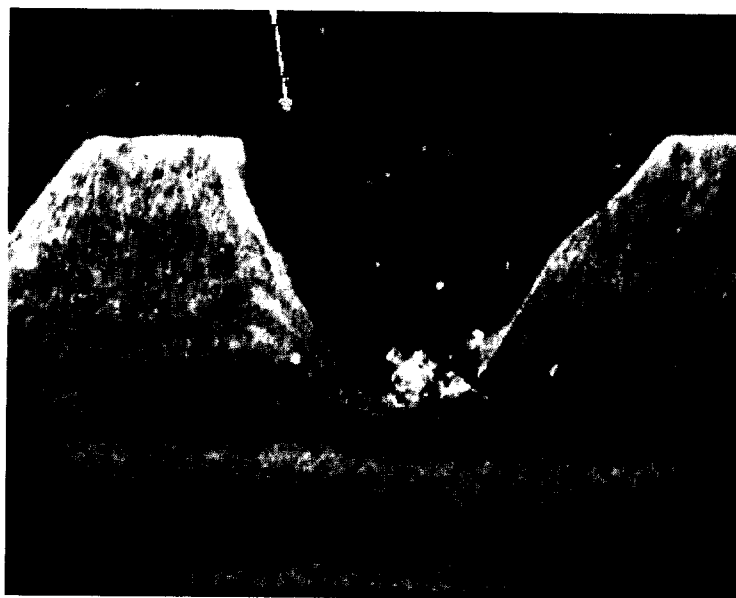
Figure 22: Minute crack in thread bottom.

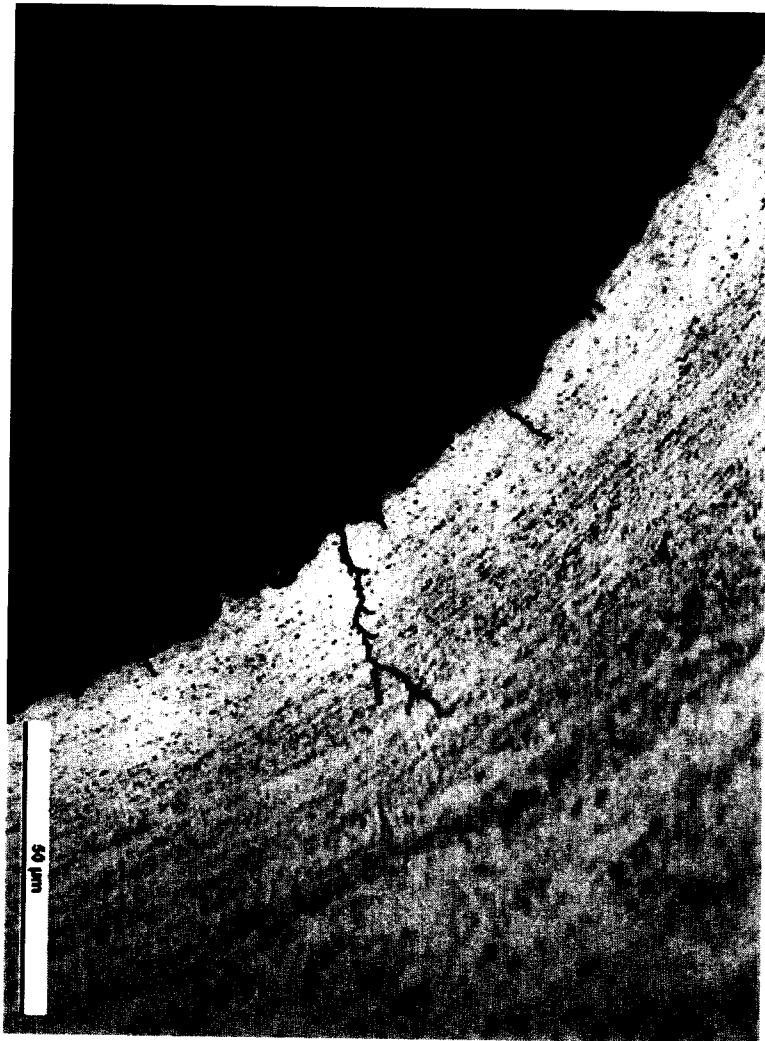
Figure 23: Example of crack in thread bottom.

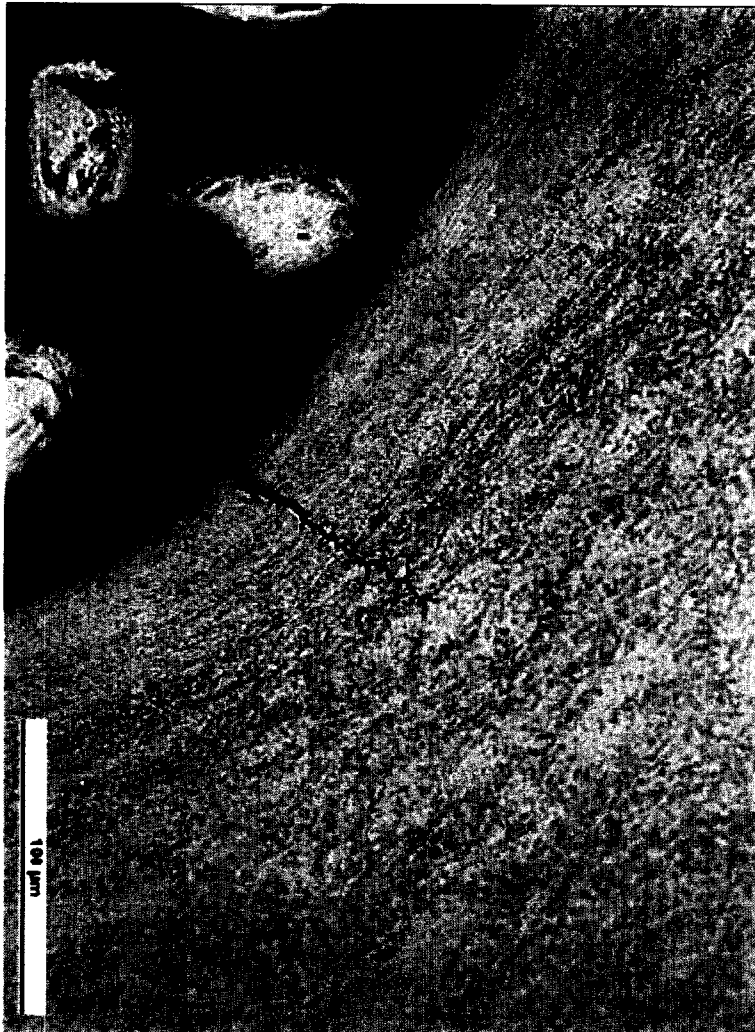
Figure 24: Example of crack in thread bottom.

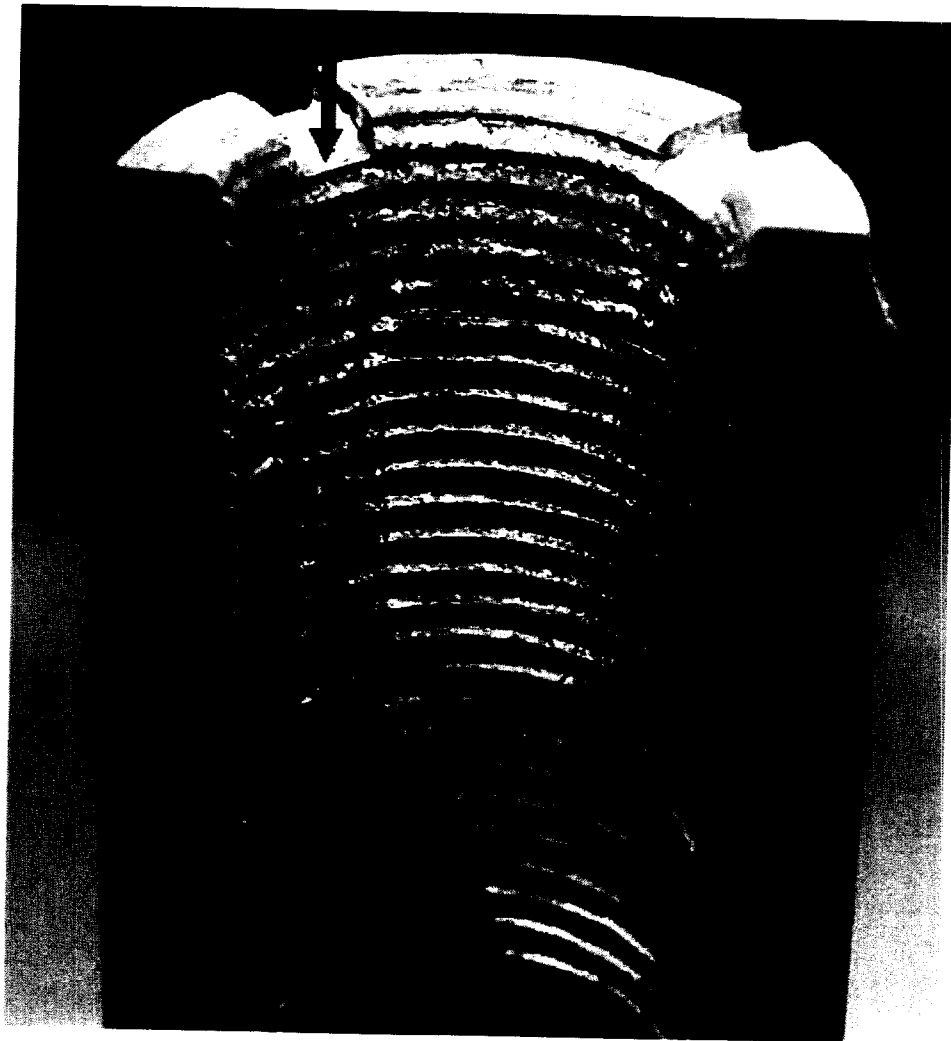
Figure 32: Overview of piston rod section showing less corrosion in the key way area (at arrow).

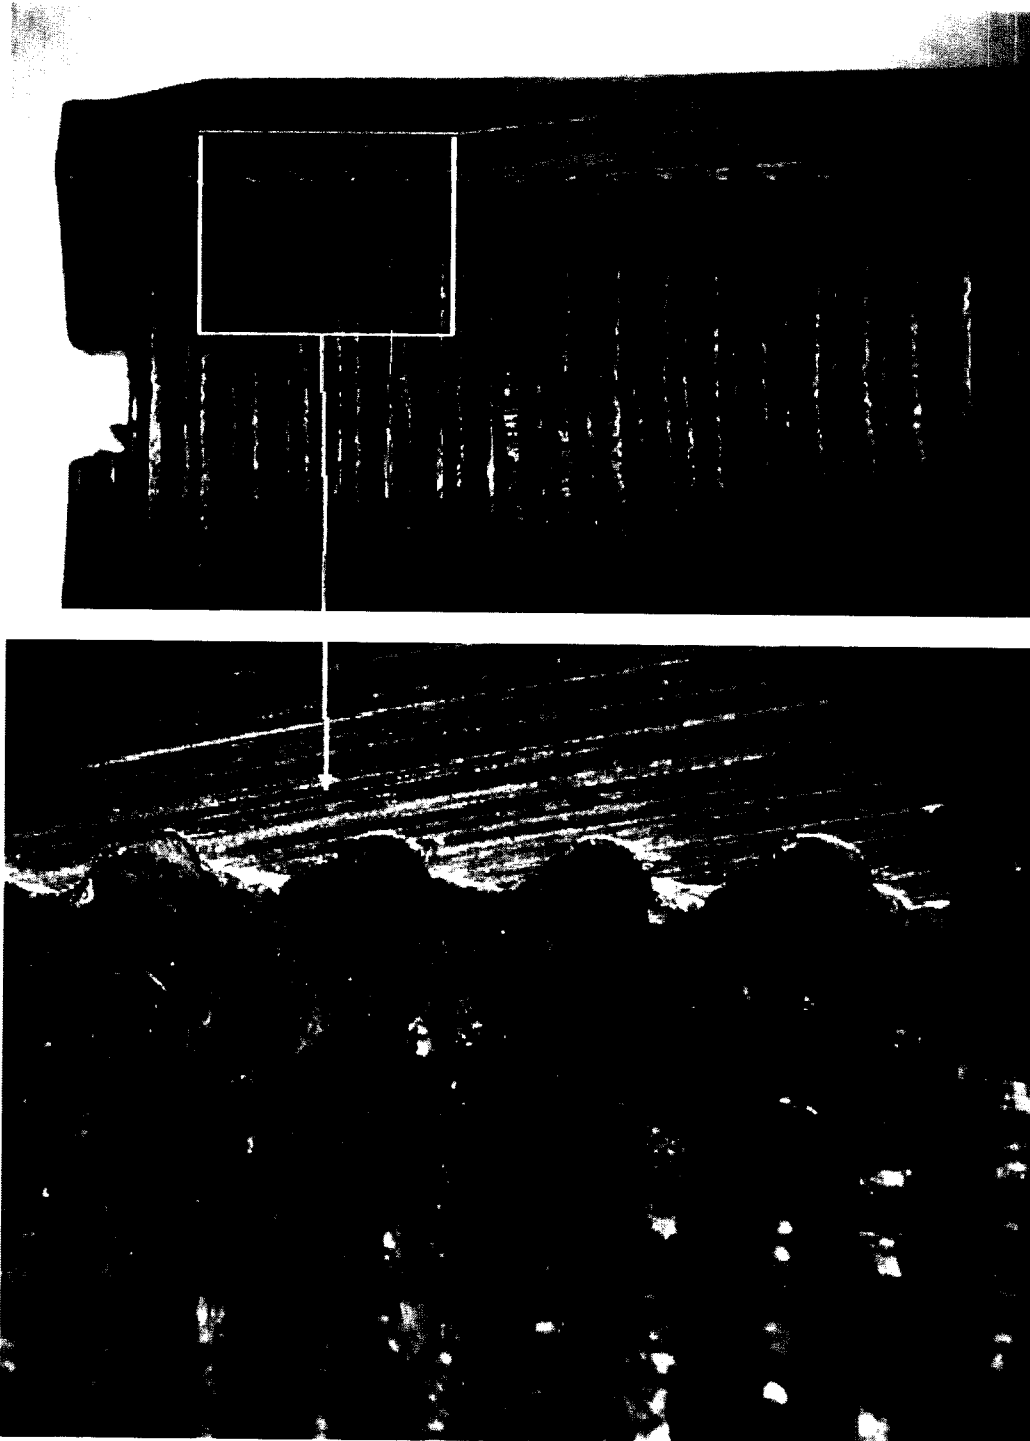
Figure 33: Corrosion attacks in piston rod threads. Note also the wear marks in thread top (example at arrow)

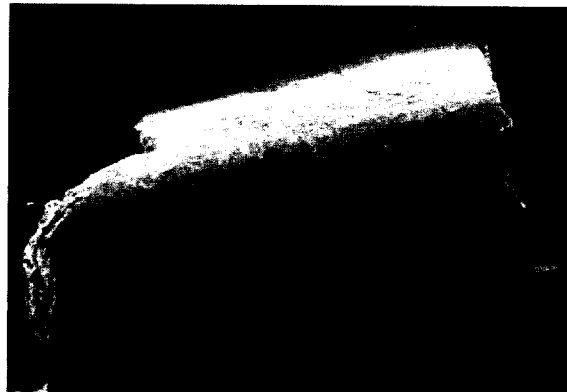
Figure 34: Left actuator piston rod end. The threads are partly filled with hard brittle scales that could be plied out easily. Bottom photos represent front and back sides of such plied-out scales.

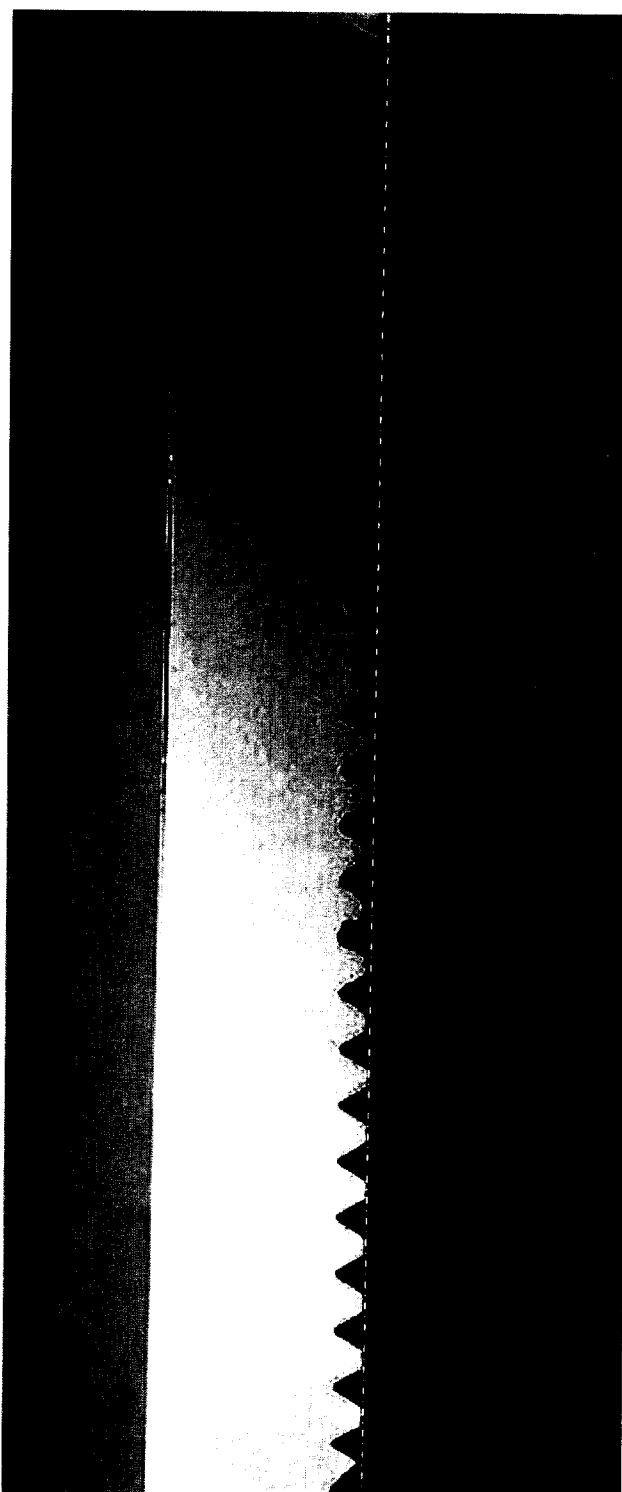
Figure 36: Longitudinal section of left actuator piston rod female thread showing distribution of corrosion along the threaded bore. The super imposed white line indicates the nominal thread top.

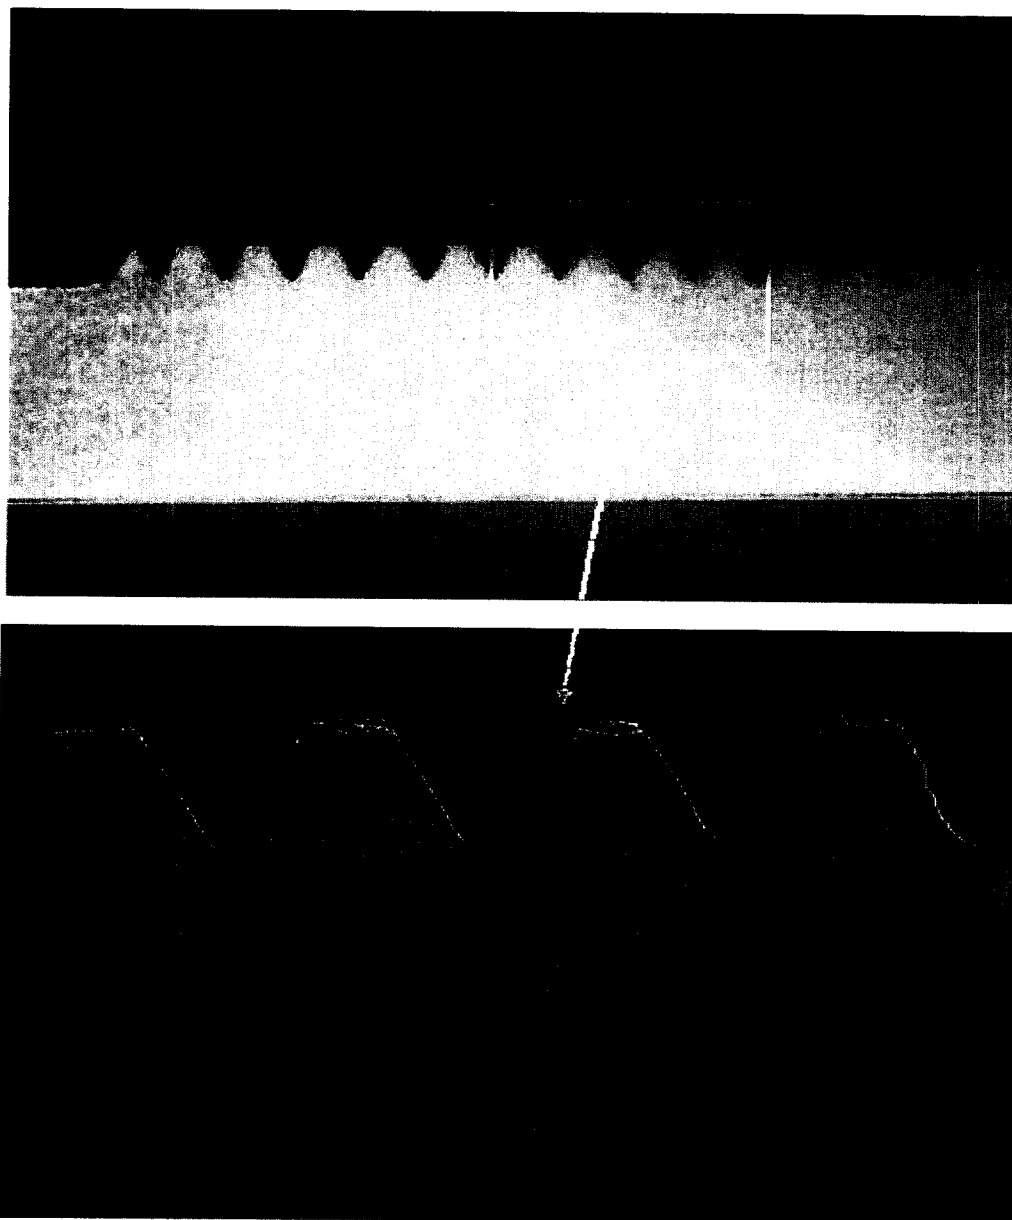
Figure 37: Left Retract Actuator Piston Rod. Small crack in last two engaged threads (at arrows).
