**Accident Investigation Board
Denmark**

HCLJ510-000433

Accident to Bombardier DHC-8-400,
registration LN-RDK,
at Aalborg Airport (Denmark),
on 9 September 2007

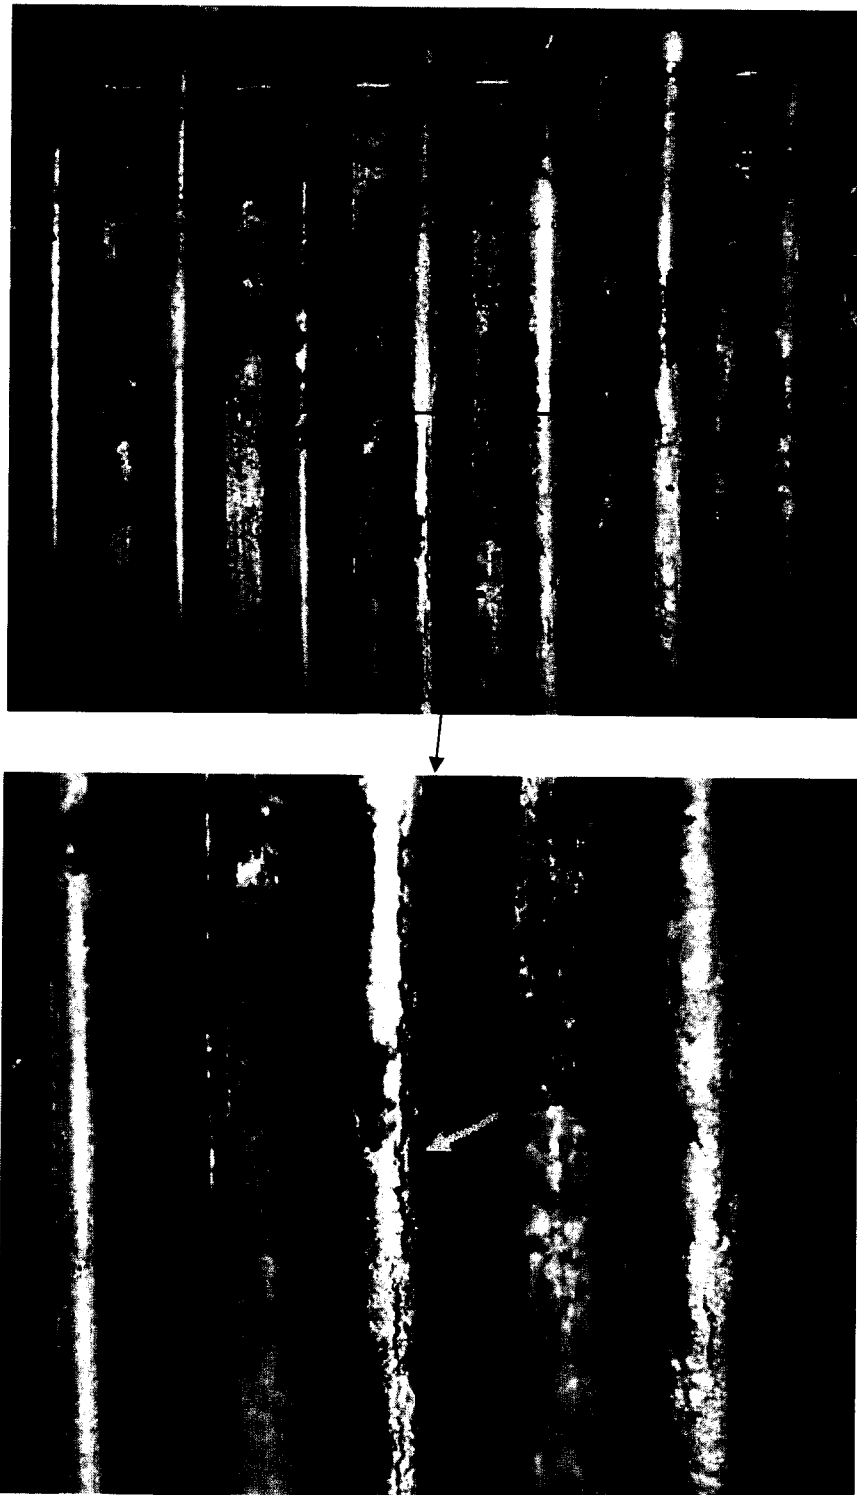
Figure 39: Light optical view of cracks in thread bottom of last engaged thread.

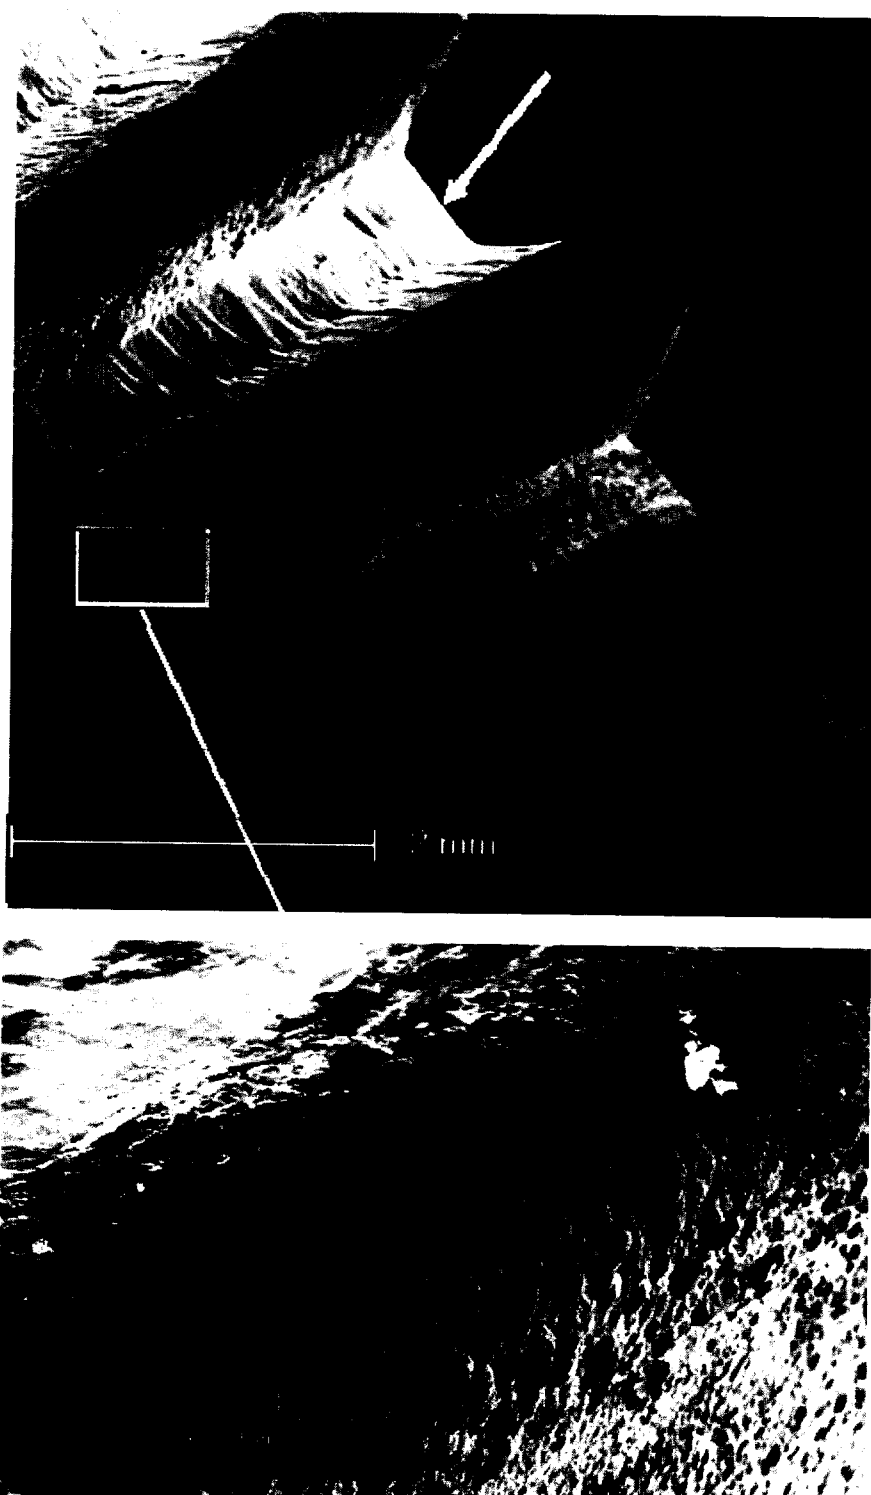
Figure 40: Scanning electron microscope images of cracks in last engaged thread. Note also the evidence of polishing wear in thread top at arrow in the top photo.

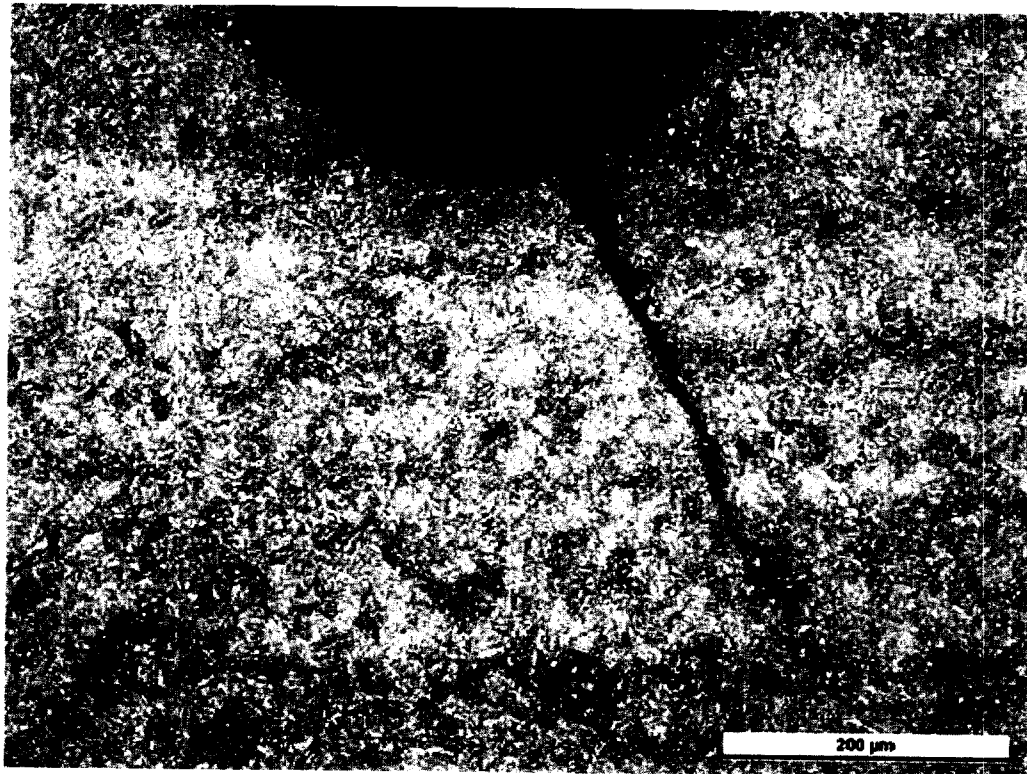
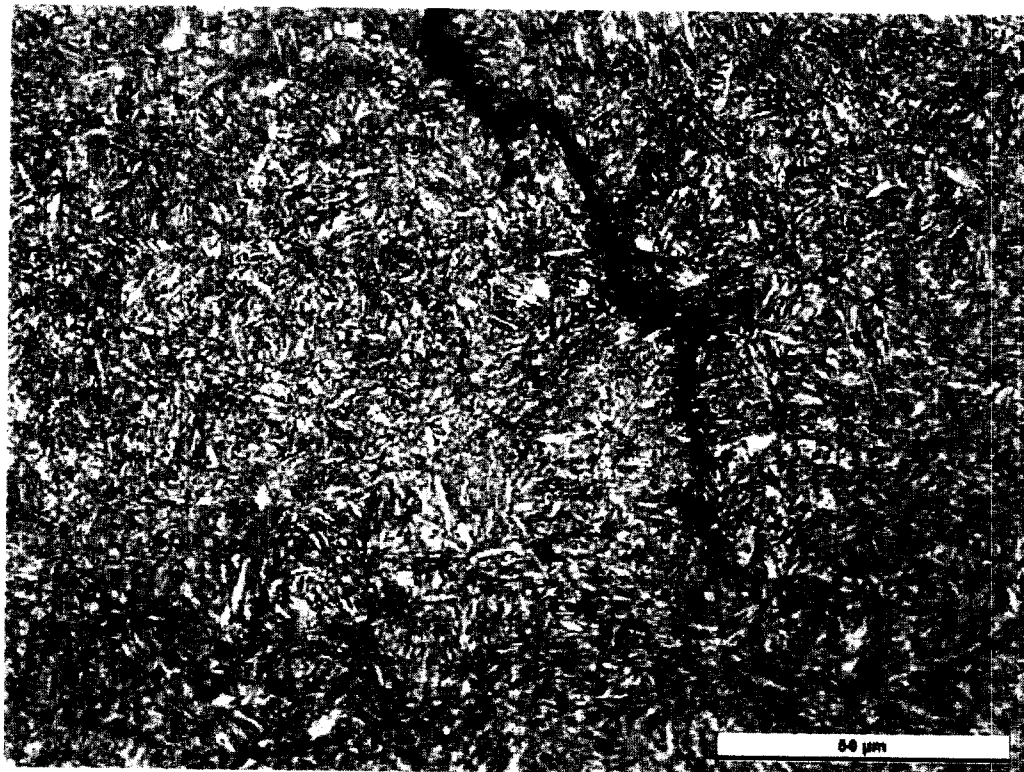
Figure 41: Metallographic section of crack in last engaged thread.

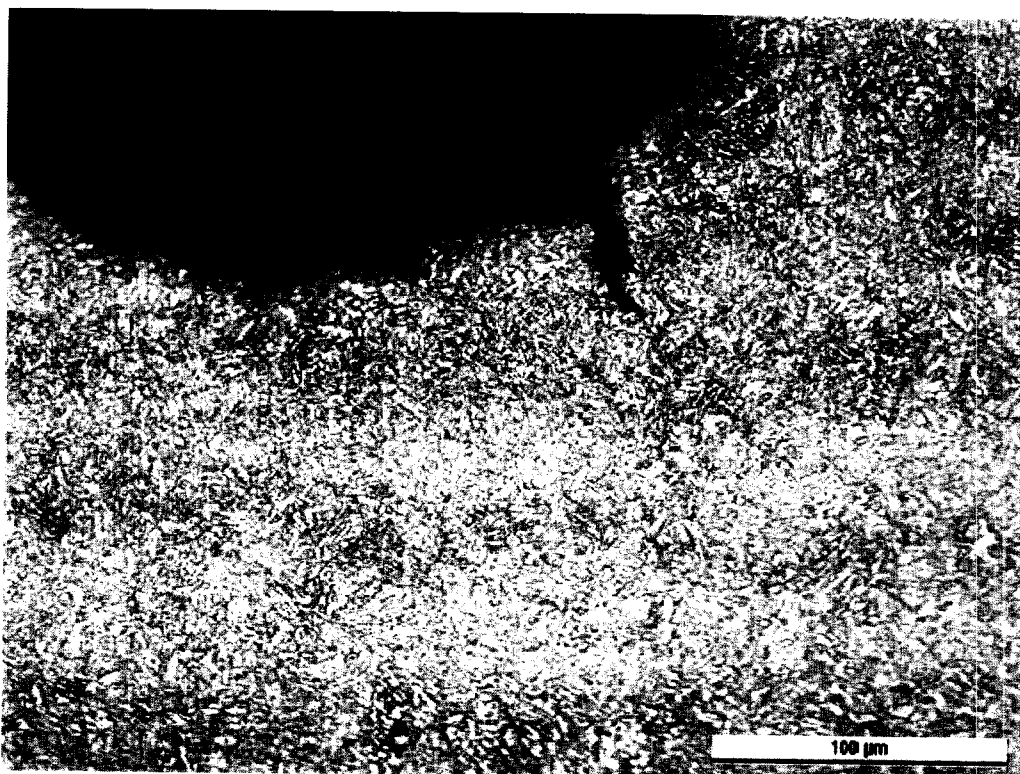
Figure 42: Metallographic section of crack in neighbour thread to last engaged thread.

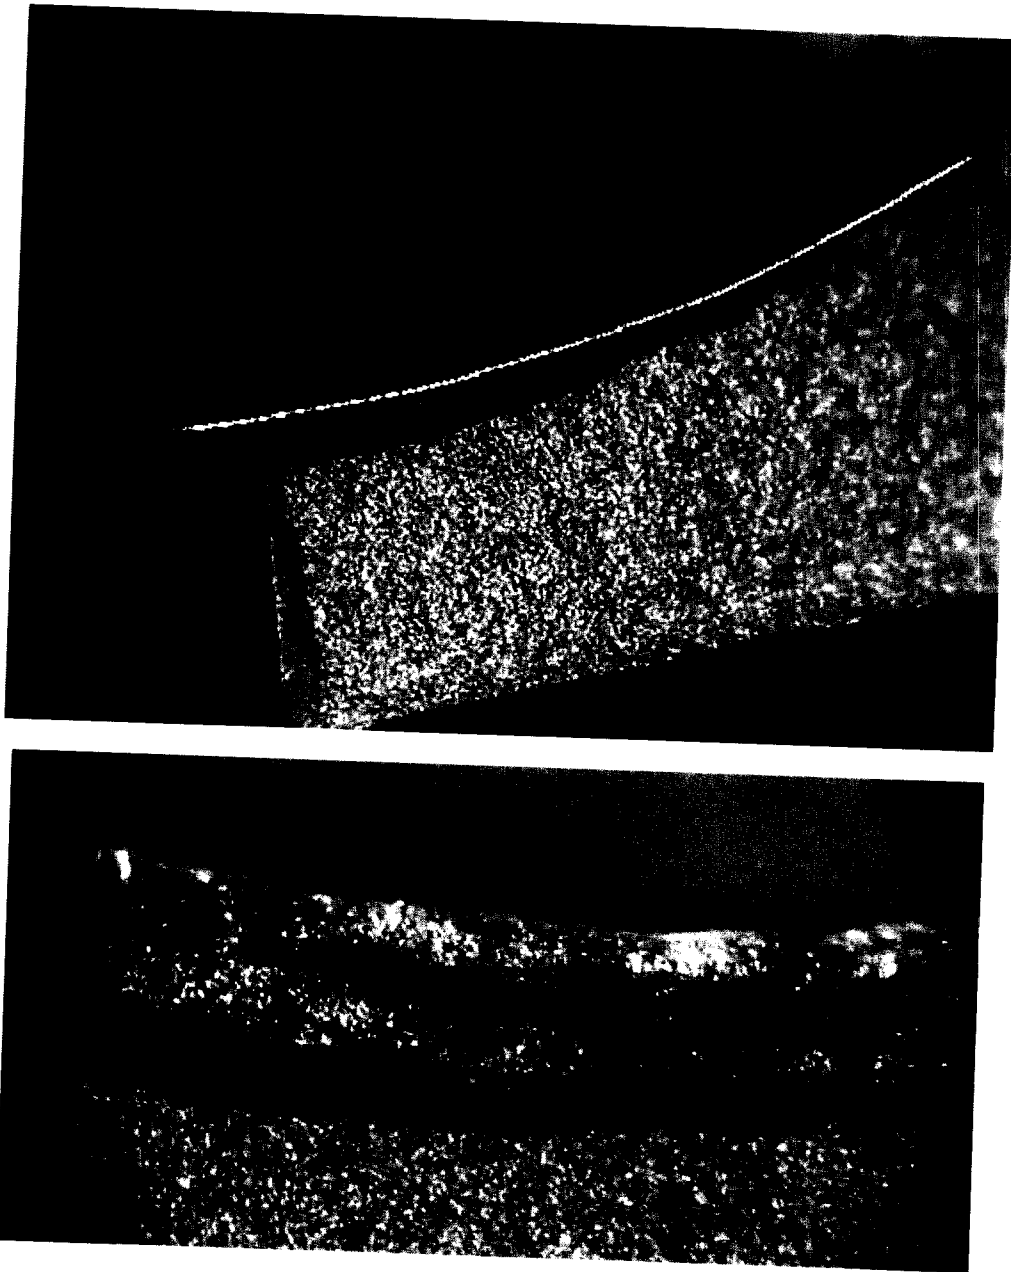
Figure 43: Free-laid crack surface. Yellow line indicates bottom of thread. The black occurring crack surface has the macroscopic appearance of fatigue cracking.

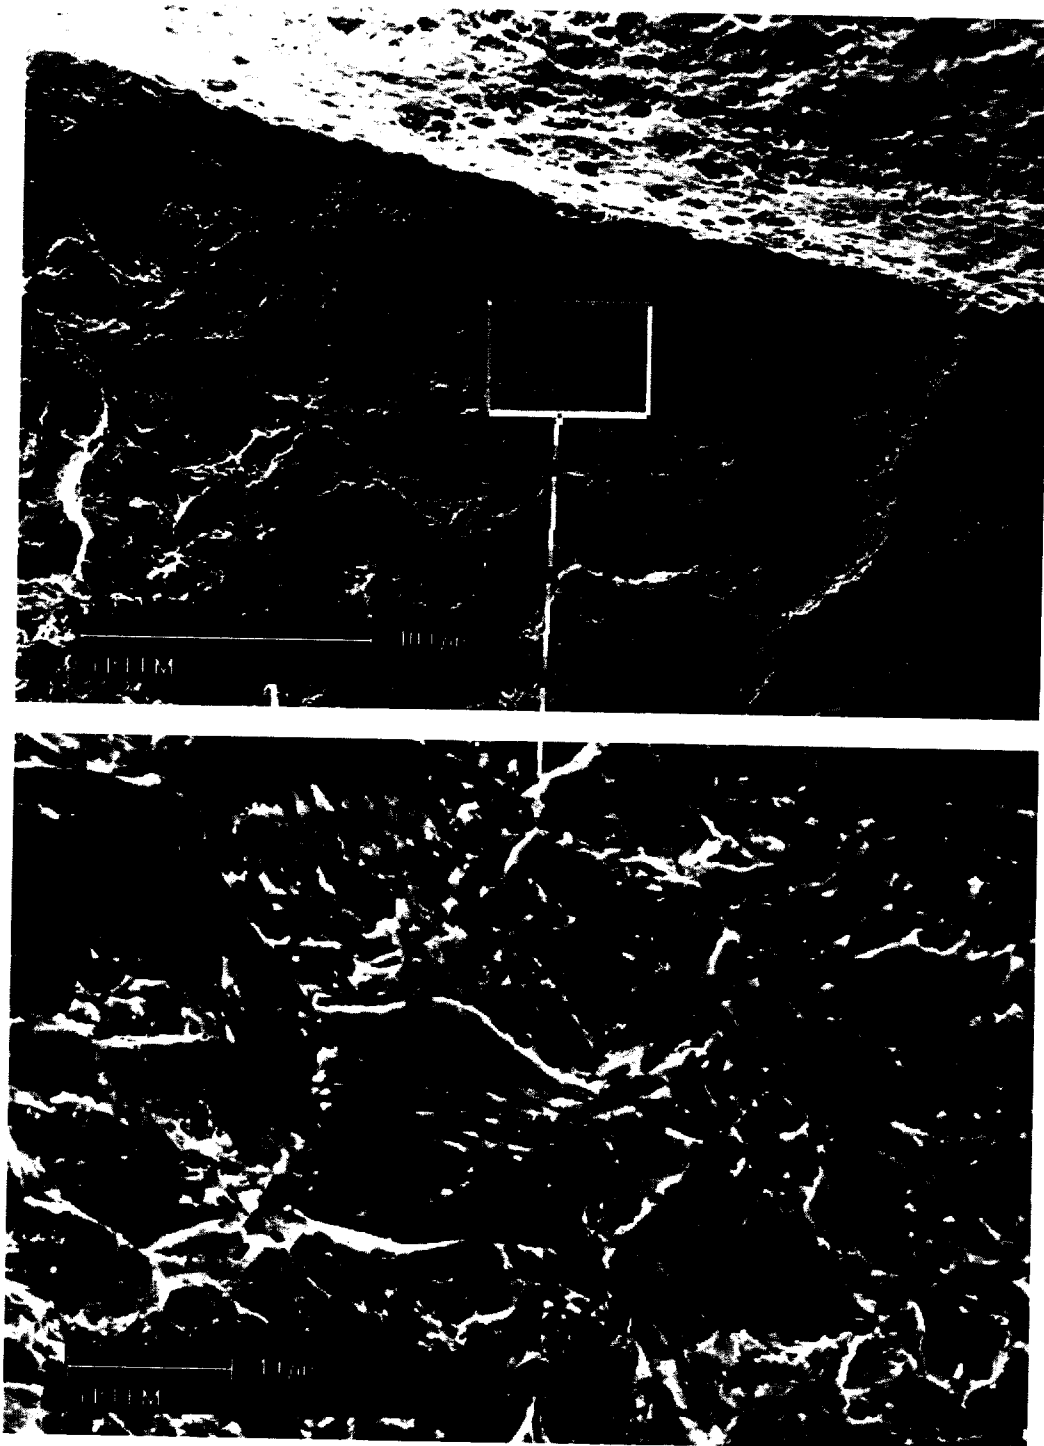
Figure 45: Typical area of crack near the surface. The appearance is typical of (low cycle) fatigue in high strength steel.
