**Accident Investigation Board  
Denmark**

**Final Report  
HCLJ510-000449**

Accident to Bombardier DHC-8-402  
Registration LN-RDI  
At Copenhagen Airport Kastrup (Denmark)  
On 27 October 2007

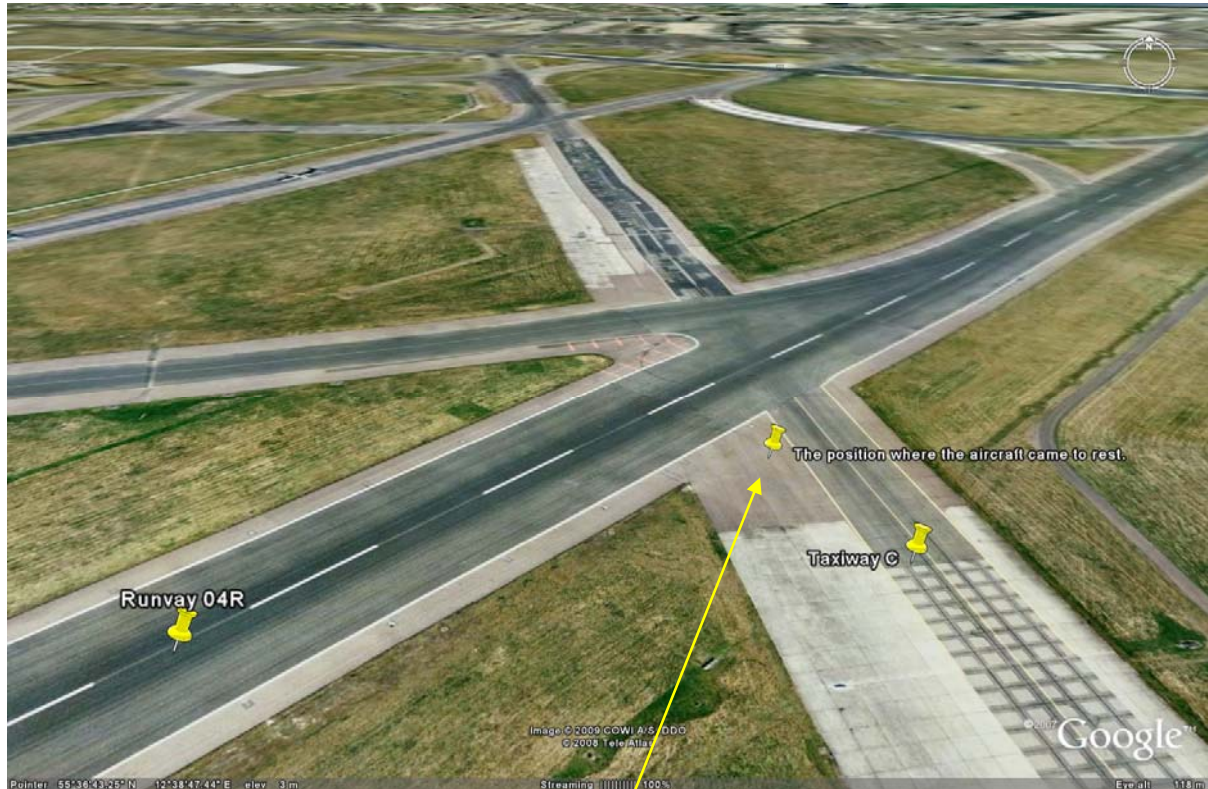
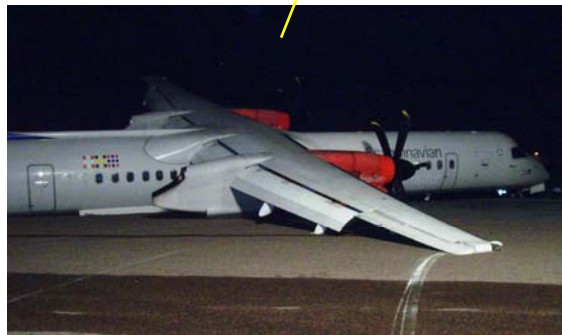
After touchdown, the aircraft rolled 7 seconds before the right propeller and the aft part of the fuselage made contact with the runway surface. 15 seconds after touchdown, the right wingtip made contact with the runway surface. 27 seconds after touchdown, the aircraft came to rest on taxiway C area heading southeast 115°.

Before landing, the right engine was shut down. Four propeller blades were damaged as a result of ground contact. The aft lower fuselage was damaged while skidding on the runway asphalt. The NLG right tire deflated and the NLG was damaged when the aircraft side slipped into taxiway C. The right outer wing sustained minor damage while skidding on the runway asphalt and concrete. The fuselage surrounding the cabin area was undamaged.

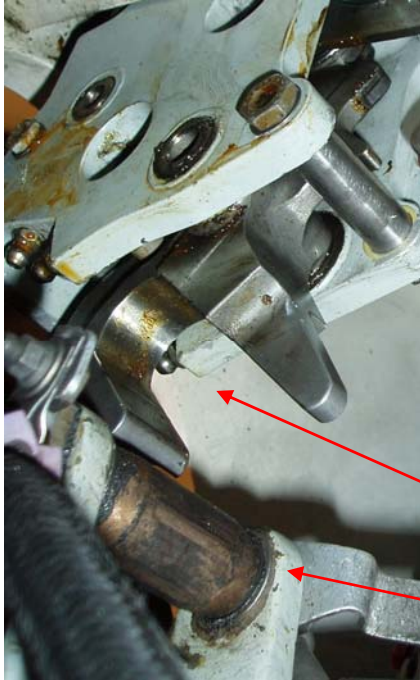
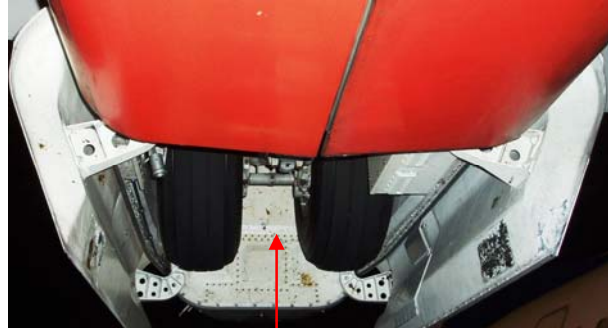
The MLG was found released from the up-lock hook but stuck in a position approximately 10 cm down from the hook.

MLG position in the right MLG wheel well

MLG up-lock hook found released

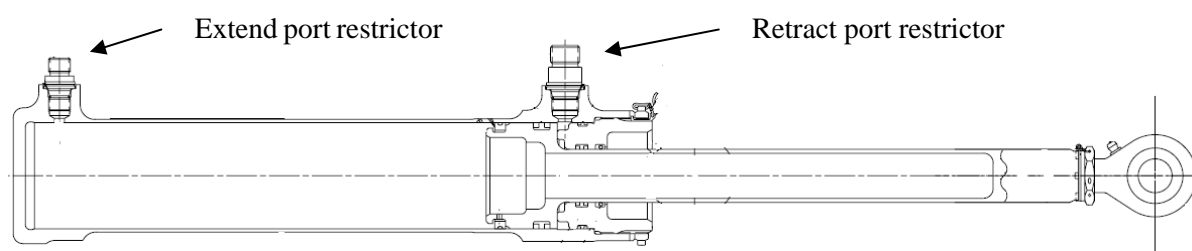
MLG Retraction/Extension Actuator

The extend port restrictor was removed and appeared to be clean as light could be seen through it. The Retract Port Restrictor was removed and appeared to be blocked, as light could not be seen through it.

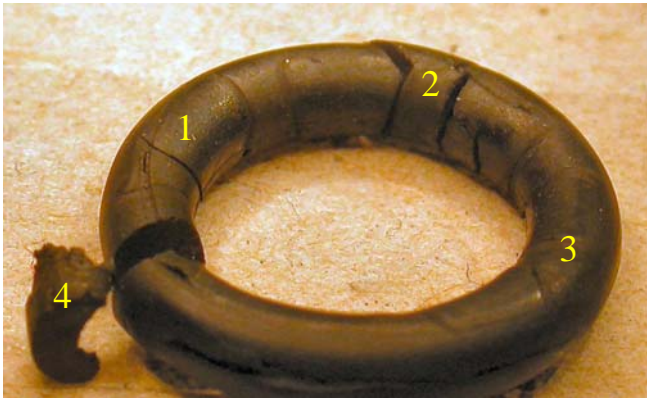
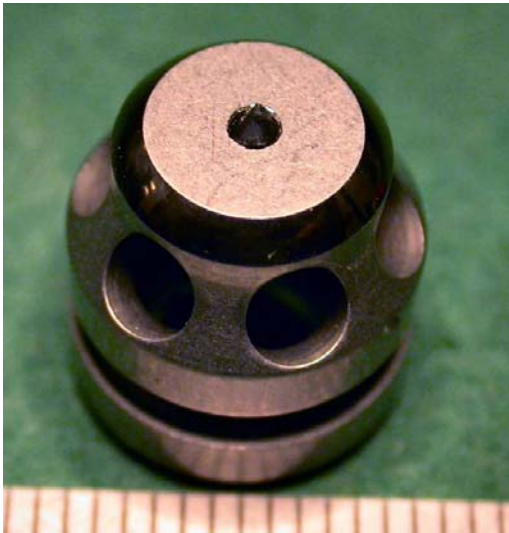
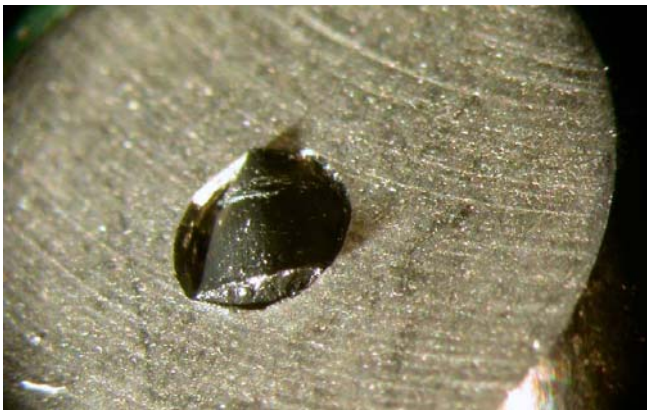
Removing the large orifice situated behind the Floating Valve in the restrictor allowed a view of the valve interior. A broken O-ring was partly emerging through one of the flow relief holes. When the Floating Valve was removed from the restrictor housing, a damaged O-ring was found in four pieces. The small orifice in the Floating Valve was blocked by a piece of O-ring material that matched the missing part of the No. 4 piece of O-ring (pictures below).

Top left: Reassembled O-ring from the four pieces found in the floating valve.

Top right: The small orifice hole in the floating valve is seen blocked by a piece of the O-ring.

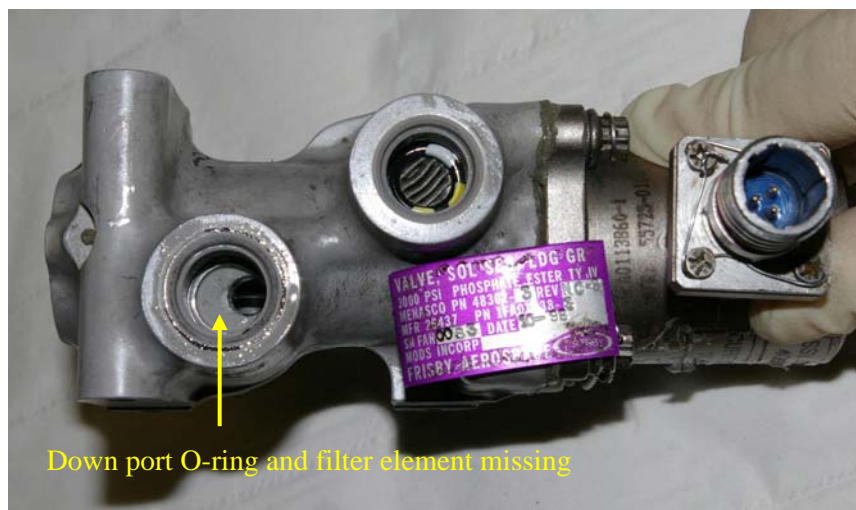
The examination revealed that the filter element and the O-ring were not present in the down port of the SSV (shown below).

Microscopic inspection of the down port, from which the filter and the O-ring were missing, showed damage in form of linear score marks and nicks both inside the drill bore and around the entrance of the bore. For comparison, the up port O-ring and filter were removed and the up port inspected. This port showed no evidence of damage.

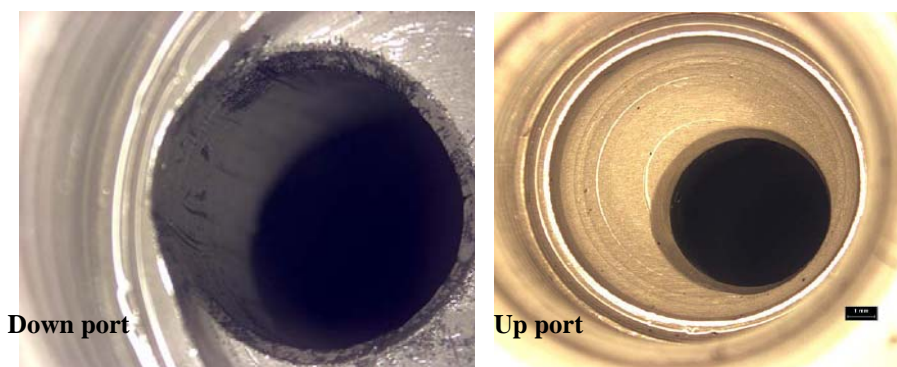
The down and up port drill bores is shown below.

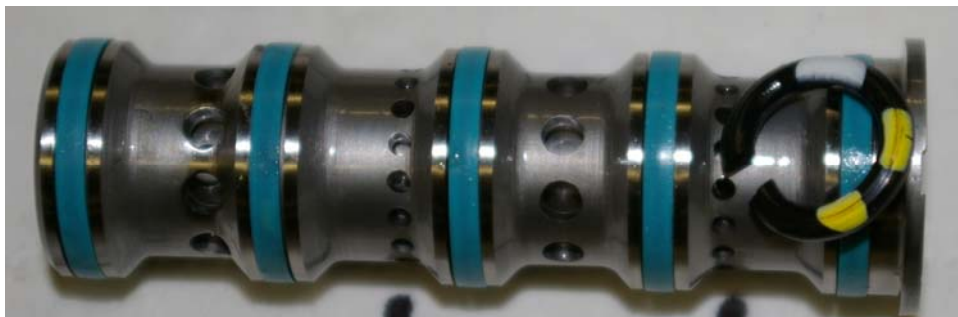
Examination of the SSV showed that passage of a cross section 0.103 +/- 0.003 inch O-ring (NAS1611-110) was not possible due to the sleeve hole diameter (0.069 inch/0.073 inch) inside the SSV.

Sleeve from SSV S/N FAH-0083 and a NAS1611-110 O-ring are shown below.

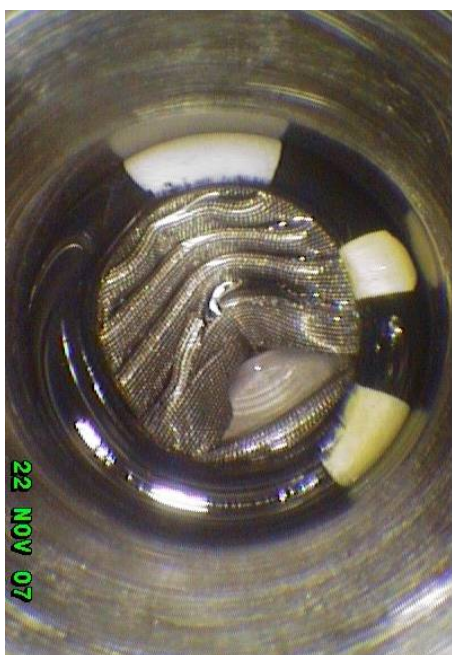
Left:  
The filter element is damaged but still in place behind the o-ring.

Right:  
Collapsed filter element and damaged o-ring.

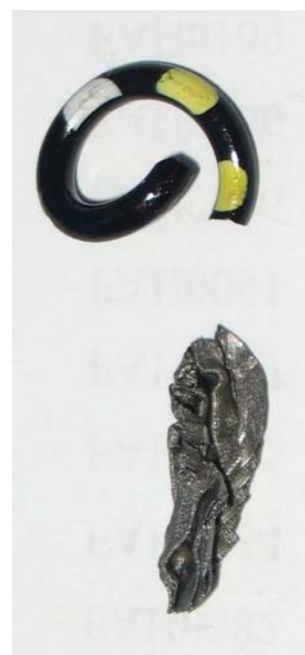
Below:  
Collapsed filter element migrated into the SSV port drill bore.

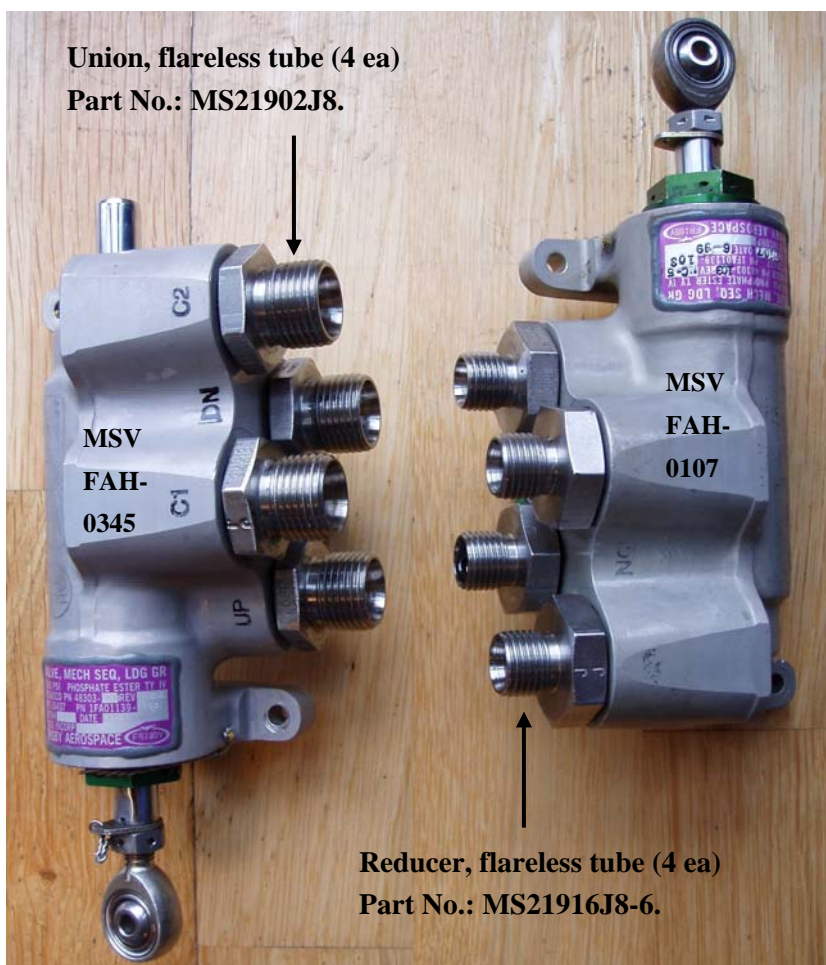
The MSV was found to be configured with unions different from these attached to MSV S/N FAH-0345. There were no other findings or remarks.

Note: The MSV FAH-0107 is shown as it was found by the investigation team in the storage system.

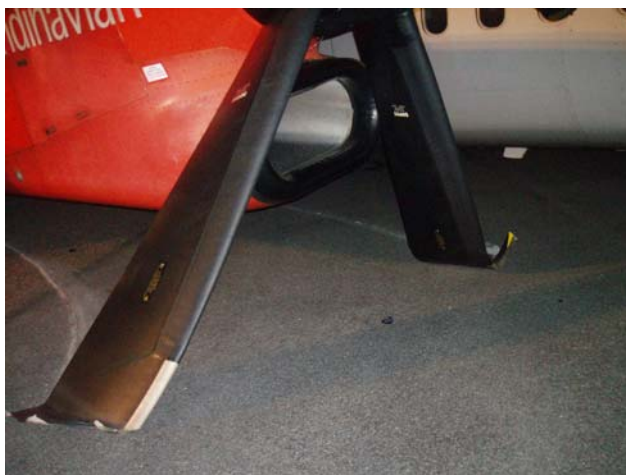
As mentioned in Section 1.12.1, the right engine was shut down by the flight crew before landing to minimize the risk of propeller blade or blade debris separation and penetration into the cabin area fuselage. Four propeller blades were damaged while skidding on the runway asphalt (following picture), but no debris separations from the engine or the non powered propeller occurred and the fuselage surrounding the cabin area was undamaged.

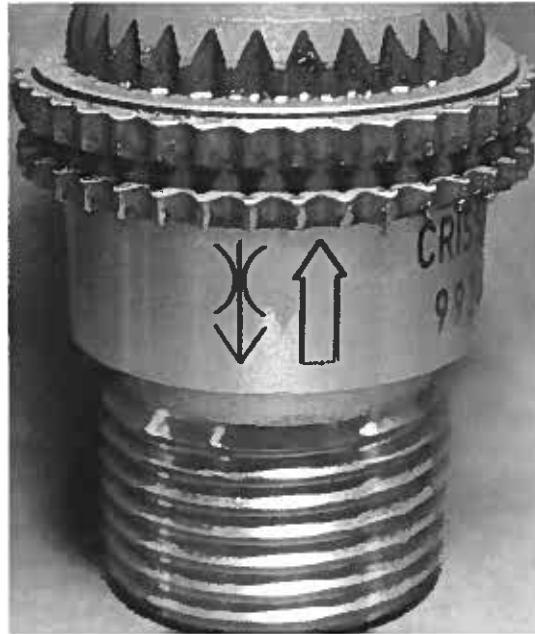
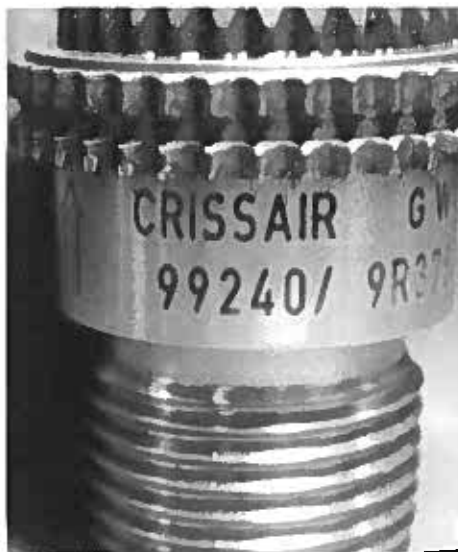
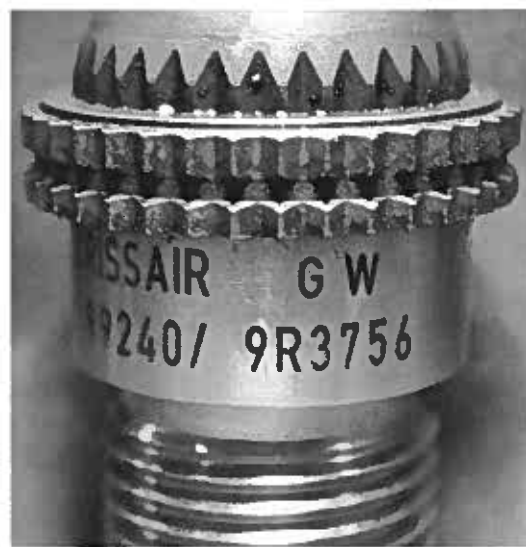
Figure 1: External views of the blocked flow restrictor (labelled SN 074).

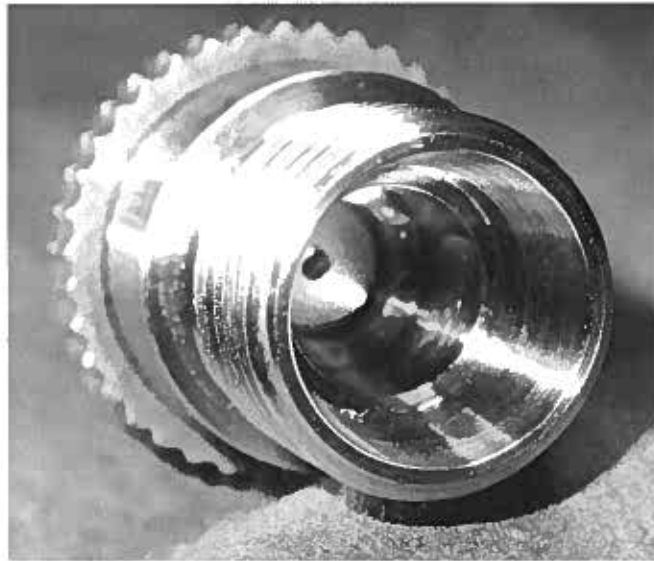
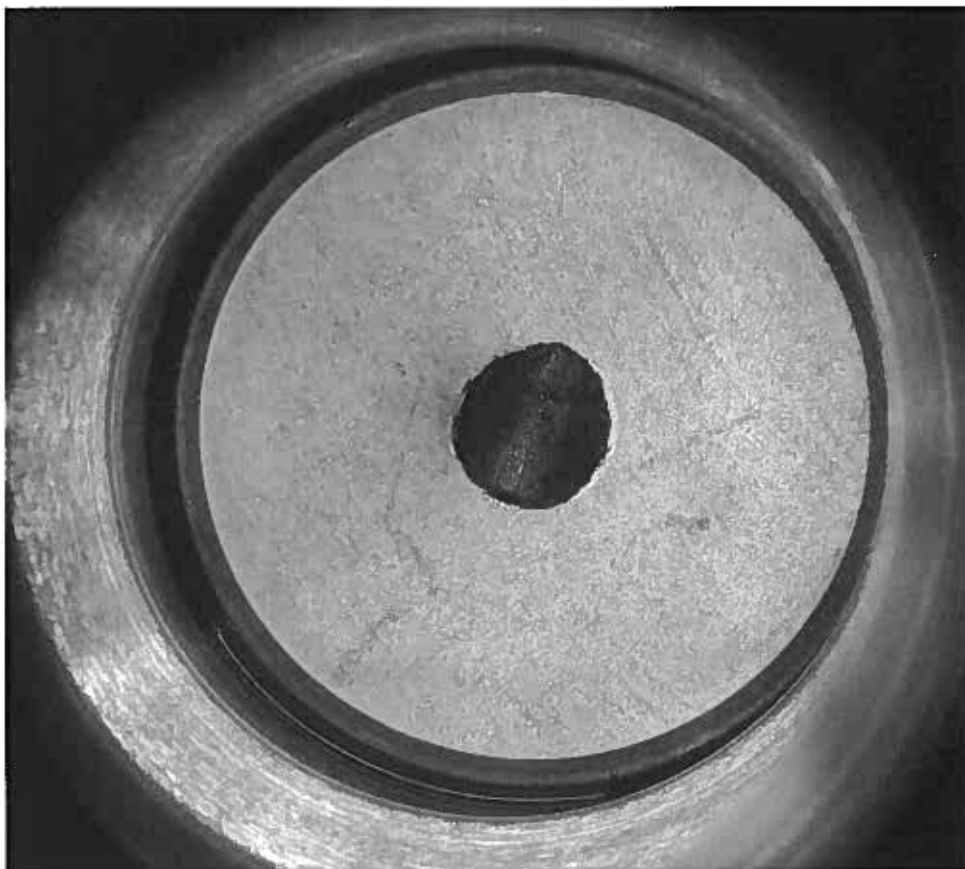
Figure 2: View down into the S port revealing the blocked orifice hole.

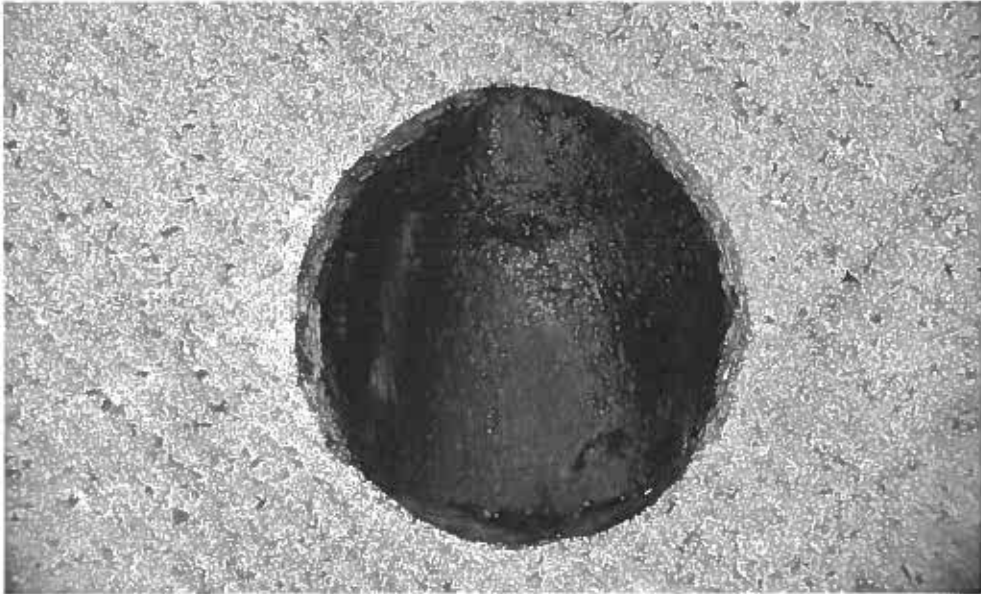
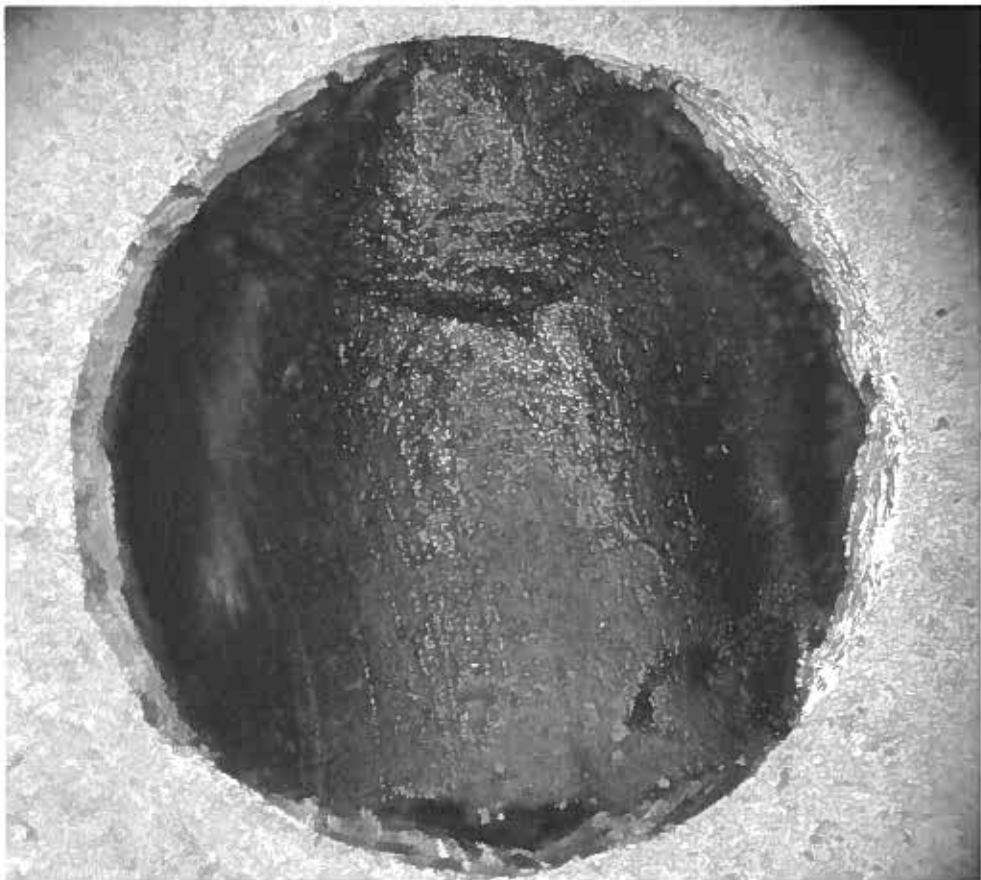
Figure 3: Higher magnifications of the blocked orifice hole as viewed through the S port.

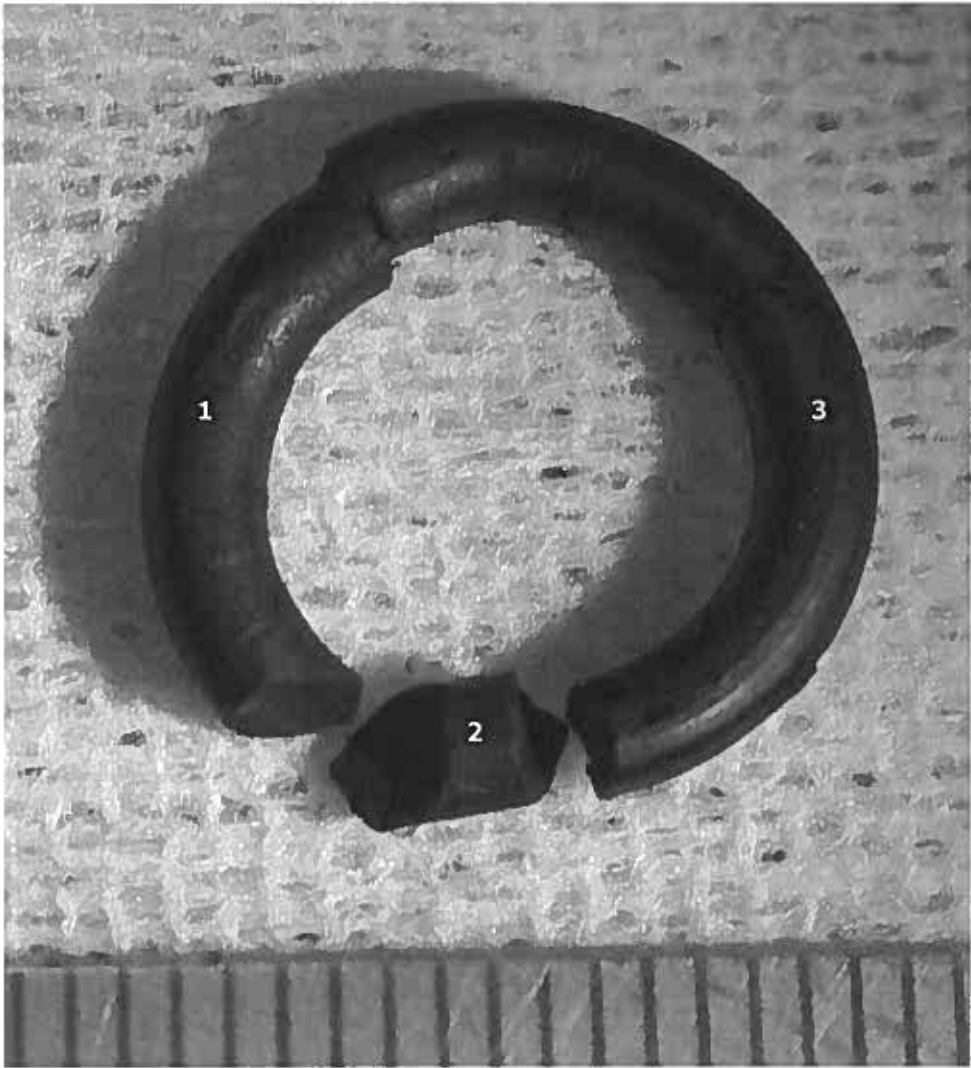
Figure 7: Retrieved parts of O-ring material trapped between cone and housing.

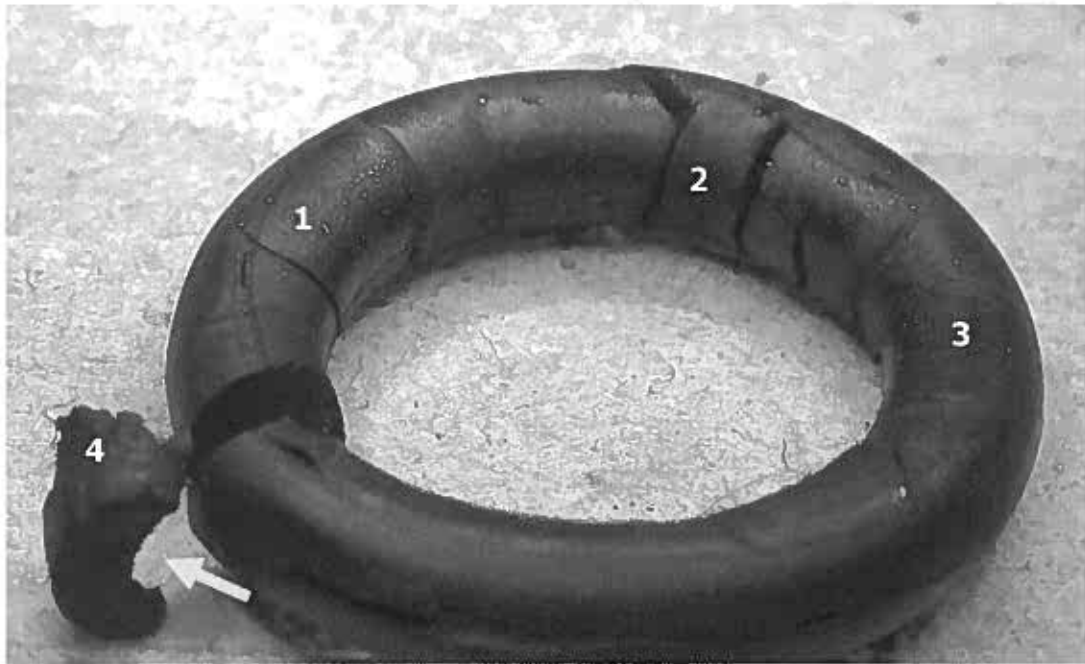
**Figure 8:** Reassemble of O-ring using all retrieved material except the small piece still residing in orifice hole. The arrow points to where the missing piece fits.

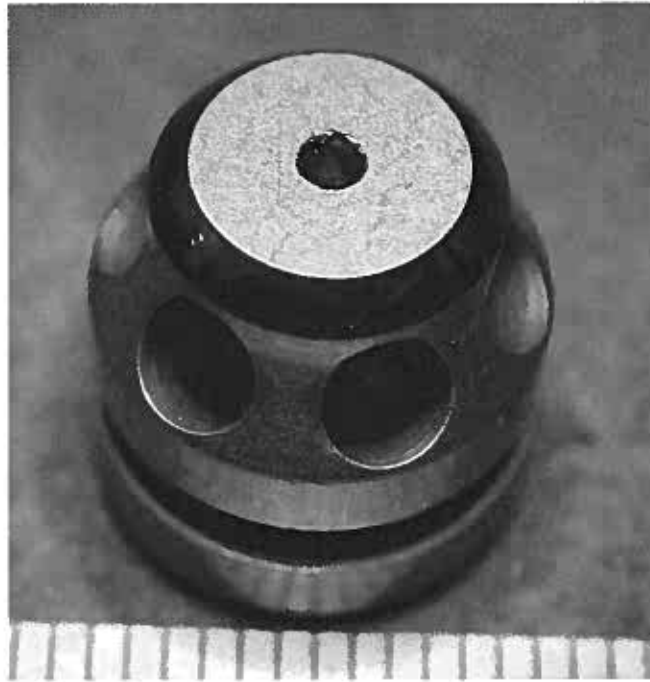
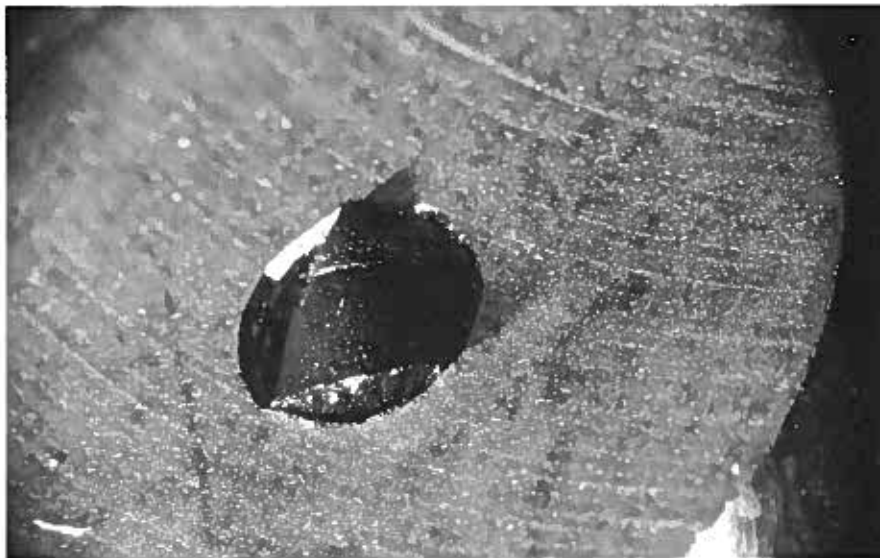
**Figure 9:** Missing piece of O-ring in Figure 8 still residing in orifice hole.

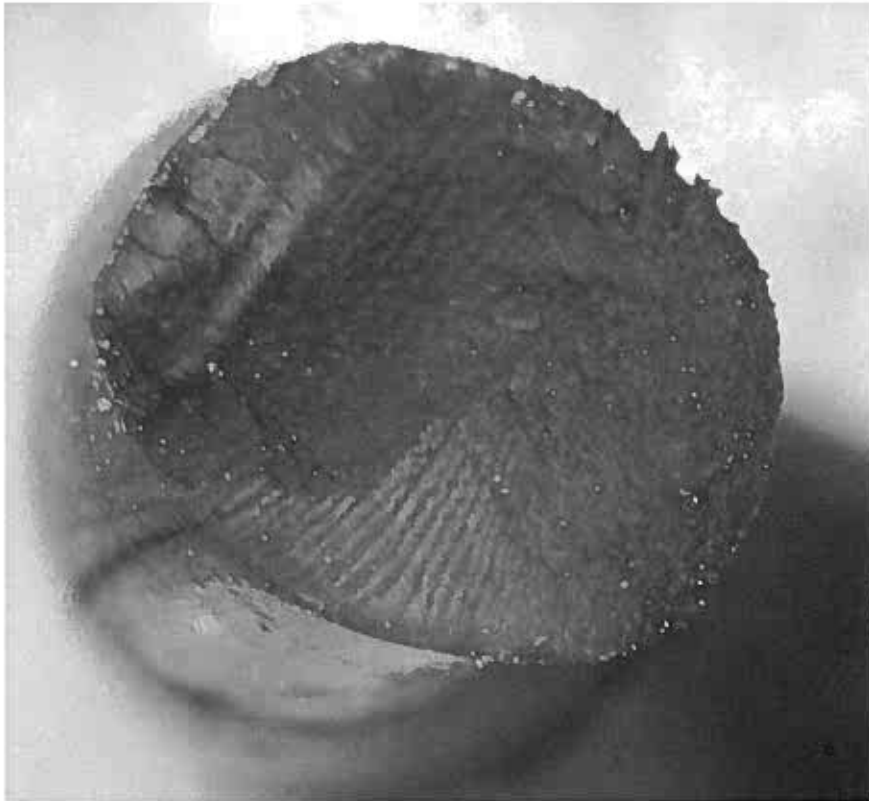
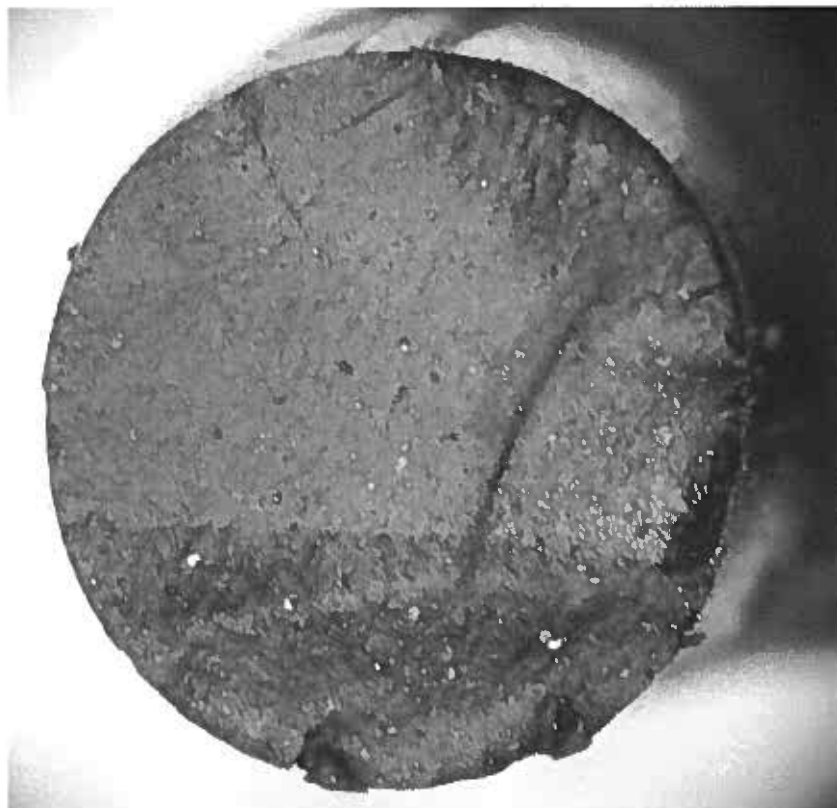
Figure 15: View of "free" ends of retrieved O-ring showing evidence of stepwise cutting.
