Investigation Report

C1/2010M

M/S LINDA (FIN), falling overboard of four containers into the Baltic Sea, south of Gotland, on 6 February 2010

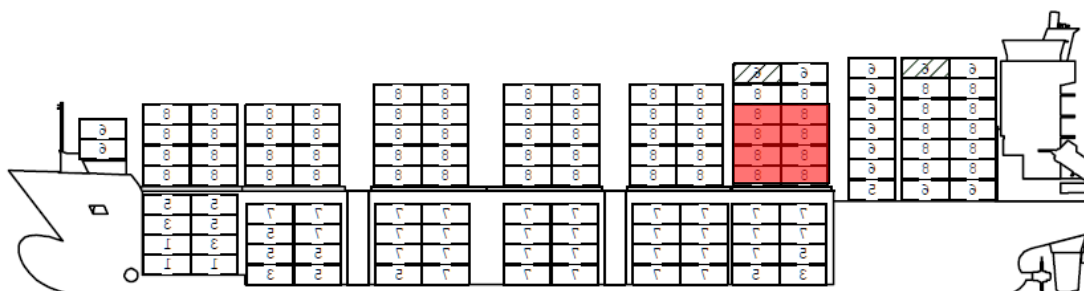
Figure 2. A layout drawing of the cargo spaces on M/S LINDA. The red rectangle indicates the location of the fallen container stack on the outermost bay on the port side of the vessel. (© Oy Langh Ship Ab)

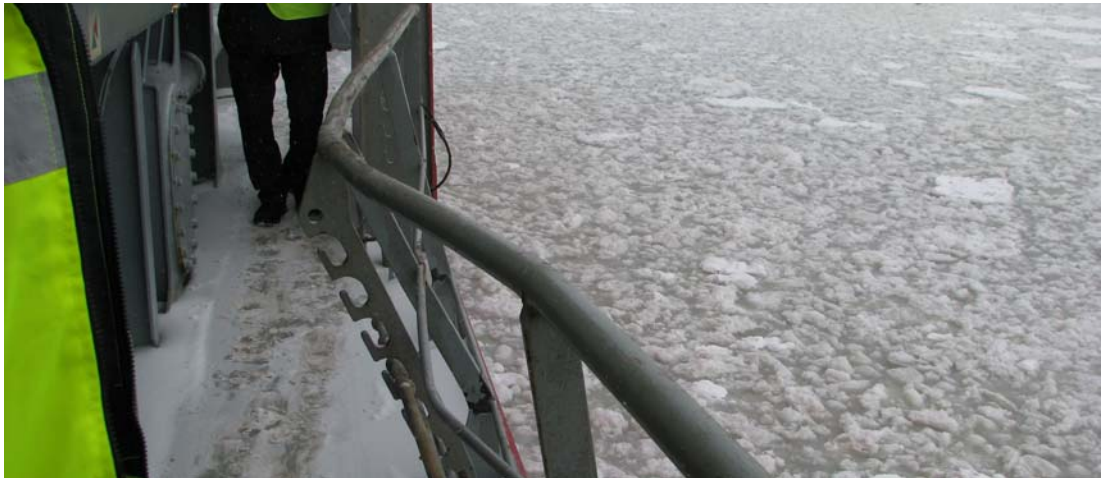
When falling overboard, the containers damaged the vessel's port side railing at a length of approx. 4 metres (Figure 5). The vessel did not suffer any other damages.

Figure 5. The railing damaged by the fallen container stack on the port side of the vessel.

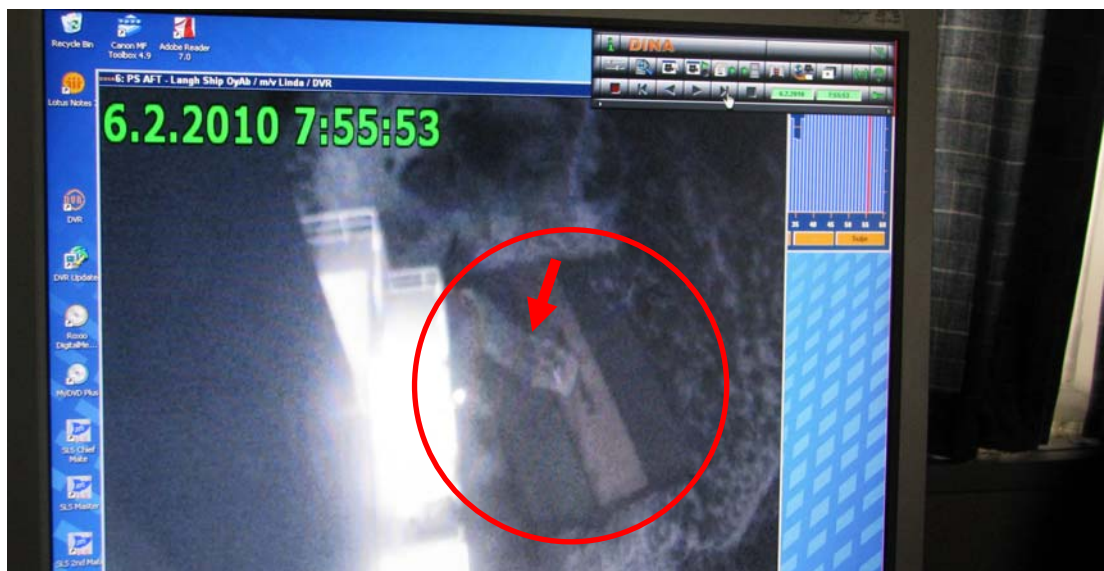
The vessel has CCTV cameras on the boat deck on both sides of the accommodation spaces. The port side camera recorded the containers in the sea after they had fallen overboard. The containers which contained cargo were attached to each other as one block. For example the roof of the broken reefer was also attached to this block.

Figure 6. A picture recorded by the vessel's CCTV camera photographed by a camera from a display on the vessel. The block formed by the three containers attached to each other can be seen in the picture (the red circle). The roof of the broken reefer container is on this block (the red arrow). The wall of the reefer container drifts somewhat behind the block.
