SAFETY REPORT

LEOPARD
Pirate attack on 12 January 2011

The Danish Maritime Accident Investigation Board
Carl Jacobsens Vej 29
DK-2500 Valby
Tel. +45 91 37 63 00

This safety report is issued on 29 October 2013

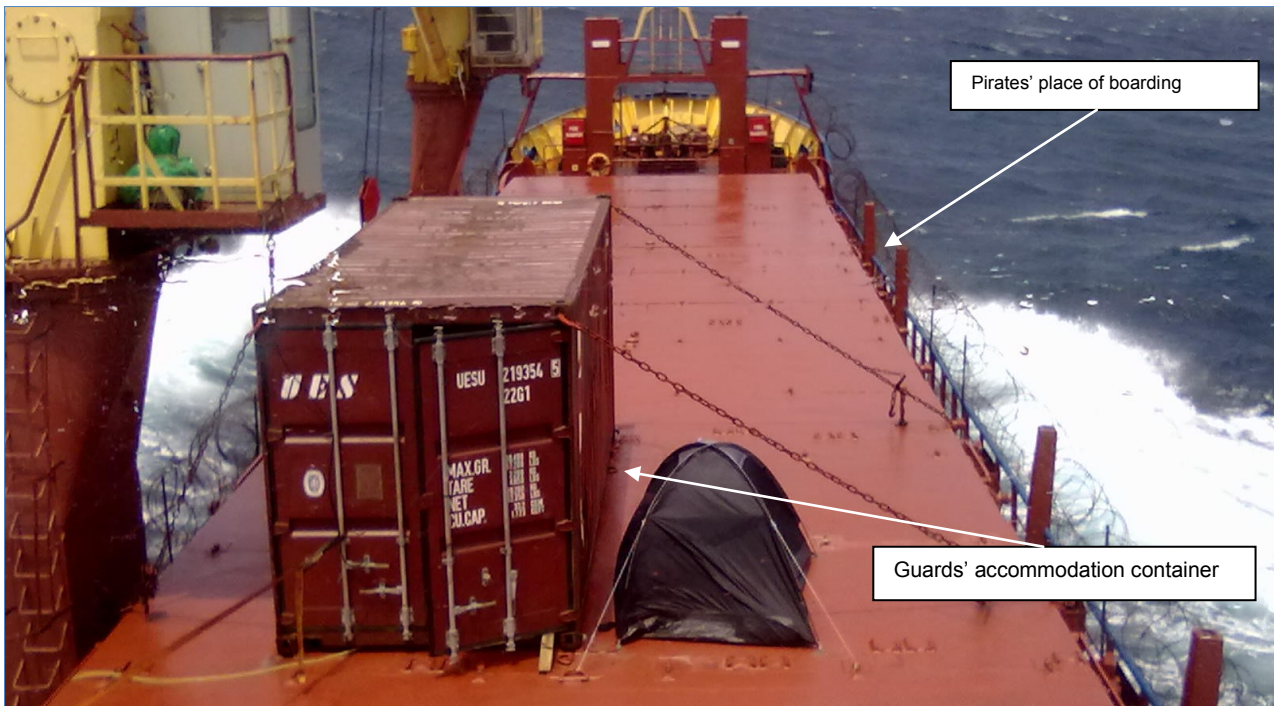
Figure 3: The guards' accommodation container and the pirates' approximate place of boarding. The picture is from a previous voyage.
Source: Private photo.

Quite some time elapsed before the crew could hear the pirates rummaging on deck and in the accommodation where it sounded as if they were trying to break into different rooms. They also heard the pirates working on the after deck, where it subsequently turned out that they had rigged the ship's pilot ladder in order to get more men on board. The pilot ladder had not been removed from the deck because the ladders for the life rafts were available anyway. The crew had not removed these ladders for general safety reasons.

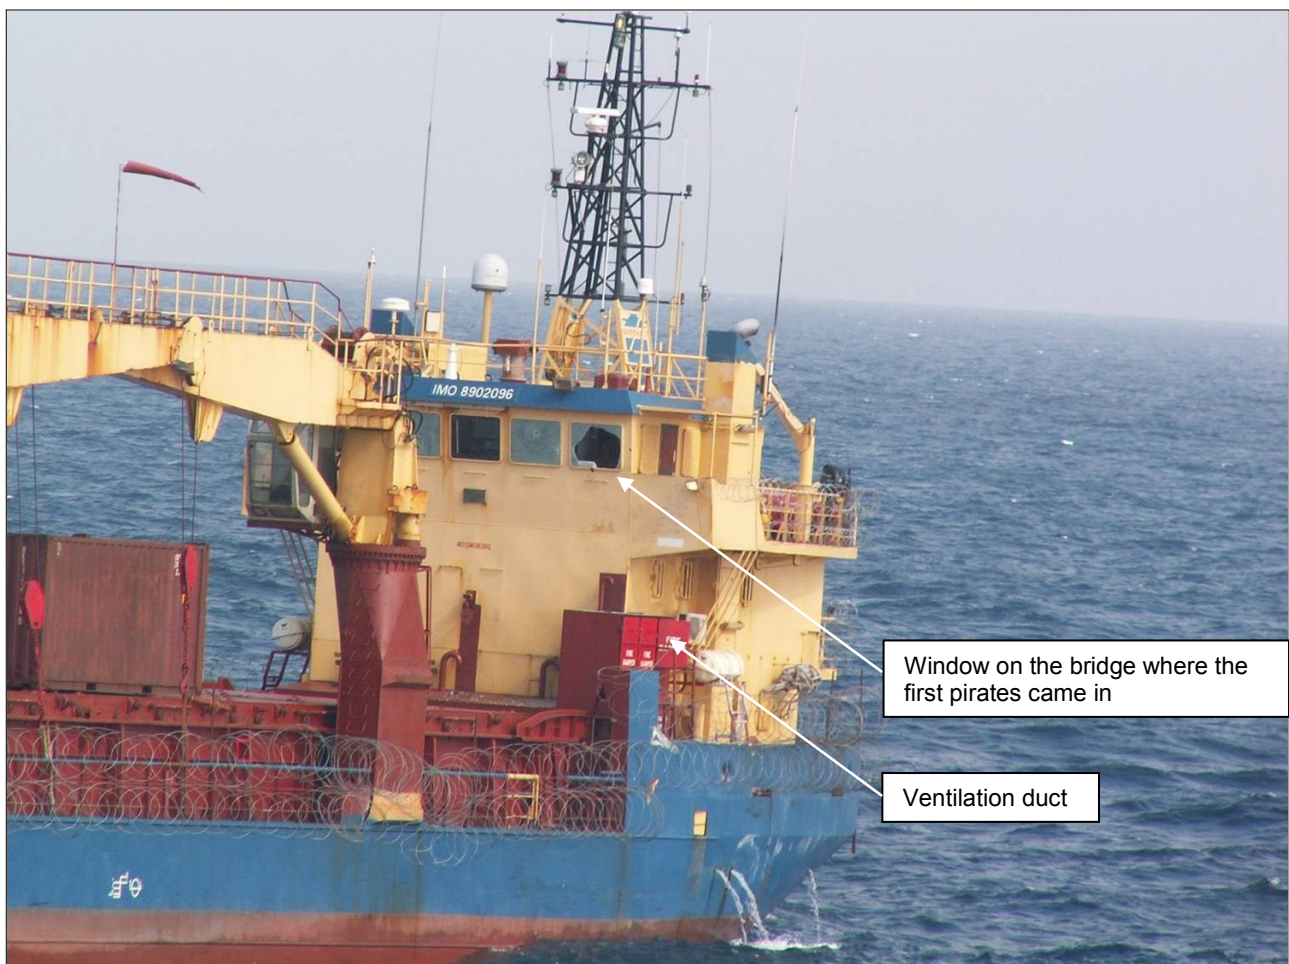
The crew were led from the workshop to the port side of the bridge, and during this transfer the pirates were being violent to them. The crew noticed that the front window on the port side of the bridge had been smashed and that there was blood in the glass fragments. This was an indication that one or more of the pirates had cut themselves before getting in through this window via the ventilation duct below (figure 4).

Figure 4: Accommodation on the LEOPARD
Source: Admiral Danish Fleet

It is not clear how the pirates came from the platform on top of the ventilation duct up to the bridge window, but it is likely that they used the boarding ladder that they had brought along.

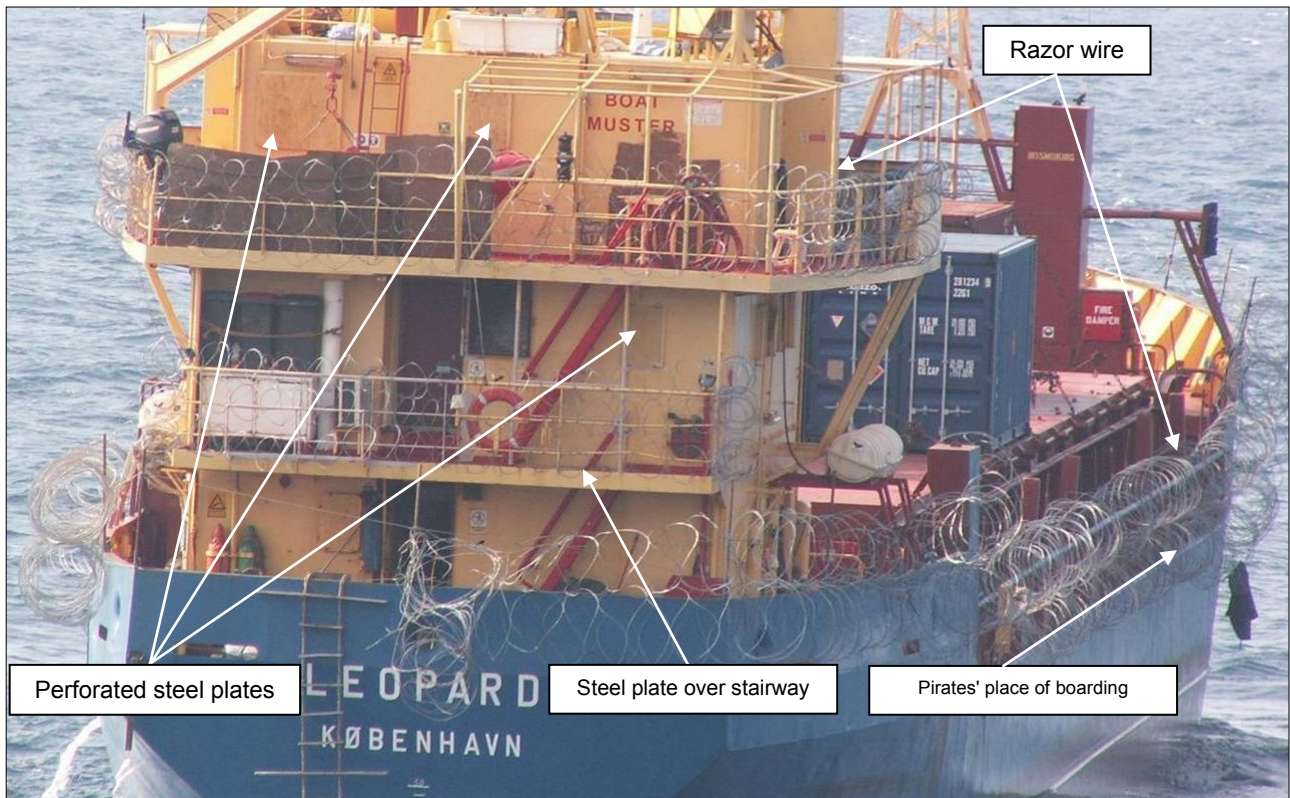
During the period after the capture of the DANICA WHITE in 2007, fittings were welded onto the gunwale over the entire length of the ship for mounting sceptres on which to secure the razor wire. During the voyage through the Red Sea, two layers of razor wire were extended along the entire ship's side as well as three layers on the accommodation (figure 5).

Figure 5: Razor wire on the LEOPARD.
Source: Admiral Danish Fleet.

Razor wire differs from traditional barbed wire in that small steel blades have been mounted on the razor wire functioning as small knives. Consequently, clothes will be caught in it, just as it could cause serious cutting injuries to persons. The type of razor wire used on the LEOPARD could have a strong springing effect and would retract if released. It was recognized that the razor wire would not be effective in stopping the pirates' access to the ship, but it could possibly delay it.

Razor wire had been fitted all around the ship and on the accommodation. The wire did not prevent the pirates from boarding. The razor wire was part of the overall measures to delay the pirates' boarding of the ship, but the ship's crew did not expect the wire to prevent the pirates from getting access to the ship, but rather that it would make the boarding more difficult and, thereby, delay the pirates.

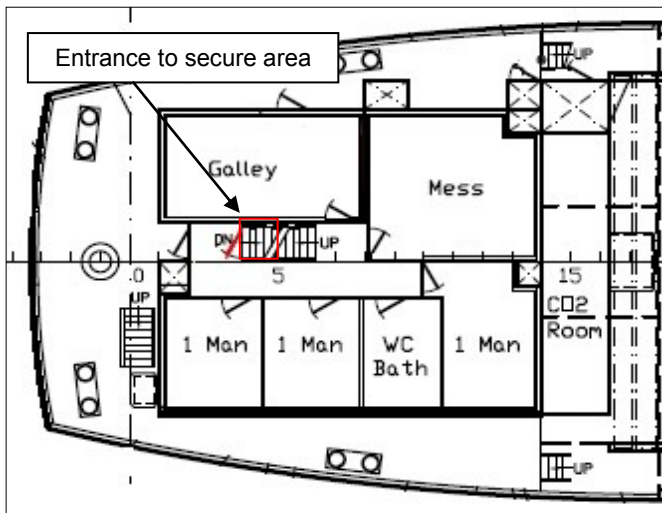
Figure 6: Drawing of main deck and companionway to secured area.
Source: Nordane A/S and DMAIB.

The companionway to the secured area is marked in red in figure 6. The door to the secured area, which opened outwards as indicated in the figure, was a fire door fitted with locking latches on the inside. Furthermore, it was reinforced by means of stainless steel plates so that it could be resistant in case pirates forced themselves into the area.

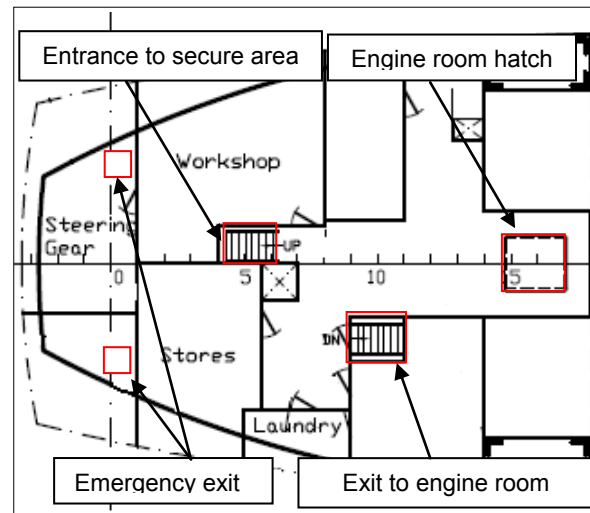
The establishment of the secured area (figure 7) was a process that took place over a period of appr. one year. The fire door was reinforced in 2007, and a VHF radio was installed in the area in 2008, i.e. before the publication of the first BMP.

Figure 7: Drawing of secured area.
Source: Nordane A/S and DMAIB.

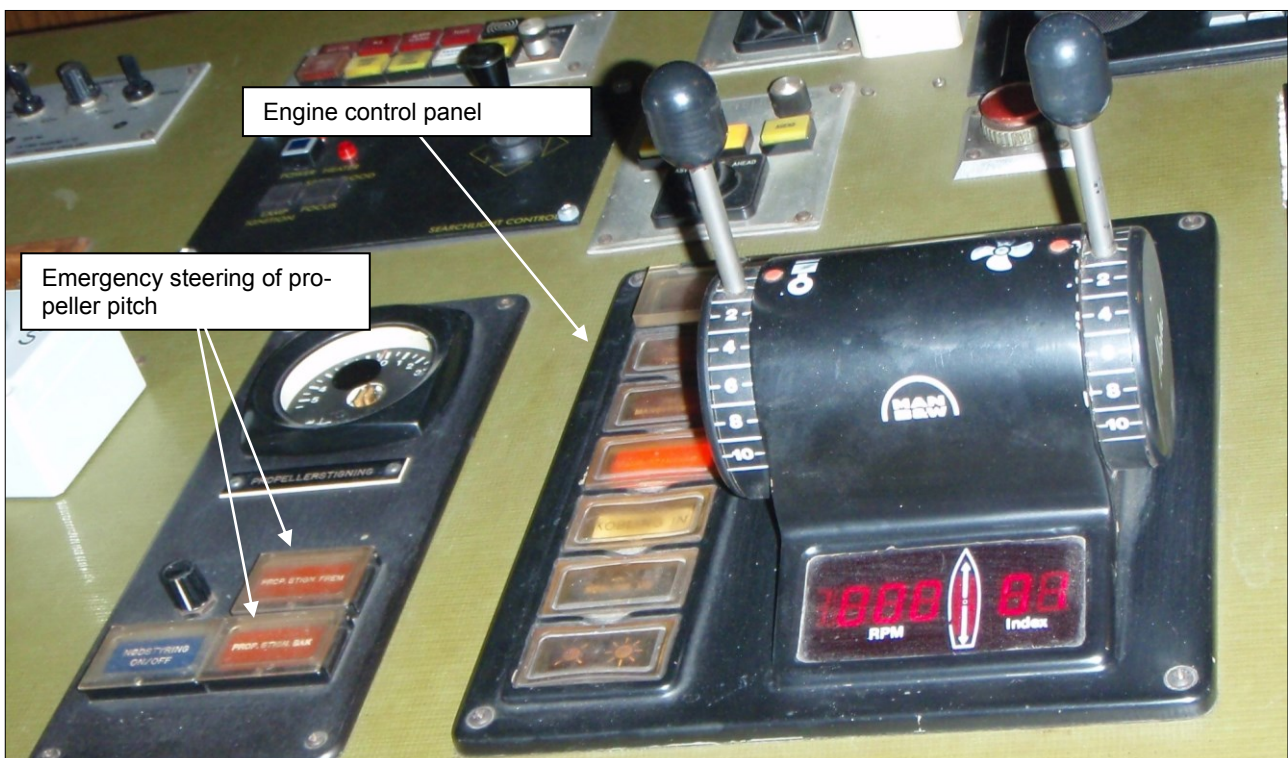
In an attempt to make the ship sail, the pirates had pressed the buttons on the control panel on the bridge at random (figure 8) and thereby made it impossible to engage the gear again though the crew succeeded in starting the engine.

The machinery was such that it was only possible to engage the gear when the propeller pitch was zero. However, the pirates had constantly pressed the emergency steering for the propeller pitch, thus destroying the system's built-in signalling of the propeller pitch. Consequently, the system could not measure that the pitch was zero, and the automatics made it impossible to engage the gear. The motorman who was responsible for the daily maintenance in the engine room was ordered by the pirates to engage the engine. He thought that the problems were related to the gear as such and, in the situation, he did not realize that it was a question of a defect in the system's internal measurement of the propeller pitch.

Figure 8: Engine control panel.
Source: Private photo.

The pirates' inability to bring the ship to Somalia was caused by the impossibility of engaging the gear due to misoperation of the emergency steering of the propeller pitch. The ship's motorman, who was otherwise familiar with the functioning of the gear, did not recognize which technical reasons prevented the engagement of the engine to the propeller shaft. It is probable that the pressure that he was subject to made it impossible for him to assess the technical circumstances and reasons for the breakdown. The Chinese chief engineer who was brought to the ship from the SHIUH FU no. 1 has not been able to contribute with decisive knowledge about machinery with which he was not familiar. The fact that the pirates were operating under a pressure of time has probably contributed to the psychological pressure imposed on the motorman and the Chinese chief engineer.

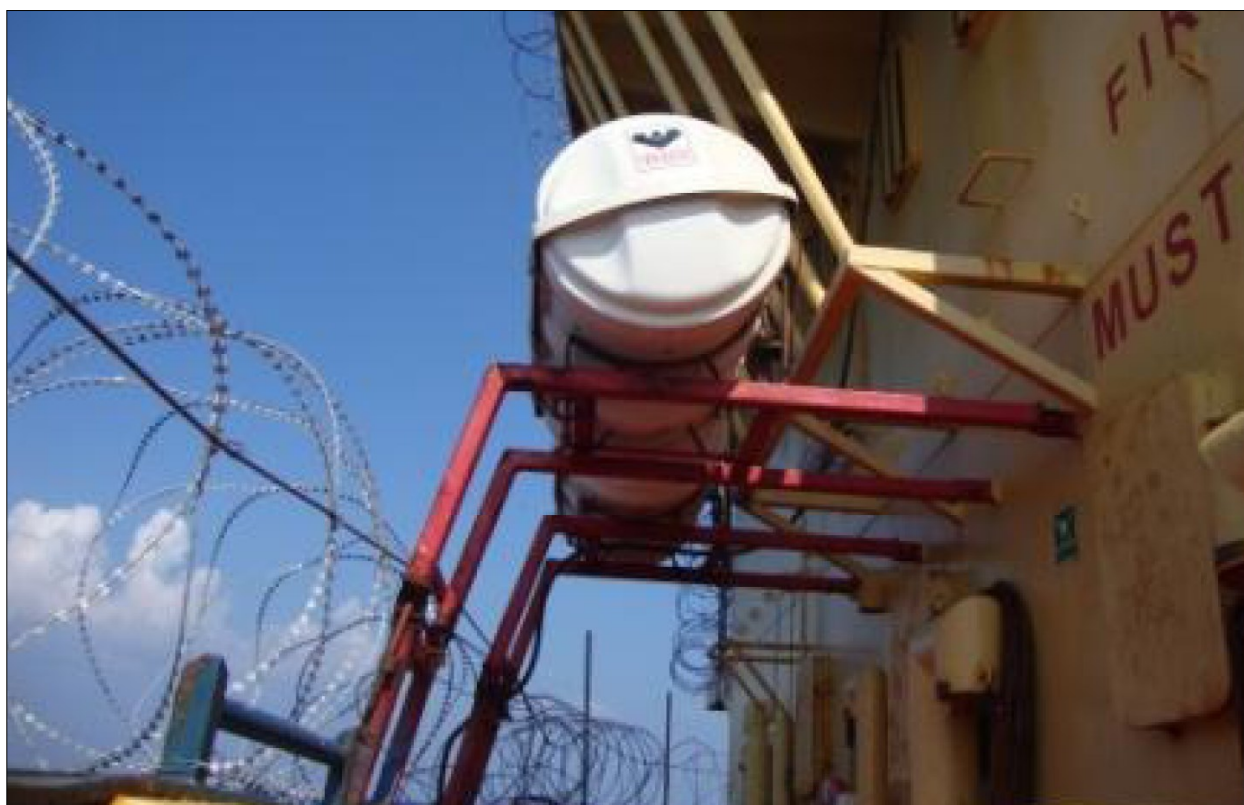
Figure 10: Picture of the liferafts on the starboard side on the LEOPARD.
Source: Private photo.

As is evident from the figure, the launching and embarkation of the liferaft will be made difficult by the razor wire. However, the ship's crew had fitted wire cutters in the vicinity so that it was possible

to release the razor wire and make room for launching the liferaft. Though it may be possible to find an apparently simple operational solution, a number of overall problems arise as regards the effect of anti-piracy measures on the use of the ship's safety and life-saving appliances. In general, it is inexpedient that prescribed safety and life-saving appliances have a conditional use, i.e. that it is necessary to carry out a number of acts before the crew can use the equipment. Specifically, this means that the crew will first have to cut and release the razor wire and maybe even pick it up in order to avoid it getting in the way and damaging the liferaft and injuring the crew. Furthermore, the wire will make the improvisation that might be necessary in an emergency difficult, for example if the crew decide to embark the liferaft from another place on board the ship and, consequently, will have to draw the liferaft along the ship's side. In addition, the liferaft and the crew could get caught in the wire in case of a loss that evolves fast and where the crew do not have time to release and embark the liferaft and, therefore, will have to leave the ship by jumping into the sea.
