**Accident Investigation Board
Denmark**

FINAL REPORT

HCLJ510-2011-43

Accident to De Havilland DHC 8-106
Registration TF-JMB
Nuuk Airport (BGGH), Greenland
The 4th of March 2011

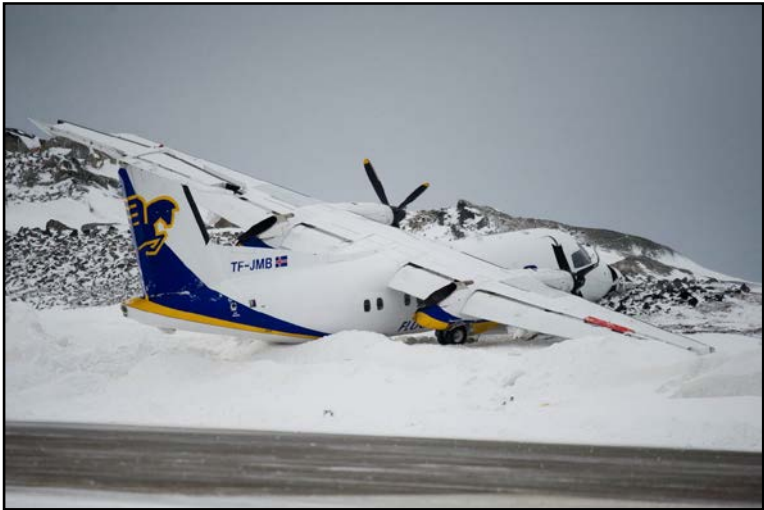
The right nacelle, the right wing, the flaps and aileron were damaged as a result of the runway contact.

The right main landing gear was substantially damaged due to the collapse of the gear.

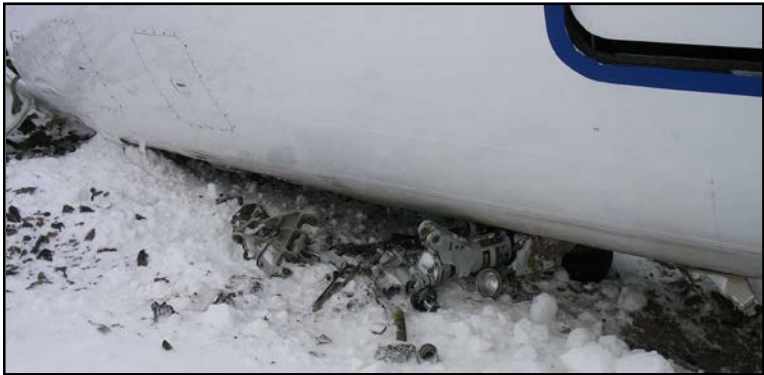
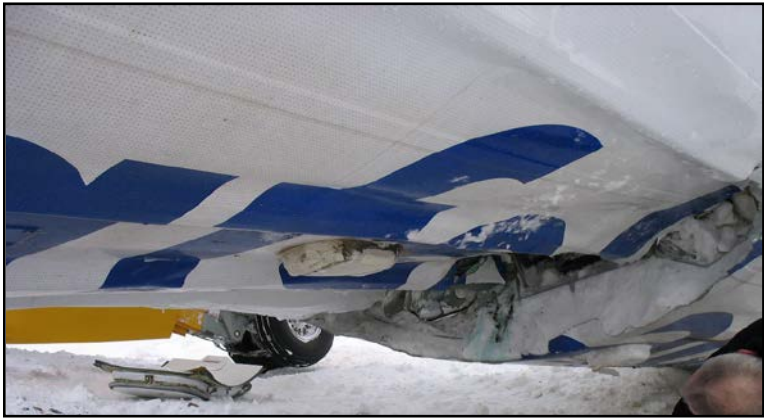
As a result of hitting the rocks, the nose landing gear was destroyed and the aft fuselage suffered substantially damage.

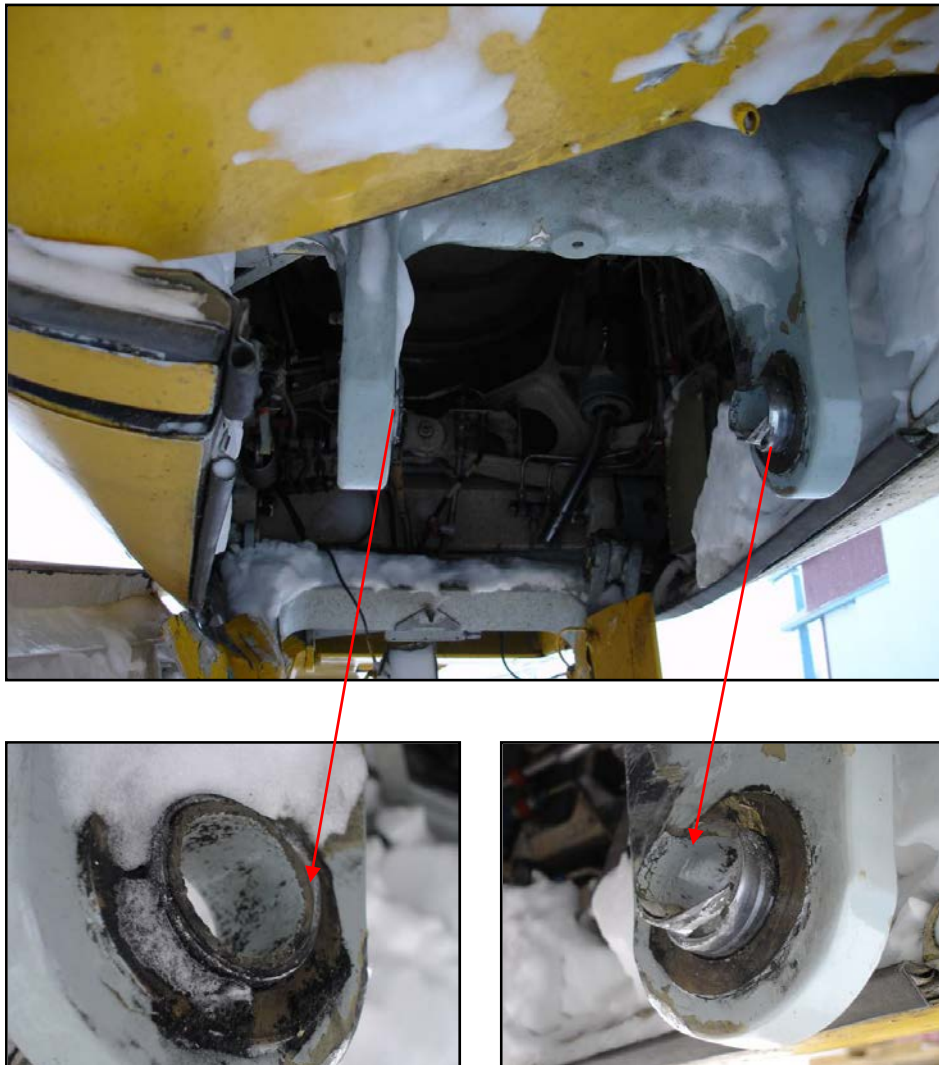
The fuse pin of the right main landing gear was found sheared at two places.

Both ends of the fractured fuse pin were found at place in the junction.

Due to fracture of the fuse pin, the shock strut was separated from the main gear yoke.

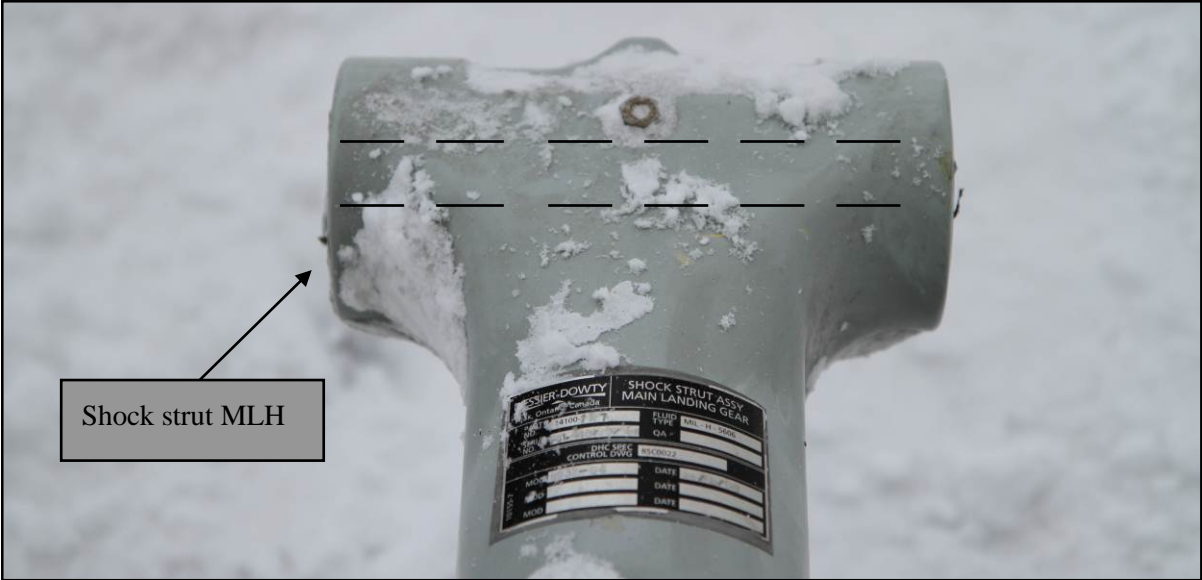
The rest of the fuse pin was found inside the head of shock strut to yoke.

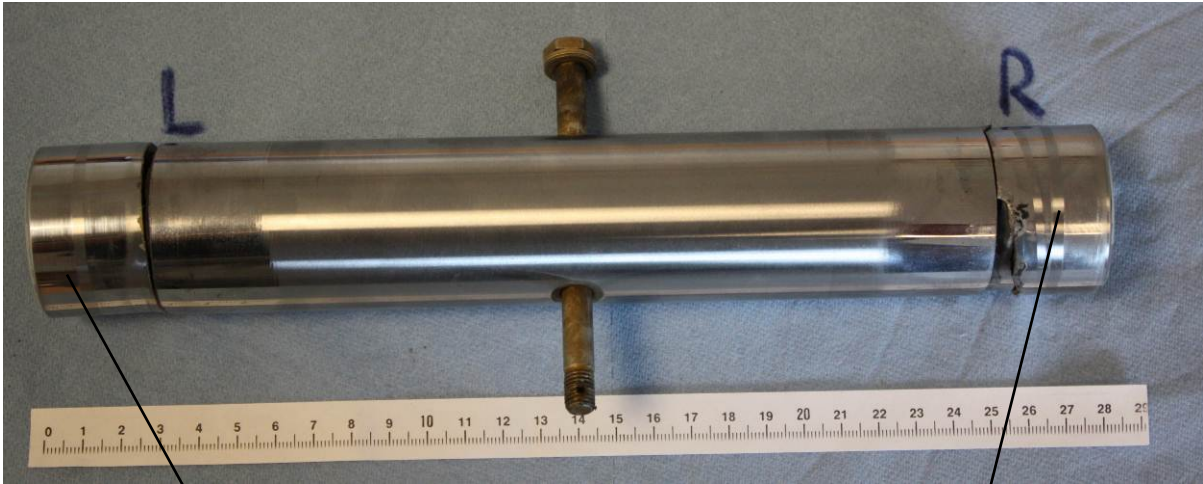
Fig. 1

The mid-section of the fuse pin, (fig. 1 with the bolt) was found inside the head of shock strut to yoke.

The head of the bolt indicates the forward direction (flight direction). The two ends (L & R) of the fuse pin were found inside yoke junction to shock strut.

A hint of inflection on the upper side of the fuse pin can be seen, fig 1. The remaining of the fracture in the nature of a clean shear - see figure 1, 2 and 3.

Fractures in the fuse pin were caused by shear (shearing).

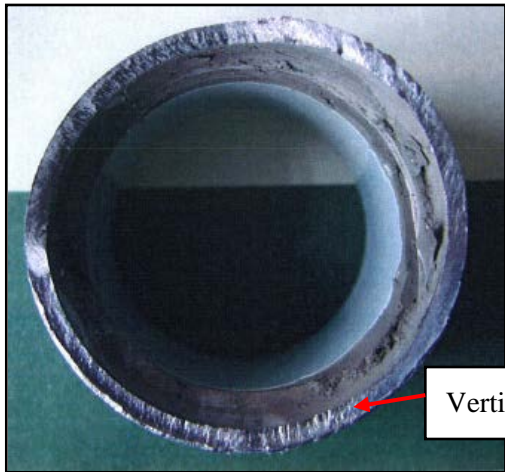
Fig. 2

The surface of the fractures from those pieces found in the gear yoke, showed marks coming from vertical upward force. This force triggered the fracture. See fig. 2 and 3.

It predominantly was a vertical-shear leading to the fractures.

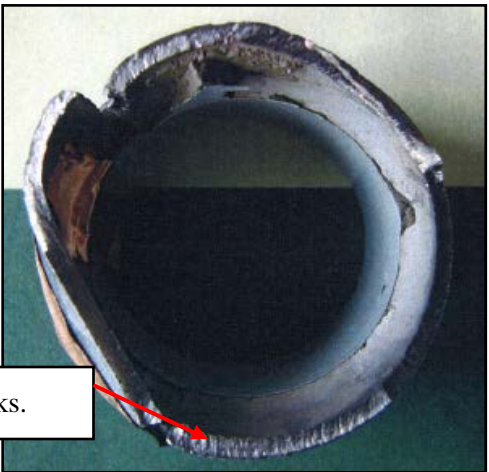
Fig. 3

Vertical upward marks.

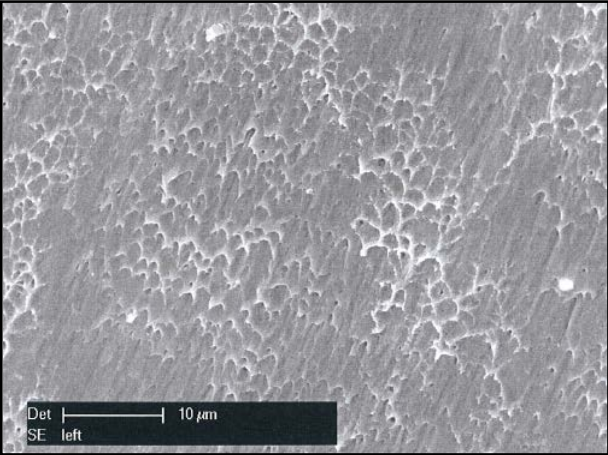
Fig. 4

The investigation only found areas there were smeared, which did not give fractographic information and areas with dimples. Examples of areas that were found dimpled are shown in the fig. 4 (distinct shear dimples) and fig 5 (dimples characterize as overload breakage in wholesome materials).

There was no evidence of fault or pre-existing cracks in the fuse pin.

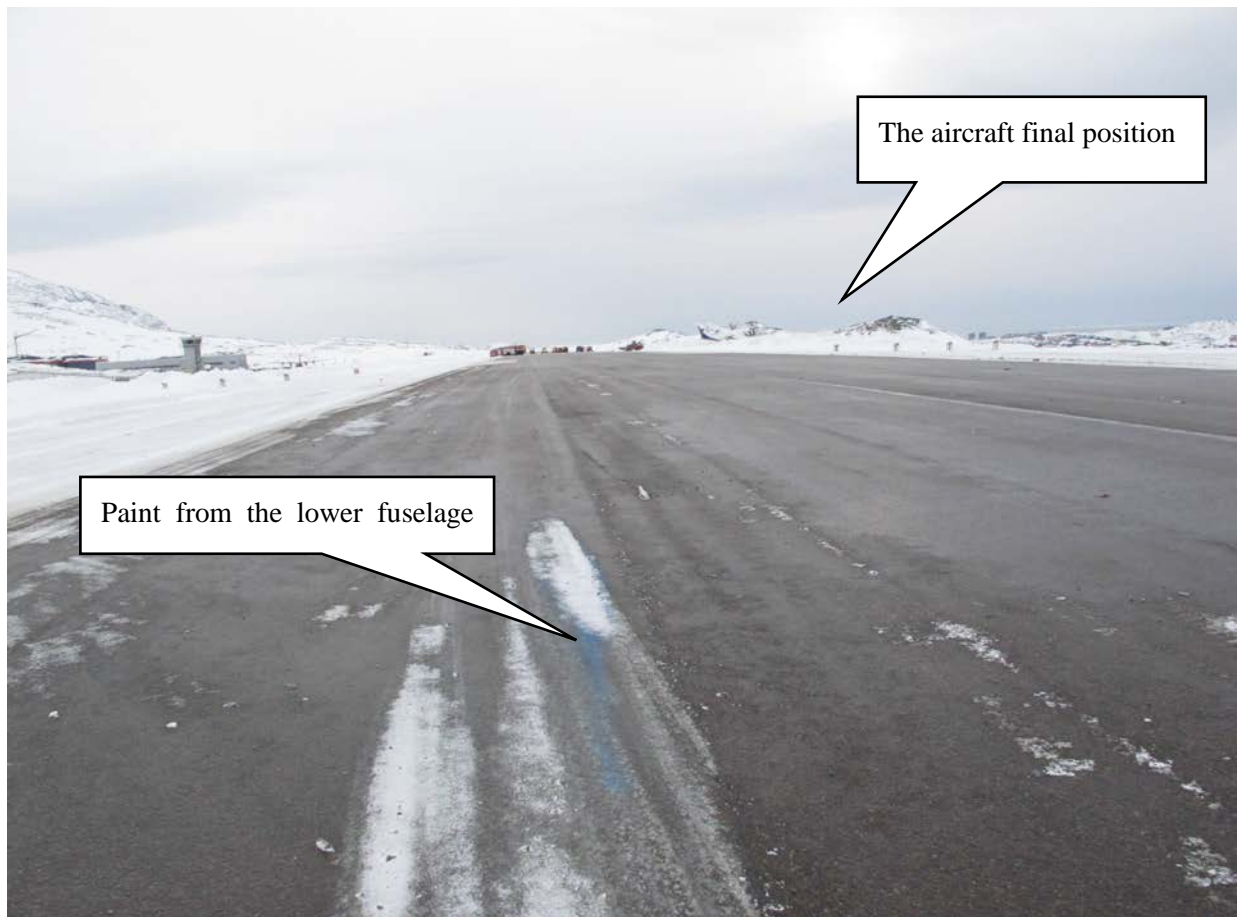
The aircraft touched down on runway 23 at time 16:09 hrs.

At touchdown the right MLG fuse pin sheared; consequently the right MLG collapsed and the fuselage made contact with the runway.

An excess load of the right MLG at touchdown caused the fuse pin to shear as a result of overload and consequently, the right MLG collapsed.

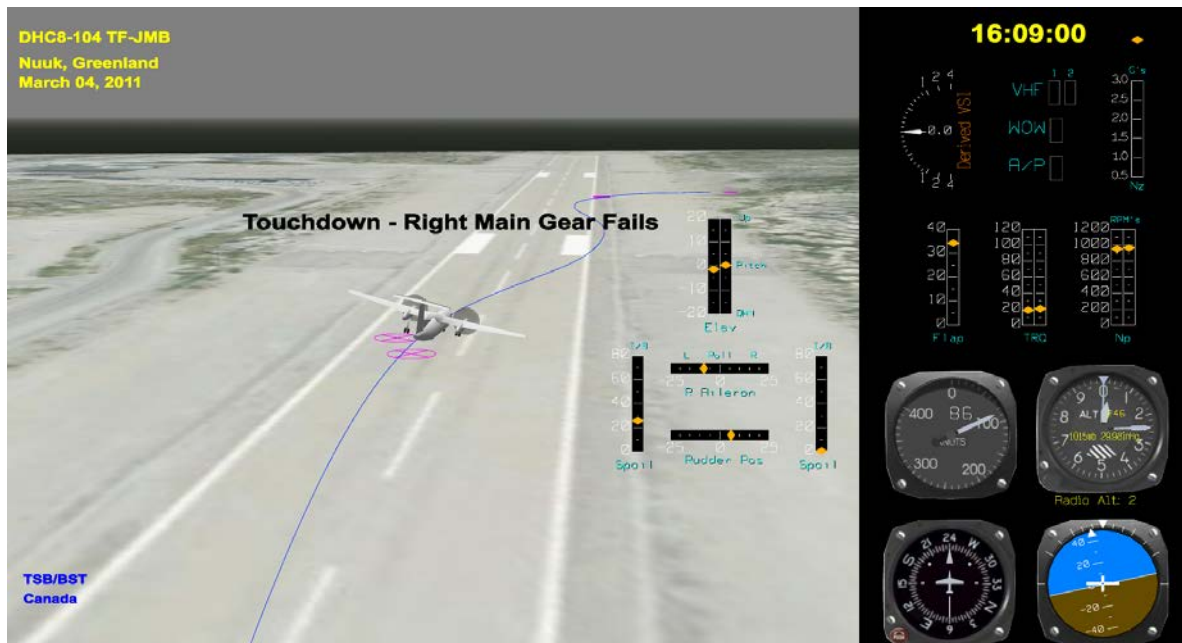
Time 16:09:00 – touchdown

The RA had dropped from 14.7 feet to 1.2 feet in one second. The average rate of descent from RA 14.7 feet to RA 1.2 feet was 13.5 fps (810 fpm).
