Surveillance Report

Package / Item:	Bascule span to the Railway bridge "Jernbanebroen over Limfjorden"
Supplier:	MT Højgaard
Purpose of visit:	Production & Quality Surveillance – Steel structure Visit No. 2
Location / Address:	Tarcon Tarnobrzeg Poland

Date of Visit / Review: 2012-08-14

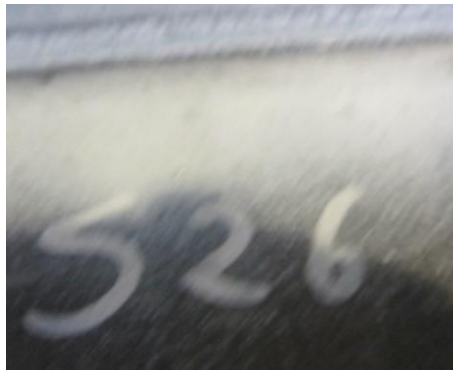
Tarcon informed Rambøll, what pen markers were/are used for welder's signature on the steel surfaces. Based on a trial test in the shop, Rambøll found that only pen markers were used, and a logbook with notes about which welds each welders had produced were shown. Rambøll was informed that welders ID additionally will be noted on the production drawings. Rambøll has no comments.

Welder number S26 signature made with a pen marker.

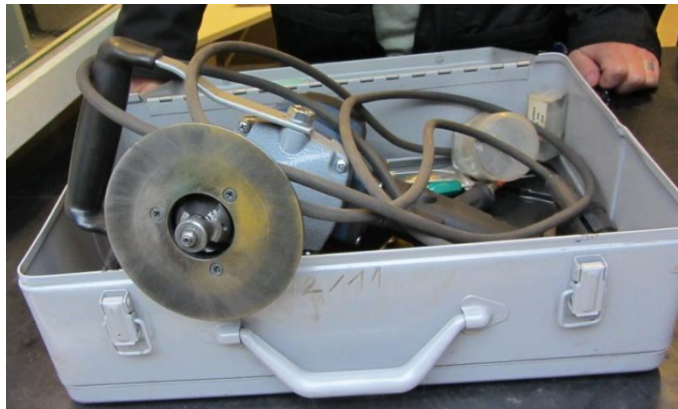
Tarcon showed the equipments for rounding the edges and some profiles where the edges had been rounded. Based on a trial test Rambøll has no comments.

The equipment for rounding the edges

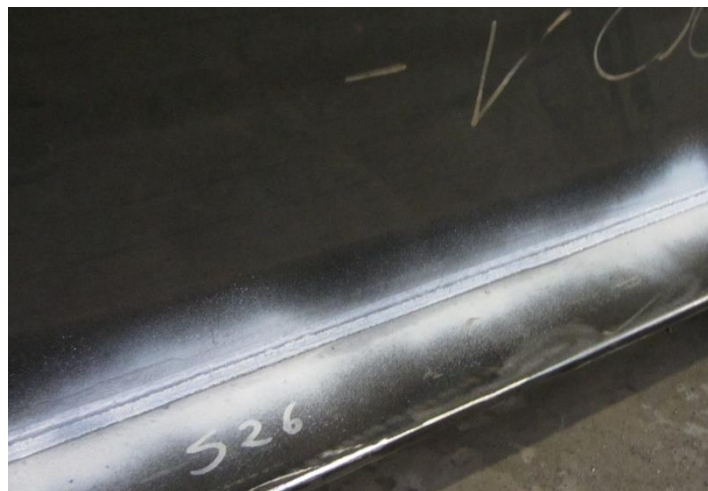
At the shop Rambøll found traces after MPI testing on both stump and fillets welds. A logbook showing which testing there had been made on each element was shown together with examples of documentation documents for UT and MPI testing. Rambøll was concerned about the extent of NDT and commented that the amount shall be according to EN1090-2.

According to EN 1090-2 the extent of NDT is for some types of welds defined by the coefficient of utilization. NIRAS as the consultant is the only one to give Tarcon this information. Rambøll find it urgent to follow up on the extent of NDT and whether it is checked – especially because some welds (for selected connections) cannot be checked after execution.

Traces after MPI testing.

To ensure that Tarcon know exactly where it is needed - it is important that Niras give this information and check that it is on the production drawing. Otherwise, Tarcon will not test the elements.

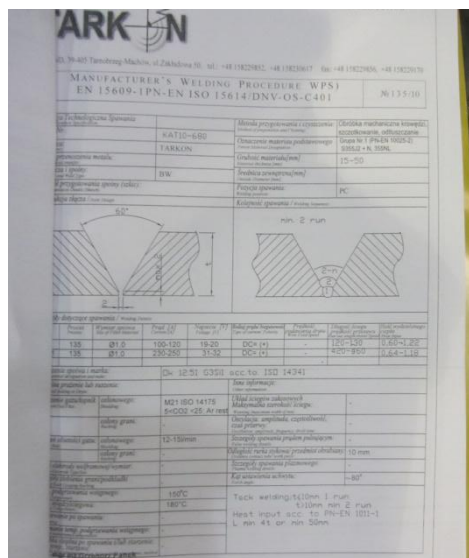
At the inspection Rambøll asked the welding engineer about WPS number 135 with focus on the preheat temperature (this WPS was present in the project specified folder at the shop floor). The welding engineer informed that they for plates with thickness around 50 mm preheat as stated on the WPS, but for smaller plates they lowered the preheat temperature. Rambøll find it concerning that the welding engineer told that they doesn't follow the WPS correctly, because then the coherent WPQR isn't valid. Rambøll find it necessary that Tarcon find out where they have used this WPS and if they have used it with a lower preheat then stated on the WPS some additional tests may be needed.

Rambøll also find that a preheat of 150 degrees of celsius is high for plates with a thickness between 20-40 mm, therefore as required after the first visit an additional WPS shall be used and forwarded to Rambøll.

WPS number 135 placed in the project specified folder

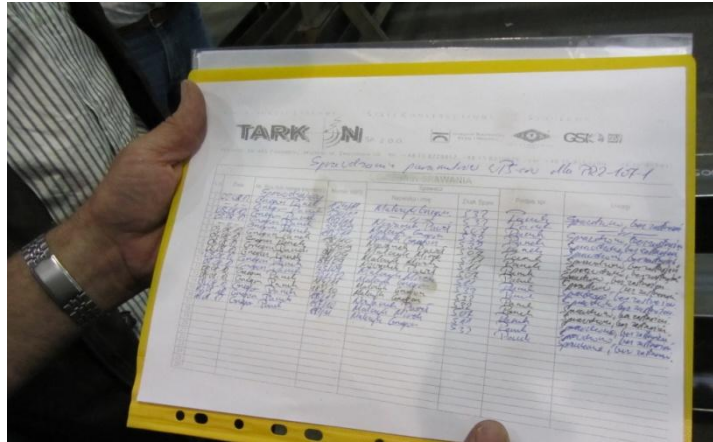
At the inspection in the shop Rambøll asked for some documentation from the welding engineer showing that they control arc voltages, travel speed, preheat and welding sequence etc. The only documentation that was shown was a log with the elements numbers and coherent WPS and the engineer's signature. This documentation is not fulfilling, it should include the results from the required control in 3834-2 section 14.3.

The documentation that was shown regarding the engineers control.

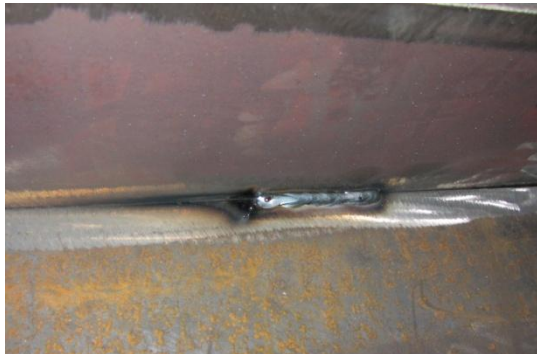
By a trial based testing Rambøll found that tack welds was made minimum 50 mm long and was removed before the final welds is performed. Rambøll has no comments.

A tack weld from this project

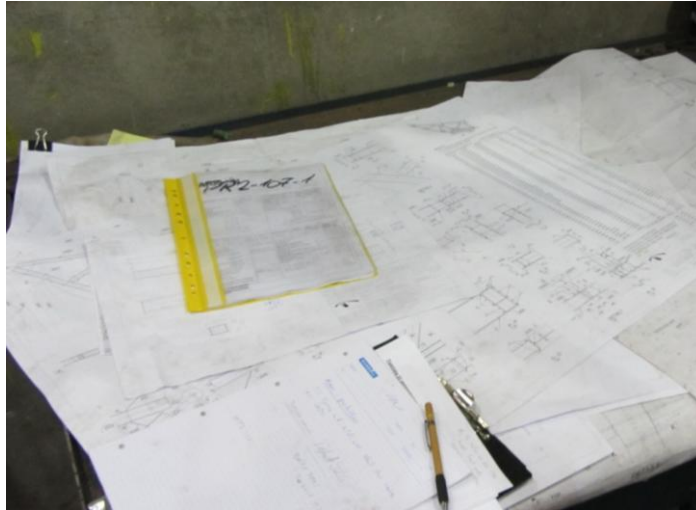
The project specified WPS's were shown by the production manager, and were placed on a table in the production shop.

WPS from this project was placed on a table in the production shop

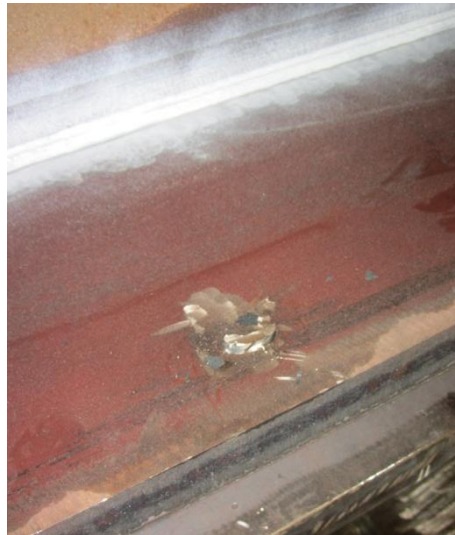
Based on a trial based test at the shop, the surfaces irregularities are repaired.

Surface irregularities are repaired

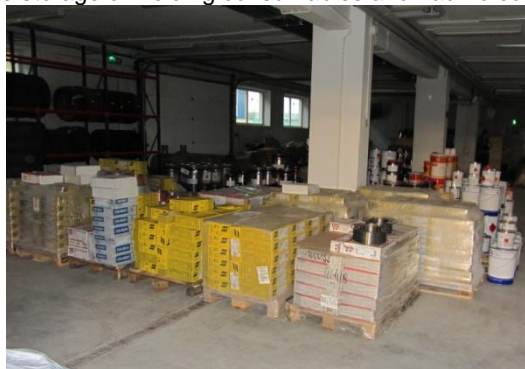
Rambøll checked the facilities for the storage of welding consumables and had no comments.

The storage at tarcon
