DANISH MARITIME AUTHORITY

Lessons to be Learned from the
"SCANDINAVIAN STAR" Disaster

Hans Christensen
director deputy

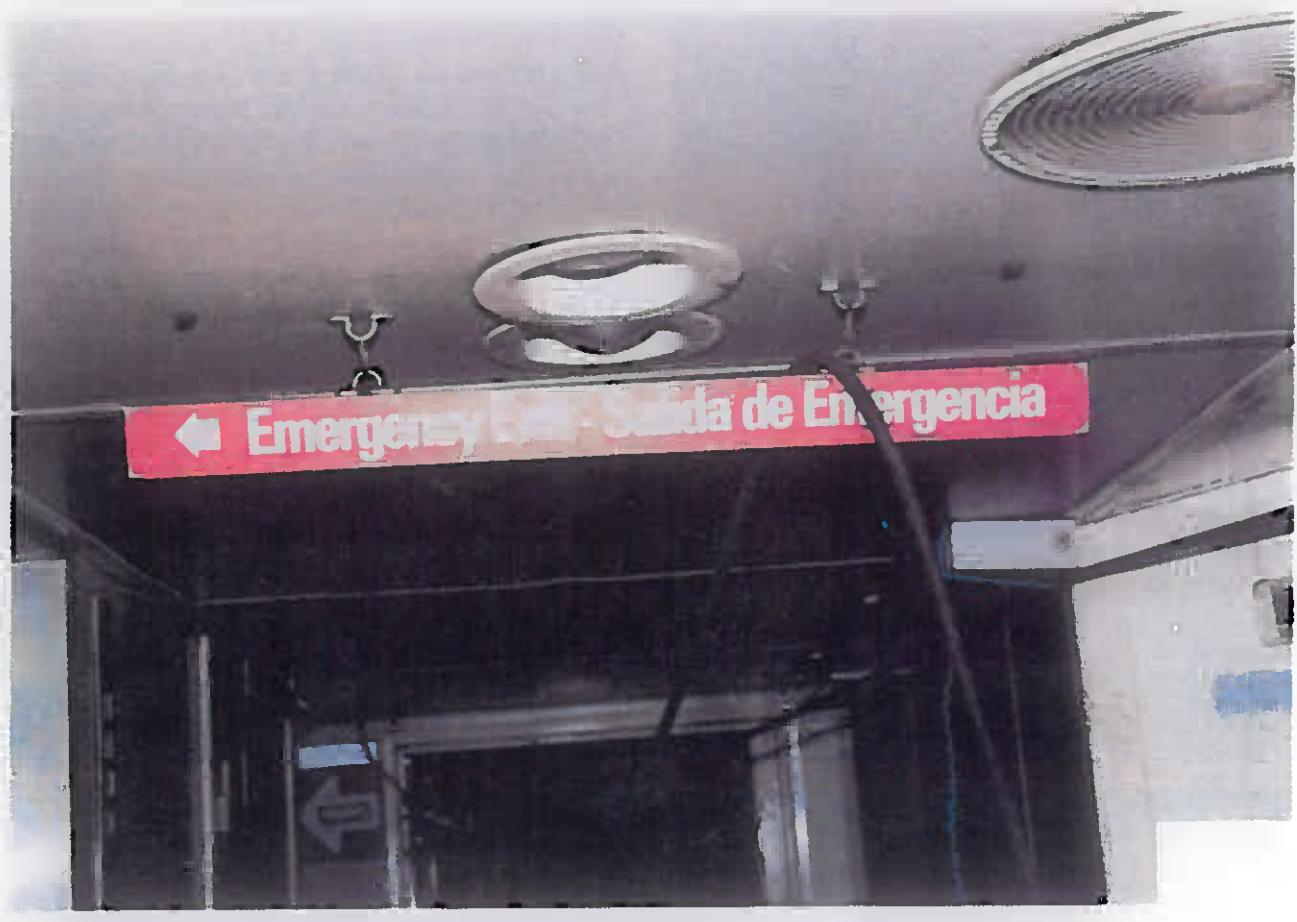
Note: Location of the signposting in the "smoke zone"

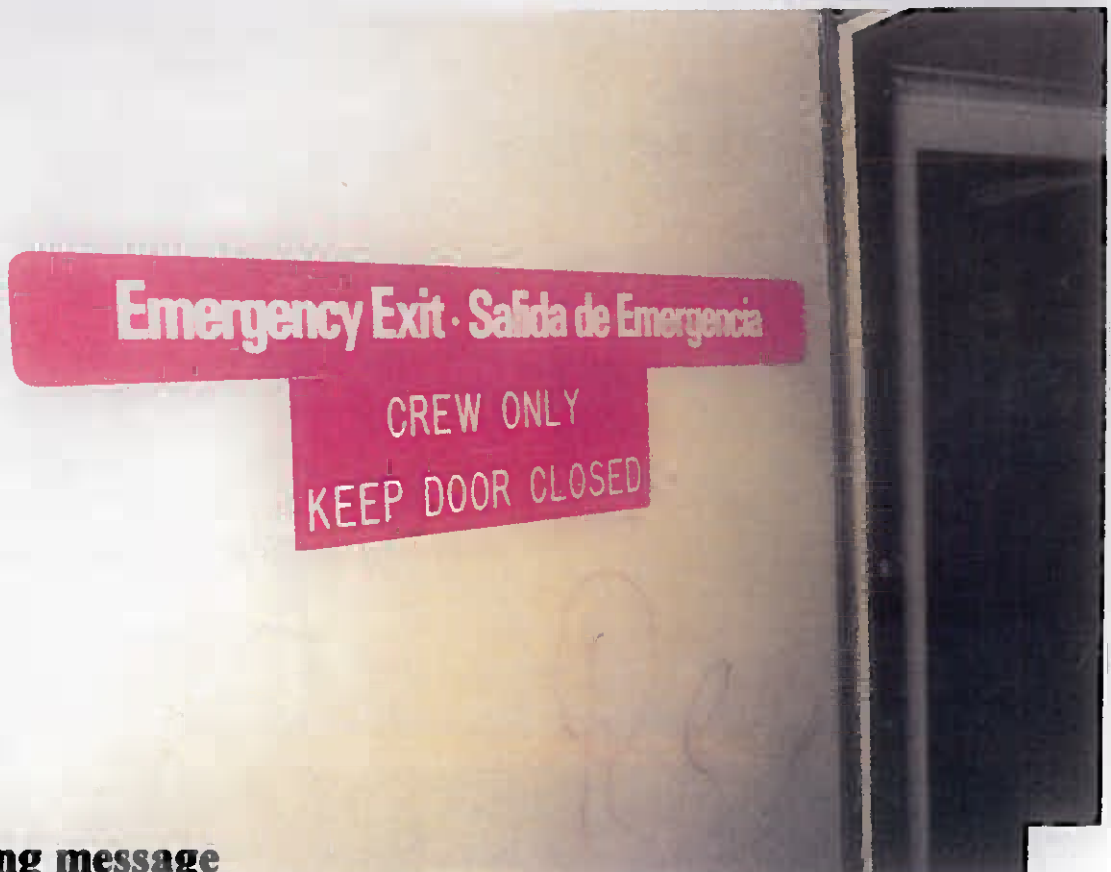
Note: The language used is not appropriate. Should have been a "Scandinavian" language

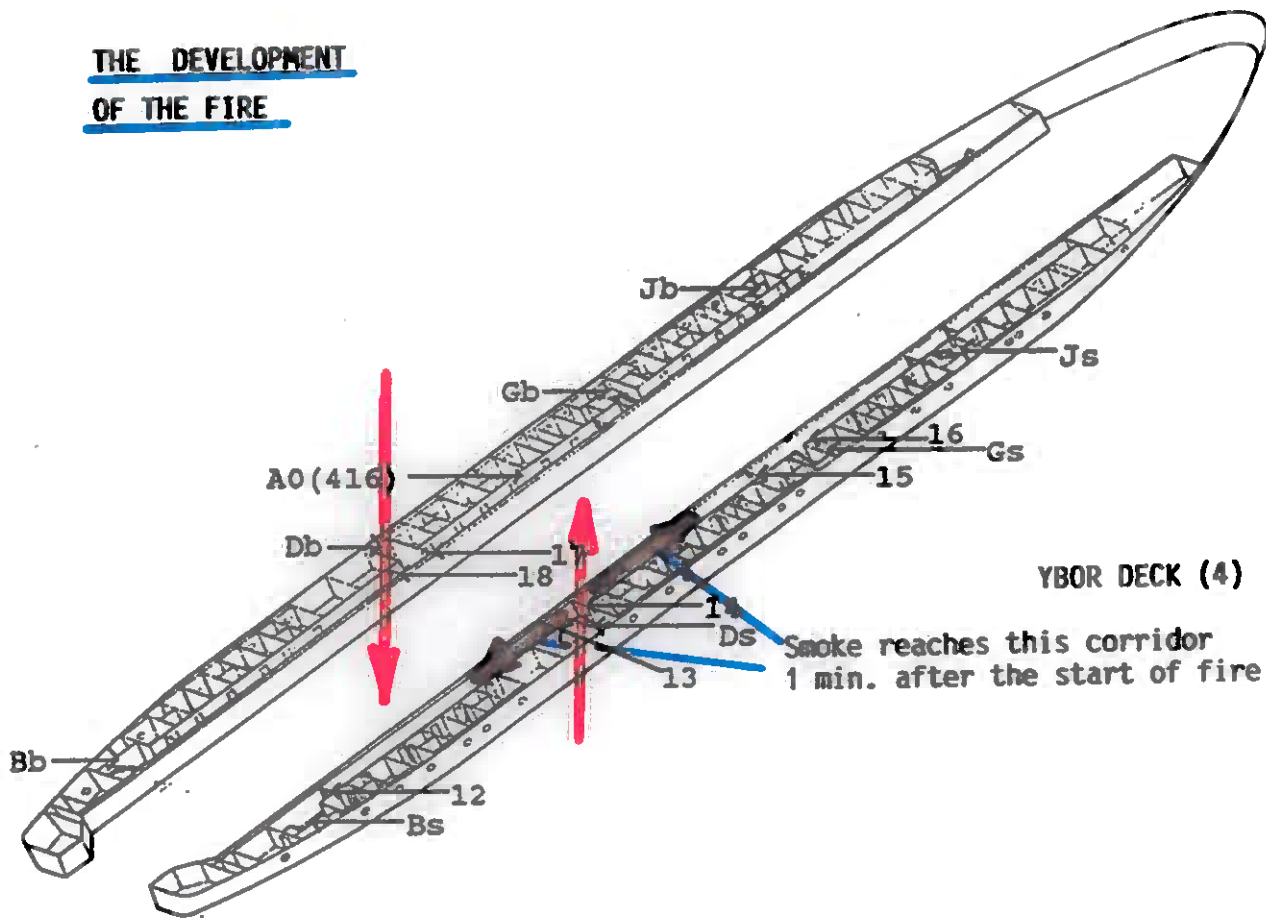
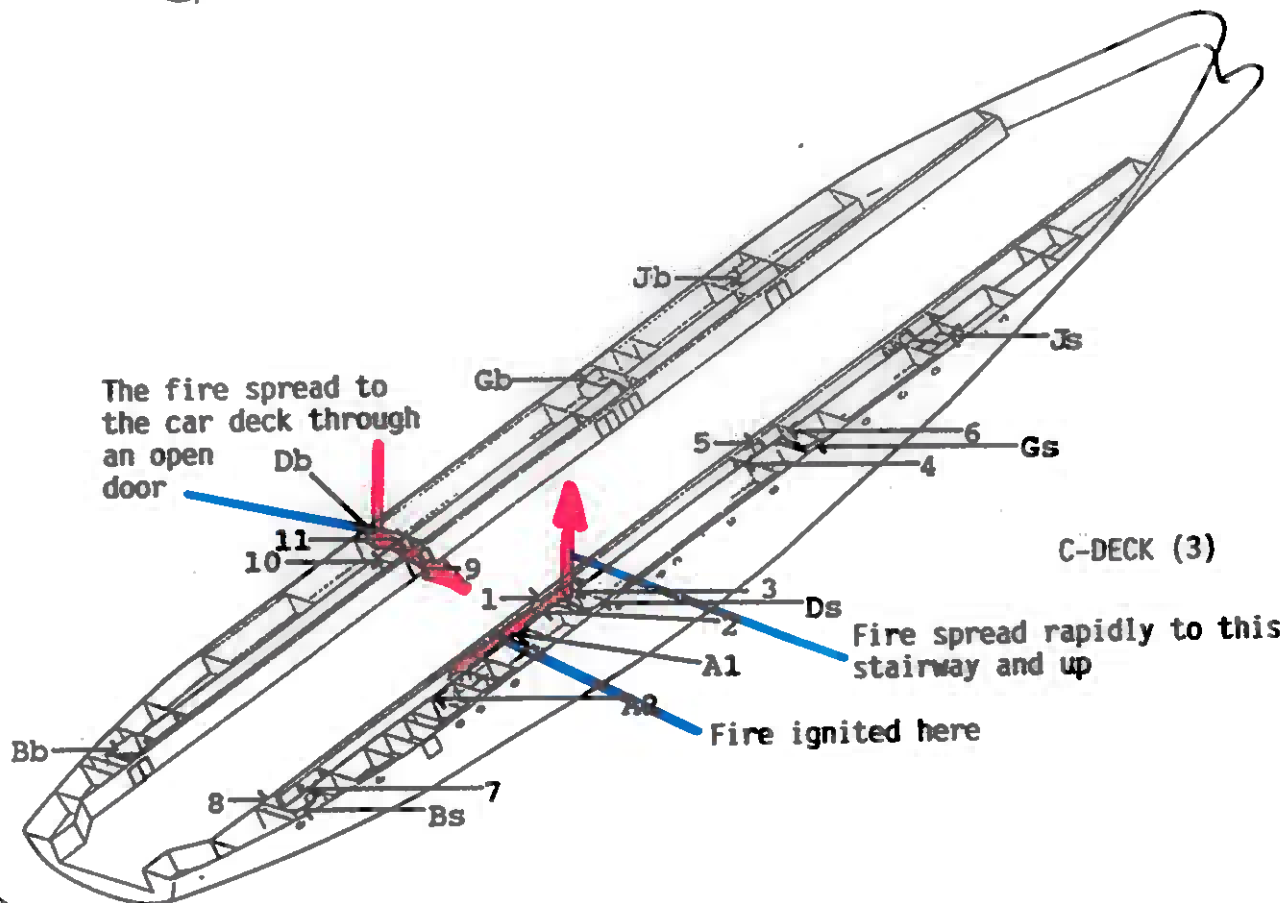
THE DEVELOPMENT
OF THE FIRE

The fire was probably started some time after 0200 hours on April 7, 1990. The site of ignition was almost certainly the corridor area on deck 3 adjoining the entrance to a stairway leading up to the cabin area. (Re. Figure 2). The cabins on this deck was not in use during this voyage. There is little doubt that the fire was ignited with a naked flame, about the size of a match or a lighter flame. The ignited material is assumed to have been a collection of paper, bedclothes etc. Two to eight minutes after the fire was ignited, the fire had attained an effect great enough to ignite the surface material on the bulkheads in the corridor. From this point onward the fire spread rapidly. One minute after the corridor surfaces caught fire, the whole cross section of the corridor was aflame. The fire was drawn to a nearby stairway, and smoke was drawn up through the staircase and into the corridor above connected to the staircase. Two to three minutes after the fire had started, smoke was observed seeping into deck 5, and two minutes later on deck 6. The fire was signalled from deck 5 by use of the press button alarm.

The flames also began spreading up the staircase, and when they reached deck 5, they were directed across the transverse corridor to the corresponding staircase on port side and down to deck 3. This spread went extremely fast. Witnesses have described it "a ball of fire" that flashed through the transverse corridor. Smoke also began seeping into the corridors from the staircase on the port side of deck 4. There was less smoke here than in the other areas, however, and after the fire no corpses were found in the corridors on the port side.

The primary, life threatening fire was now limited to the site of ignition, the starboard and port staircases and about half of the transverse corridor on deck 5. The material that was burning mostly consisted of the surface material in the corridors and in the staircases. The extreme rapid development of the fire during this phase was over in about 10 to 15 minutes. After this the fire spread more slowly from this area to the rest of the ship.
