# Limfjord tunnel Assessment and retrofitting

Technical Summary Report, Version 1.0

Date 25. juni 2019

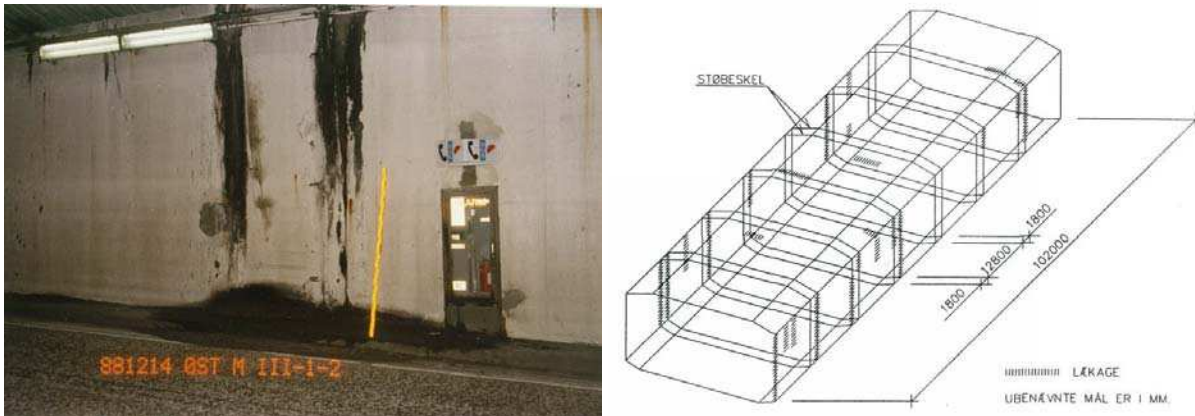
The leakages occurred mainly in or around the 1,8 m wide openings cast after the 12,8 m wide main sections. They were also concentrated in the top slab sections of elements II, III and IV.

Figure 4.4-1 Water Leakage at the short sections (Dimensions are shown in mm)

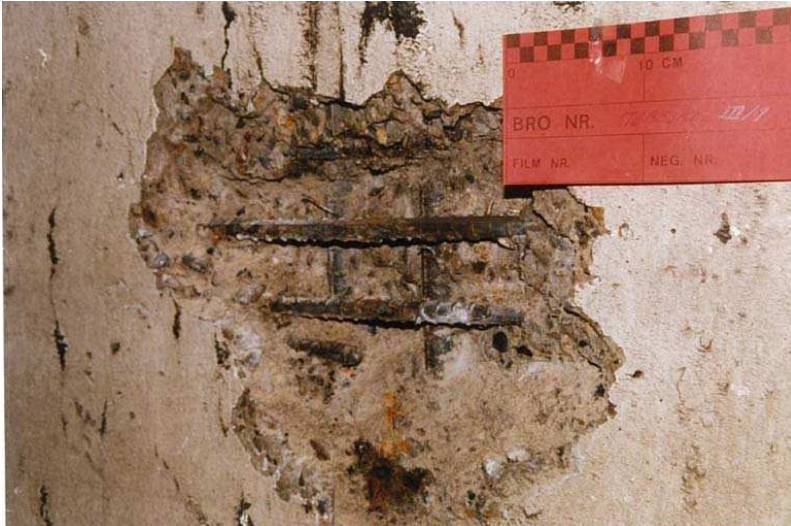
concrete repair works after a period of 25 – 30 years. Example of reinforcement corrosion as recorded from an inspection in 1988 is shown on [Figure 4.5-1](#).

**Figure 4.5-1 Reinforcement corrosion from inspection in 1988.**

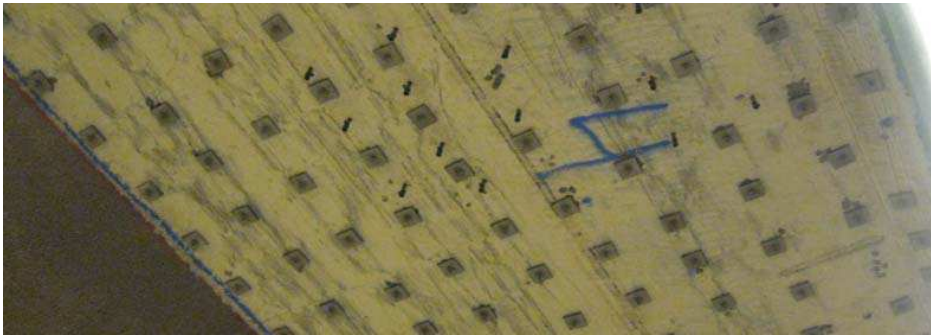
A large part of the 1998 repaired concrete in the tunnel ceiling was retrofitted in 2010 - 2011 with adhesive anchors between the repair and original concrete as delamination was observed between the repair and original concrete. This retrofitting inclusive a reassessment of the structural capacity of the repaired section is described in Section 7.5.5.

Figure 4.5-3 Installation of adhesive anchors in tunnel ceiling to make a structural connection between repair concrete and original concrete

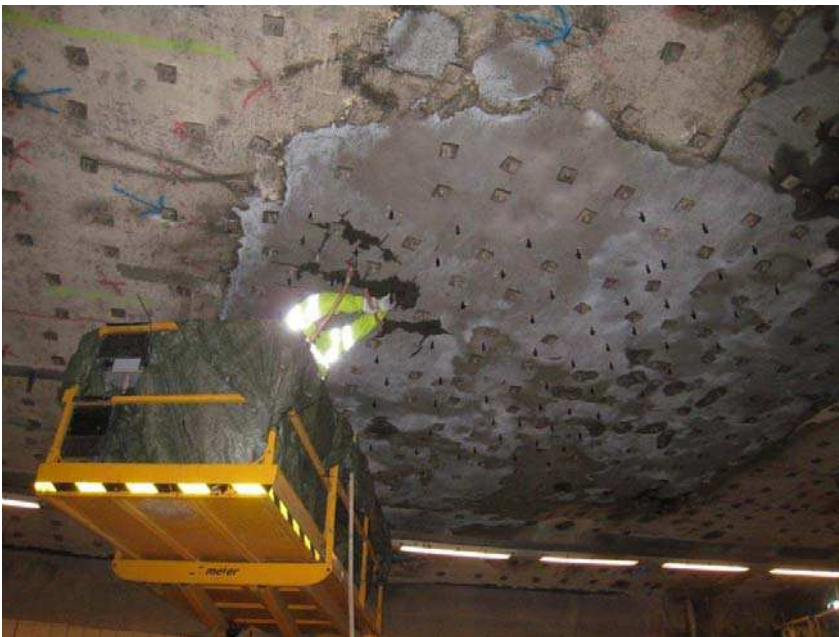
Crack injection campaigns are therefore executed every winter on almost regular basis. The crack injections are possible during late evenings and nights when one tunnel tube can be closed for traffic without creating serious restrictions for the traffic. The impact on the flow of traffic is minimal as the tunnel can be kept completely open during daytime and rush hours.

Figure 4.5-4 Injection of leaking cracks

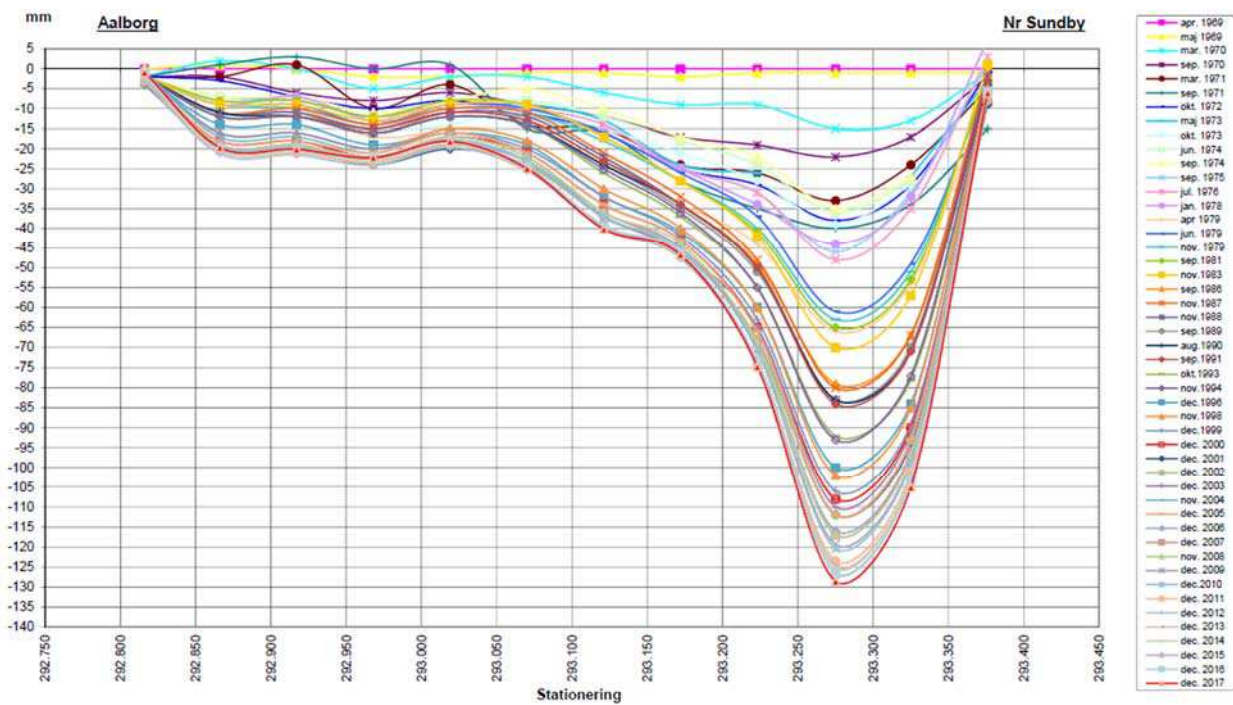
As explained above the leakages occurred already immediately after the construction of the tunnel, but at the same time some not expected big settlements started, and they have continued and show no signs of decreasing.

Figure 4.6-1 Recorded settlements during the period 1969 – 2017.

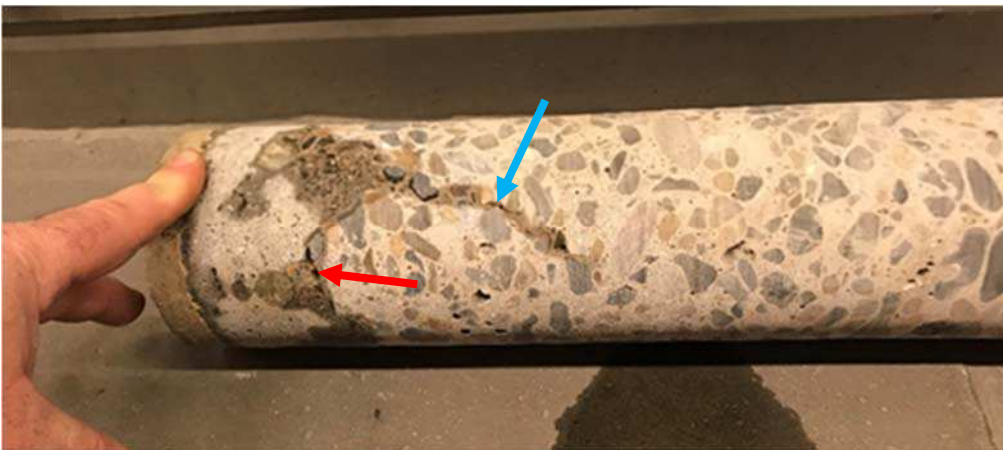
**Figure 6.3-2** Core extracted from roof. The concrete is cracked both at the interface between repair and original concrete (red arrow) as well as within the original concrete (blue arrow).

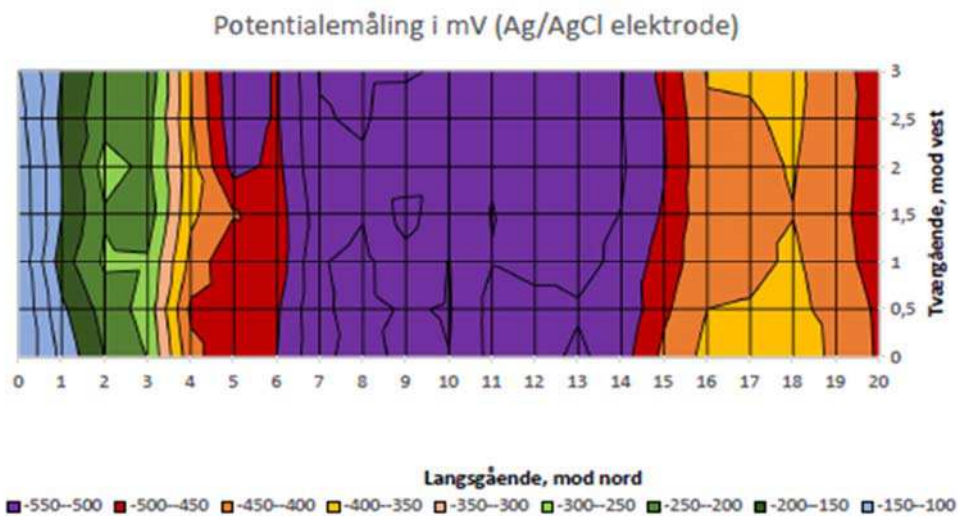
Figure 6.3-3 HCP results from roof. The whole area was wet. No corrosion observed on reinforcement in break out despite the very low potential (-600 mV). Investigated area at transition between element II (left - 3 m) and element III (right - 17 m).

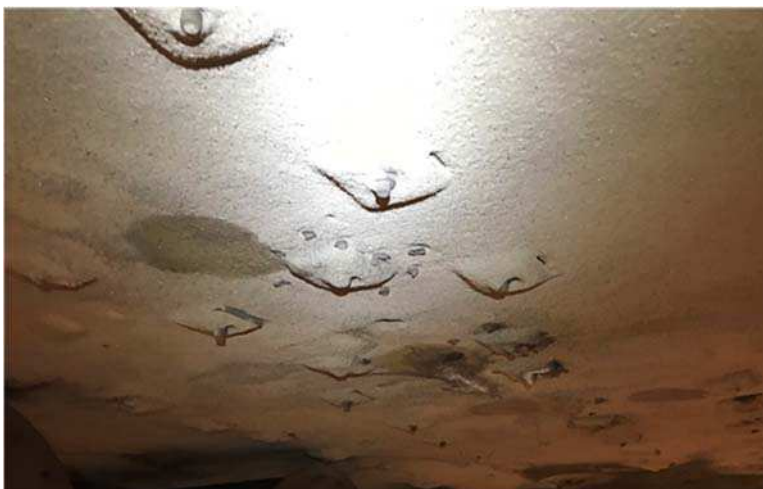
Figure 6.3-4 Area where fire protection has deteriorated.

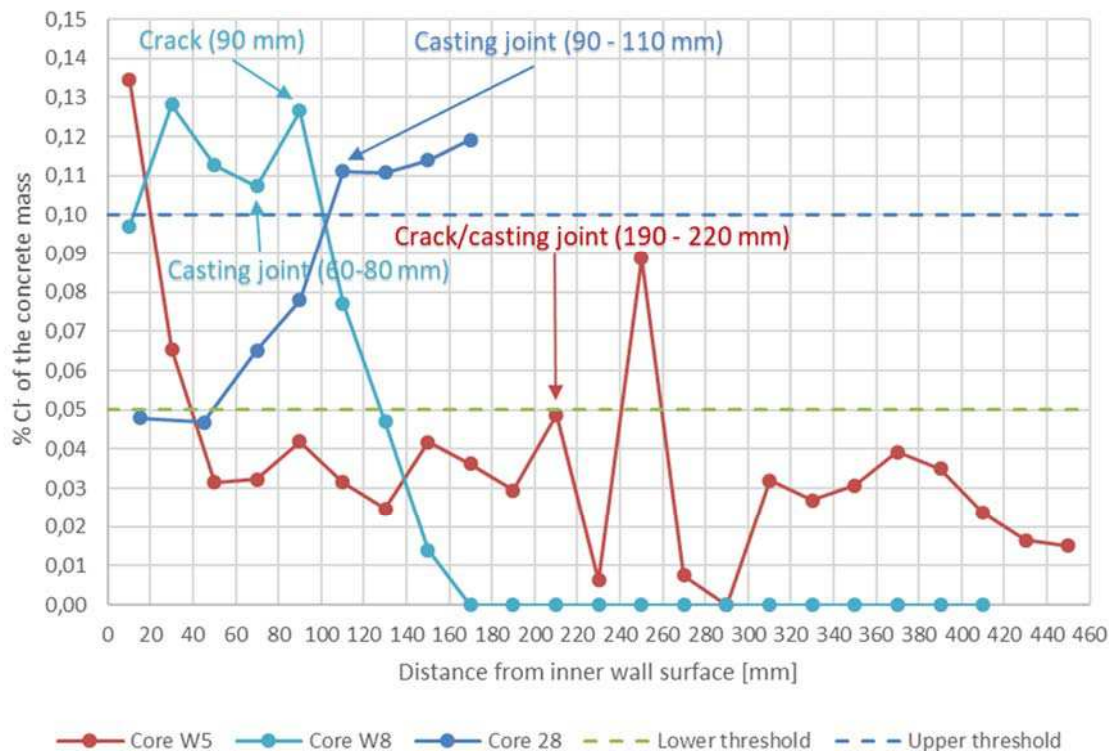
Figure 6.4-1 Chloride profiles from three cores taken from the inside of the eastern wall.

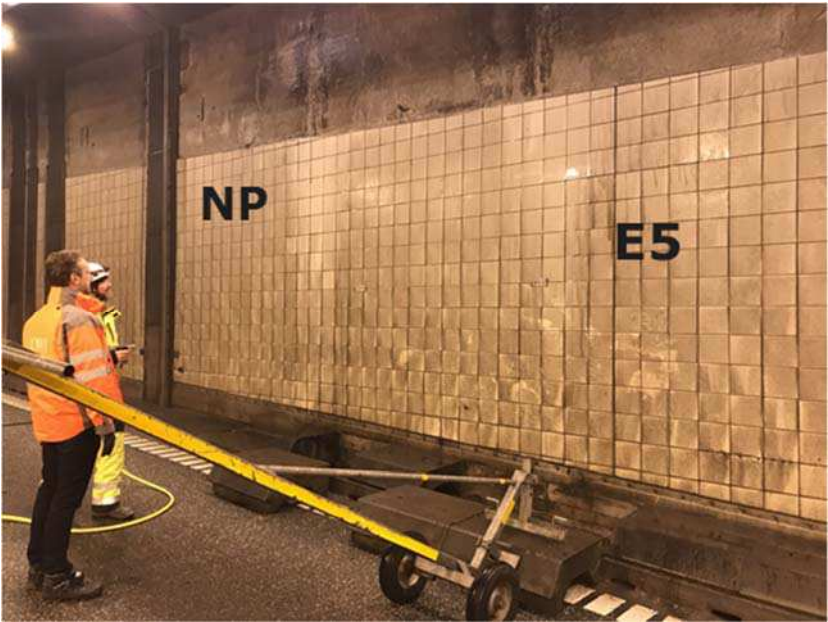
Figure 6.7-1 Closure joint between Northern Portal (NP) and Element V (E5) before removing tiles and concrete in order to inspect the reinforcement.

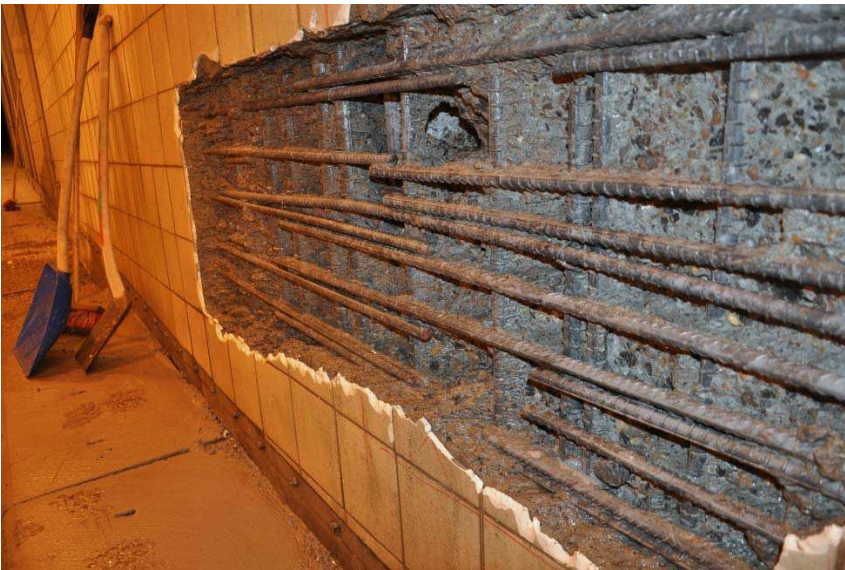
[Figure 6.7-3](#) Exposed reinforcement at the closure joint (Type 2 joint). No signs of butt-welded connections in the horizontal reinforcement.

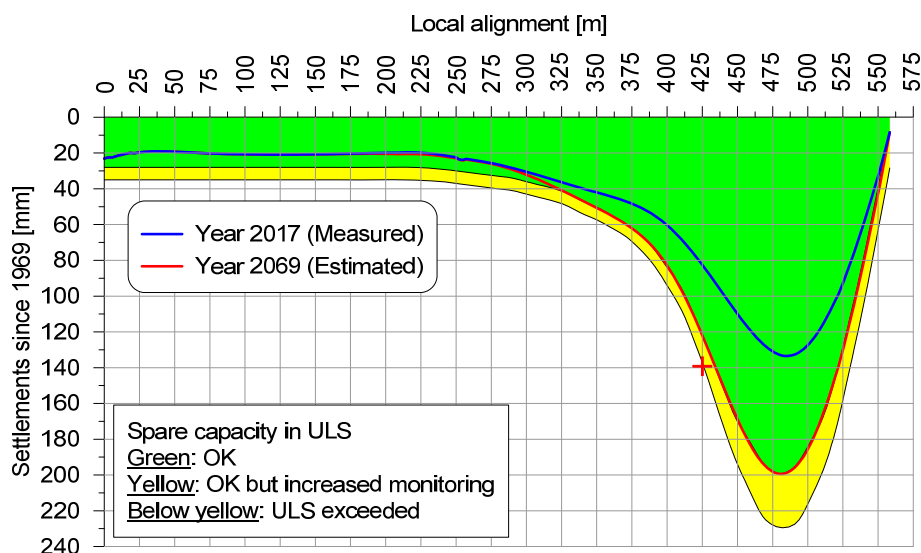
**Figure 8.5-1 Settlements of tunnel structure since 1969. Colour-code relates to whether the tunnel structure complies with existing regulations considering the ULS capacity.**
