Cost Efficient & Environmentally Friendly Coastal Protection

Pressure Equalisation Modules

Abstract

The Official Field Test

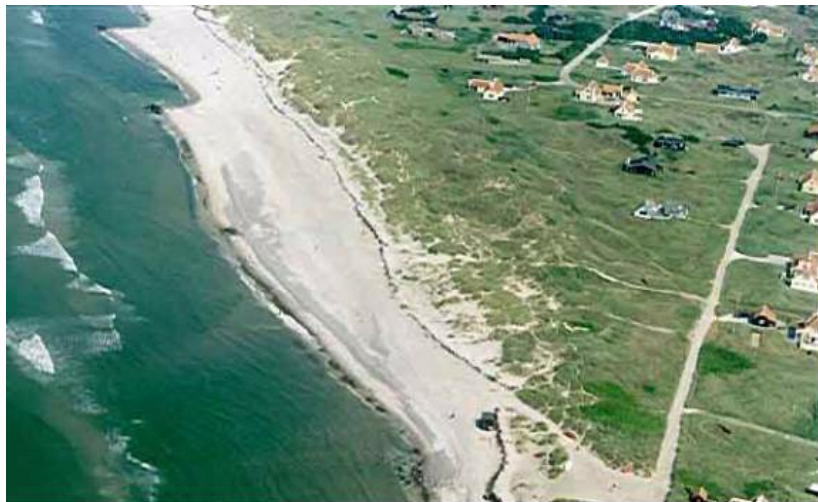
An old groyne has become part of a broad sandy beach since 1997 – when the Pressure Equalisation Modules were established by SIC.

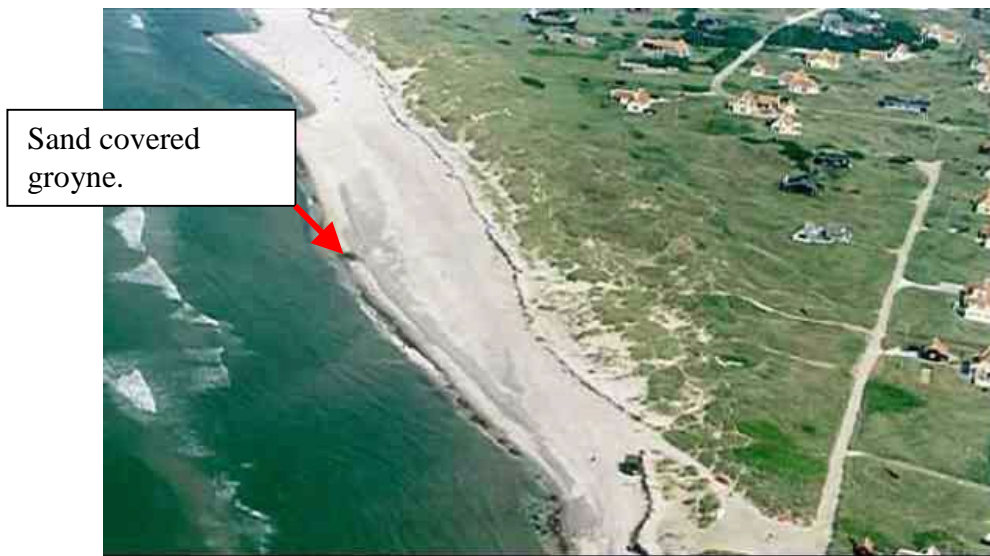
The result from the first test with the Pressure Equaliser Modules (PEM) is clearly seen on the photo in Fig. 2 below. This picture from Gl. Skagen beach shows old sand covered groyne, which has been placed – inshore and passive on a new broad sandy Beach, in the five years the PEM system has been installed.

Fig.2 SIC test area Gl. Skagen North

The PEM protection was established on this site in November 1997. Shortly hereafter, it was possible to walk outside the groynes in periods with normal tides.

At low tides it was observed, that a sand groyne was building up outside the PEM. With this observation, it was realised that the PEM technology could be developed into a new method of protecting the coastline from erosion. Further information about this test installation is found in Appendix 2. "Gl. Skagen North Test Installation".

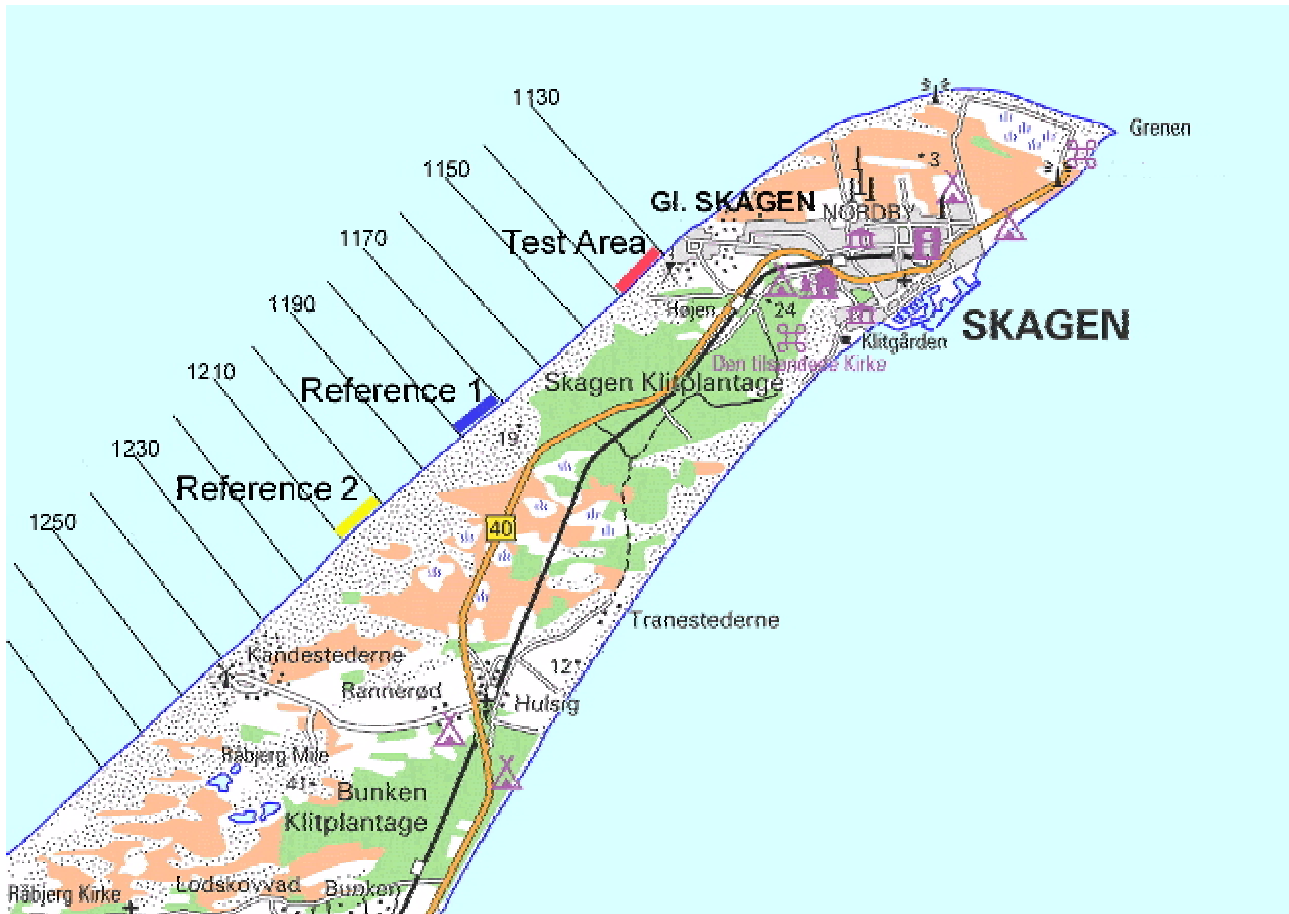
Fig. 3 Test and reference area

The field test was performed along an 8 km long coastline S.W of Gl. Skagen (please see Fig.3) Before the Pressure Equalising Modules was implemented, a baseline survey of the selected coastline was performed. Modern laser equipment was used for the measurements.

The distance between each line of PEMs is 100 metres, within the line a PEM is installed for each 10-metre. Initially the width of the beach made room for two PEMs only in each line, as the beach over time got wider, additional PEM were installed. The total distance from station 113200 to 114250 is 1050 metre.

Reference area I was located 3,0 km SW of the test area, ranging from station 117000 to station 118000. The objective of this reference area was to compare the development during the field test period of the coastal profile in a nearby site without PEM.

Reference area II was located 7,0 km SW of the test area, ranging from station 120131 to station 121134. The objective of this reference area was to compare development of the coastal profile in a nearby site without PEM during the research period

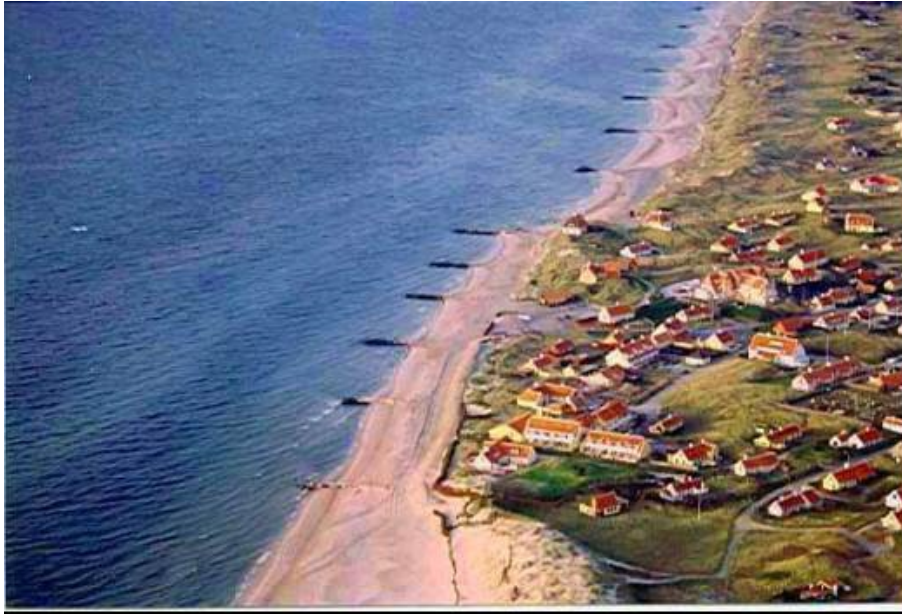
Fig 9

The groynes at Gl. Skagen before installation of PEM system by SIC

Just North of the official Field Test Area in Gl. Skagen, SIC made one of the first PEM installation. The groynes reached 10 – 15 metres out from the shoreline before installation

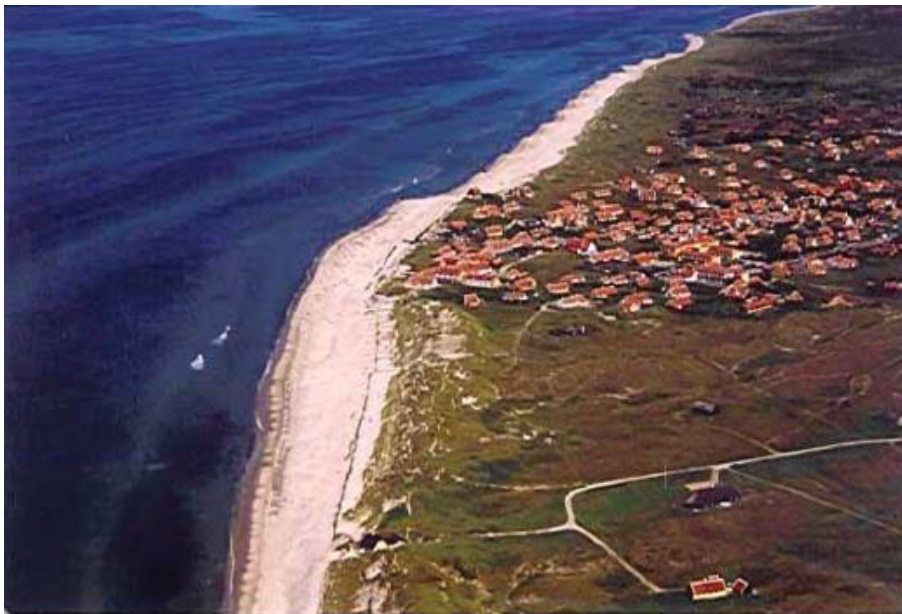
Fig 10

The groynes at Gl. Skagen one year after the PEM installation.

As the aerial photo illustrates the groynes are completely covered in sand 5 to 10 metres inshore, one year after installation of the pressure equalisation modules.

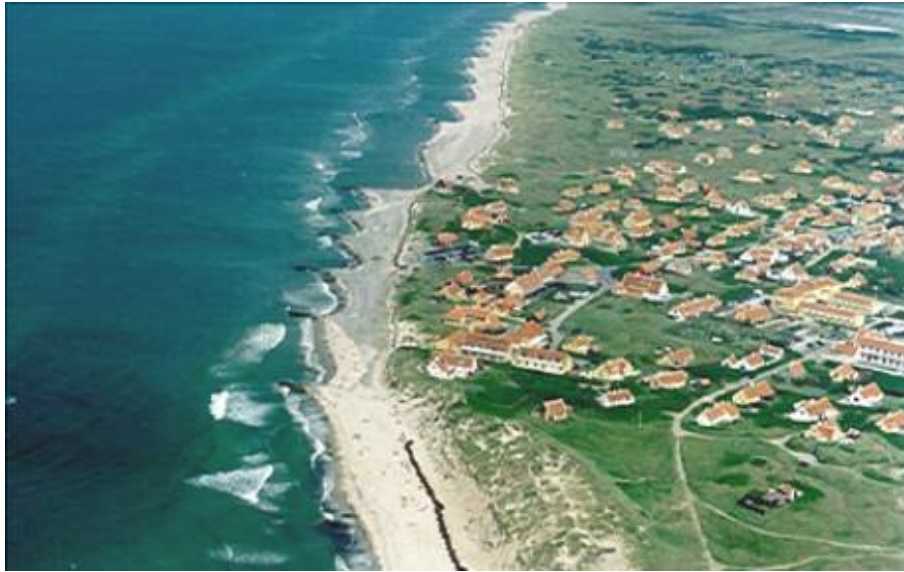
Fig. 11 Gl. Skagen PEM installation removed in 2001

After a dispute with the local authority SIC was ordered to remove the PEM installation in November 2001. The photo from July 2002 shows erosion has moved the coastline 15 to 25 metres back. The groyne is out in the sea and the sand has disappeared between the groyne.

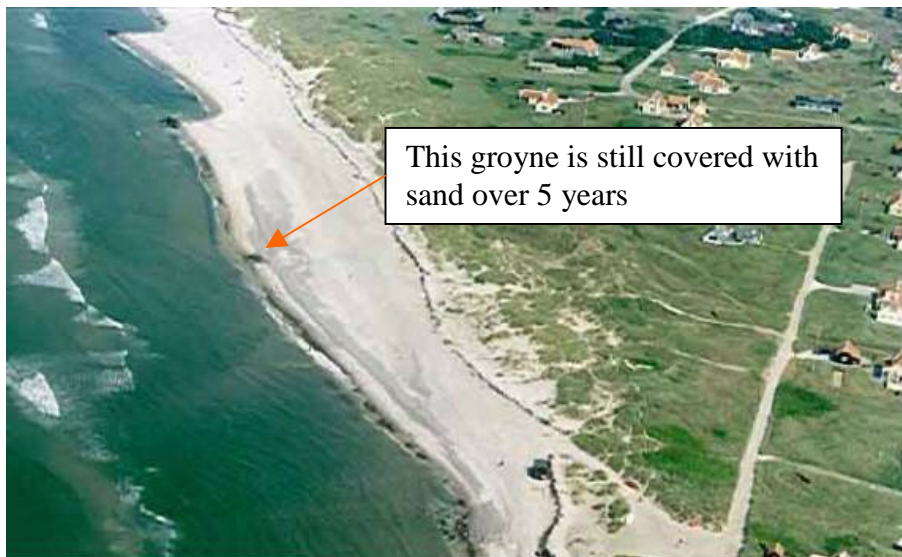
Fig. 12
Gl. Skagen one PEM was accidentally left

SIC forgot to remove one set of PEM from the site in November 2001. On this photo from July 2002 the effect is seen there has been no erosion right on this spot. This is maybe the best proof of concept for SIC's unique coastal protection system

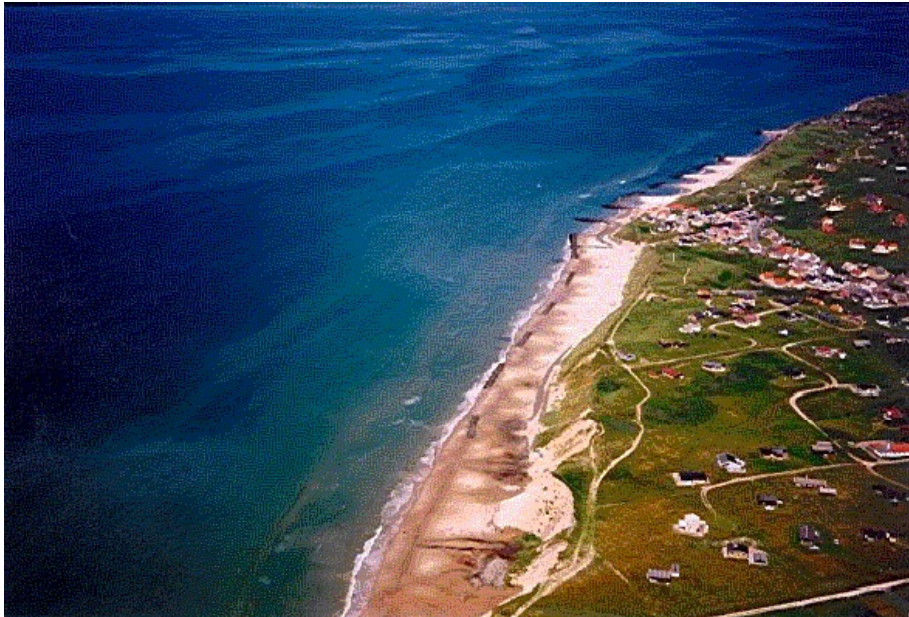
Fig. 13
Lønstrup after PEM installation 1999

SIC installed a PEM system at Lønstrup beach in April 1999. Shortly after the breakwaters are completely covered in sand as seen on the photo from 1999 in Fig 13. The beach recovered with up to 90 cm over the area.

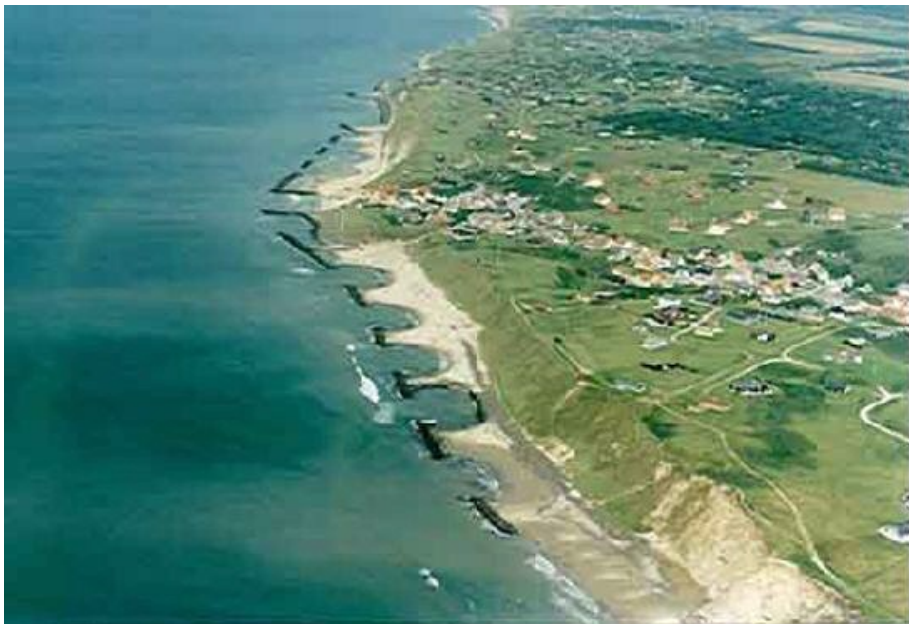
Fig. 14 Lønstrup 2002

The PEM installation was removed in August 1999, and the beach is back to the previous stage, with serious erosion.

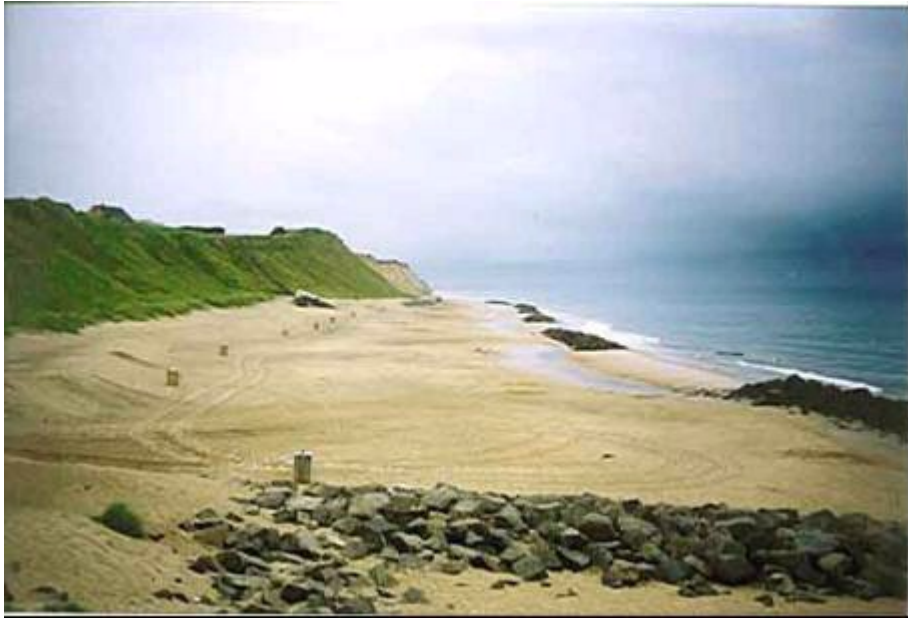
Fig.15 Lønstrup, July 1999

When the beach was protected by a SIC PEM installation, you could drive with cars on the beach.

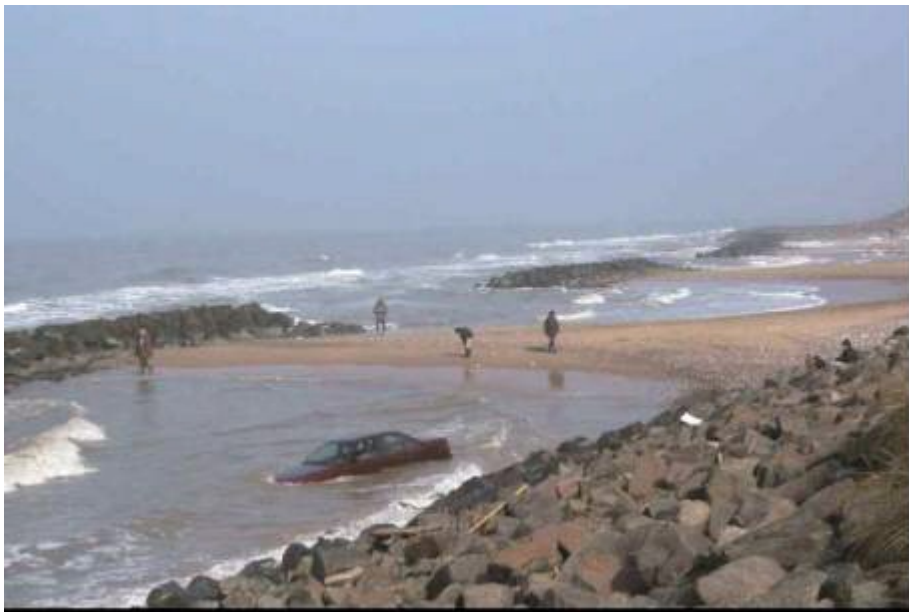
Fig.16 Lønstrup, Marts 2002.

The same beaches after the PEM installation was removed. It is not longer possible to drive with cars on the beach. We just lost a company car trying to drive here.
