Appendix 3

The SIC System compared with beach nourishment on the West Coast of Jutland.

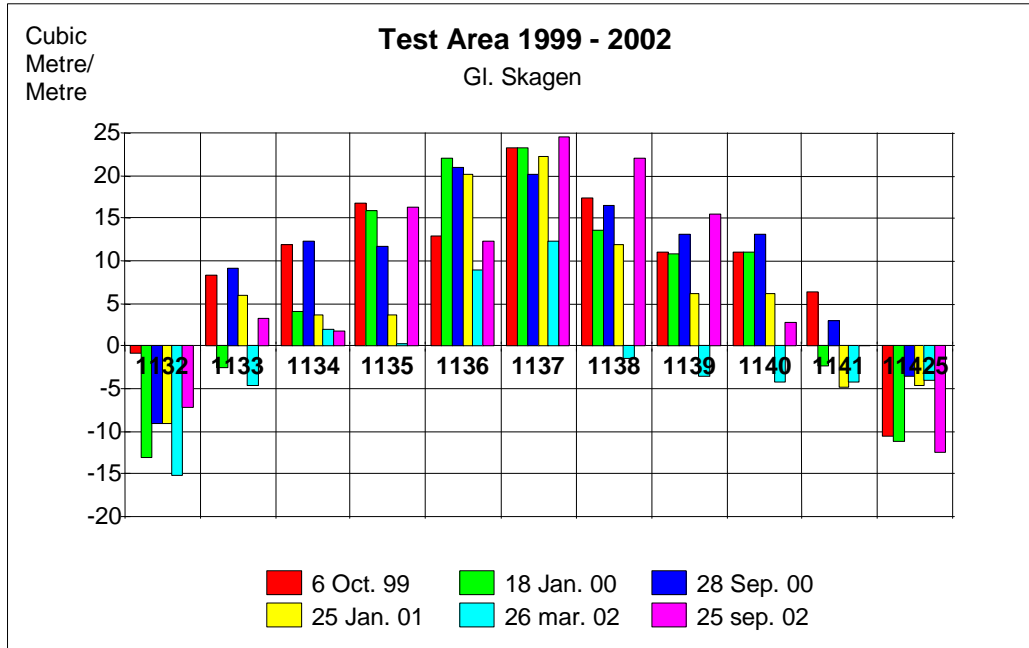
Coastal development at Gl. Skagen - fig. 1

As illustrated in fig. 1, the SIC System has a systematic building effect on a beach profile.

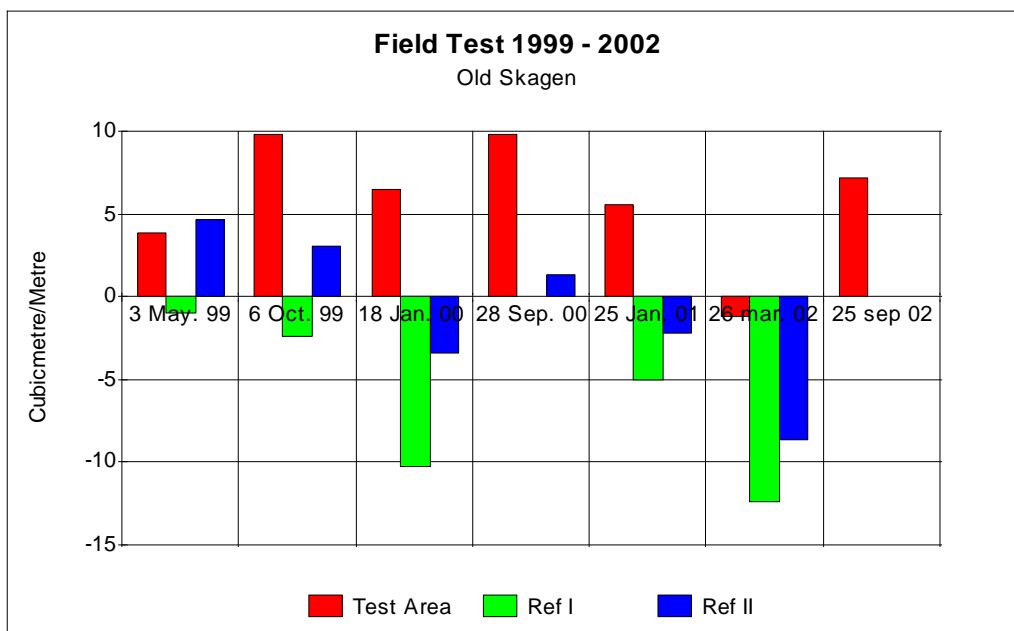
Fig. 2

The longtime effect is shown in fig. 2, where the Test Area fitted with pressure equalization modules has a coastal increase of 5 – 10 m³ per metre as opposed to the reference areas which show an erosion of 3.5 – 10 m³ per metre.

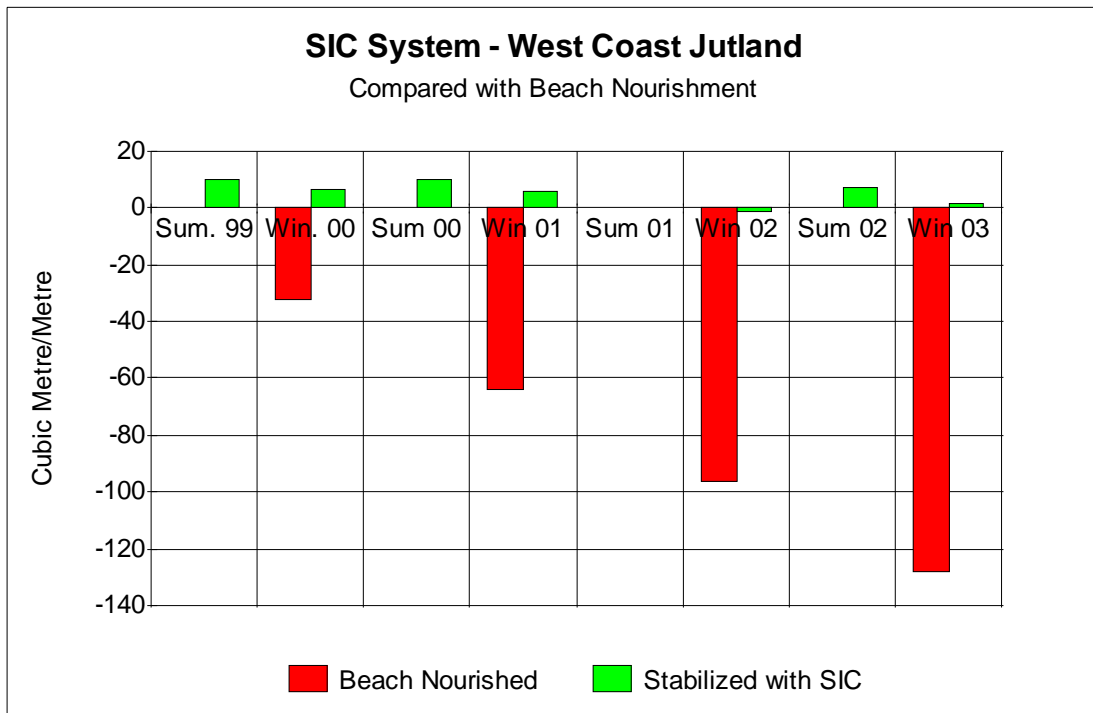
Fig 4

As illustrated in fig. 4 the SIC-treated beach is stable due to the fact that during the summer season a “buffer” is built up which is sufficient to withstand the winter storms.

Contrary to the SIC-treated beaches, erosion is occurring at a rate of 32 m³ per metre in the beach nourished areas according to the KDI record of sediment movement, Appendix 3.1.

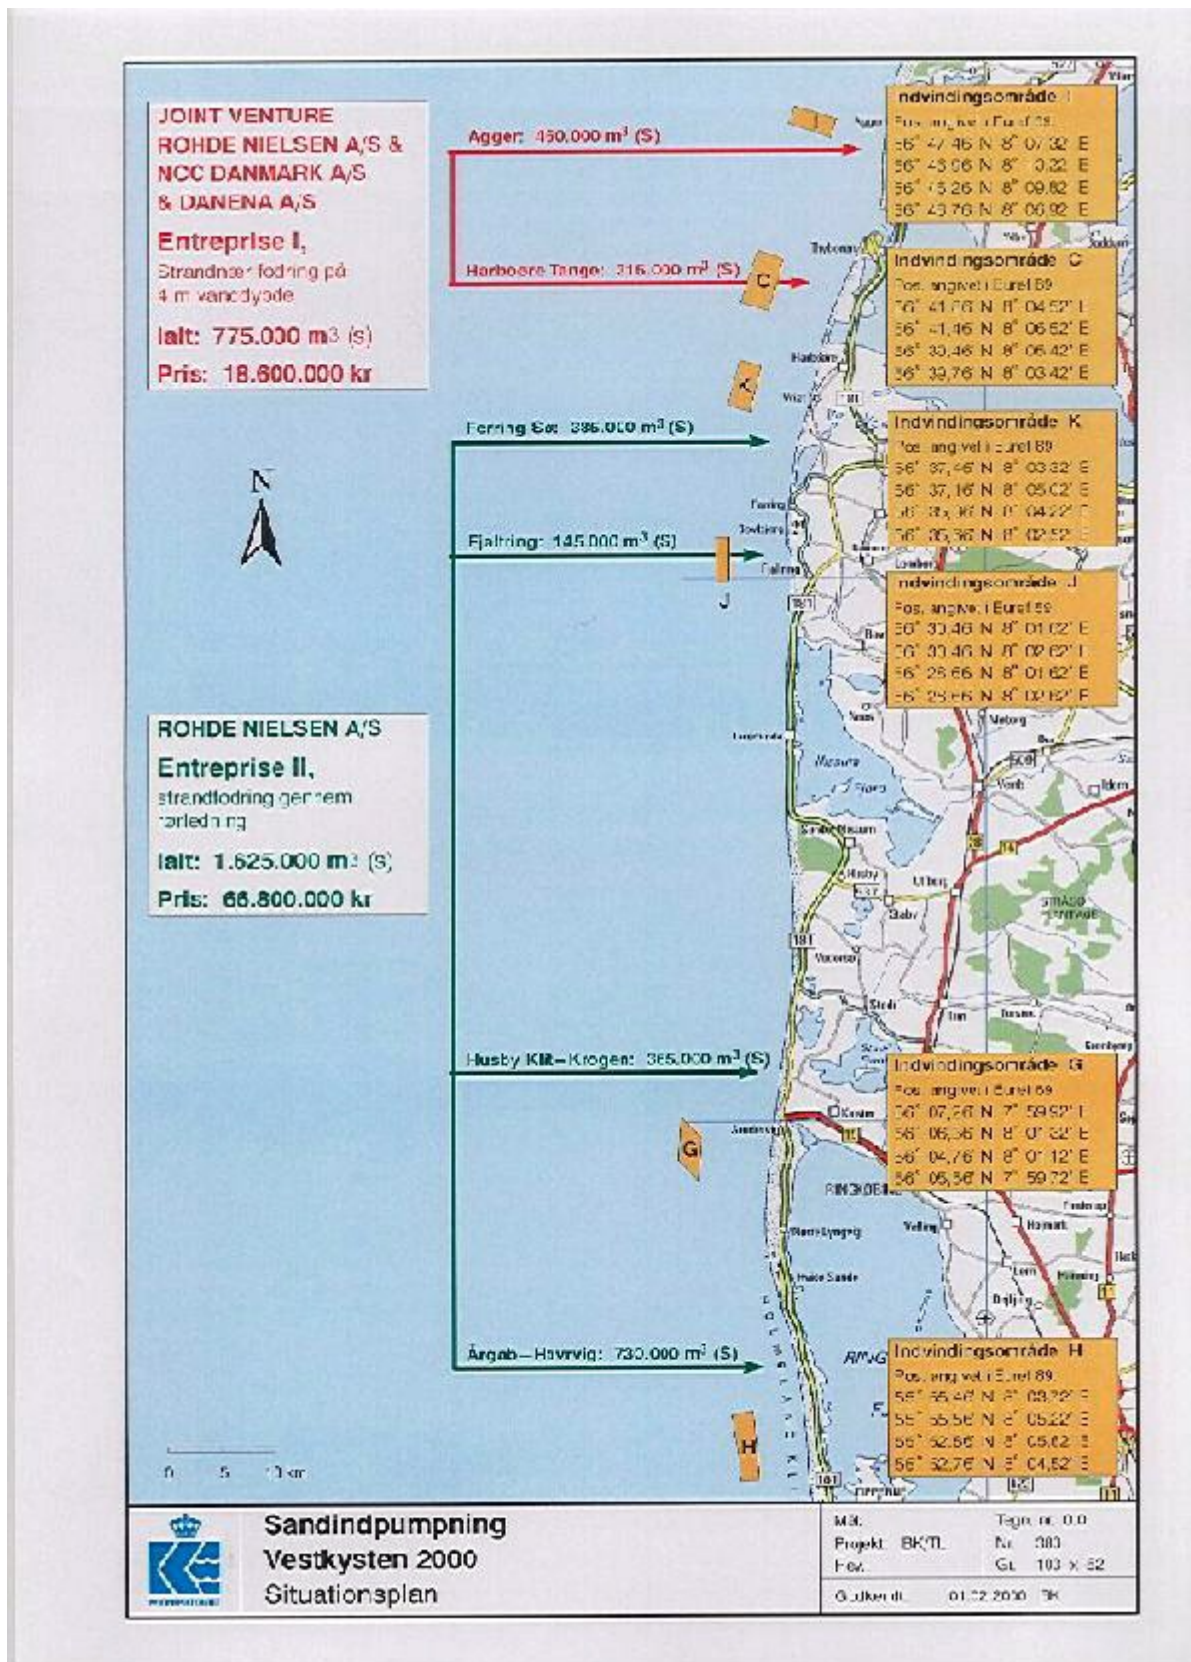
Appendix 3.2.

As it appears in Appendix 3.2, the West coast of Jutland is beach nourished every year with 2.4 mill. m³ sand; however the yearly erosion is 4.13 mill. m³ which is shown in Appendix 1 and fig. 3.
