**6.8: The near tube morphology.**

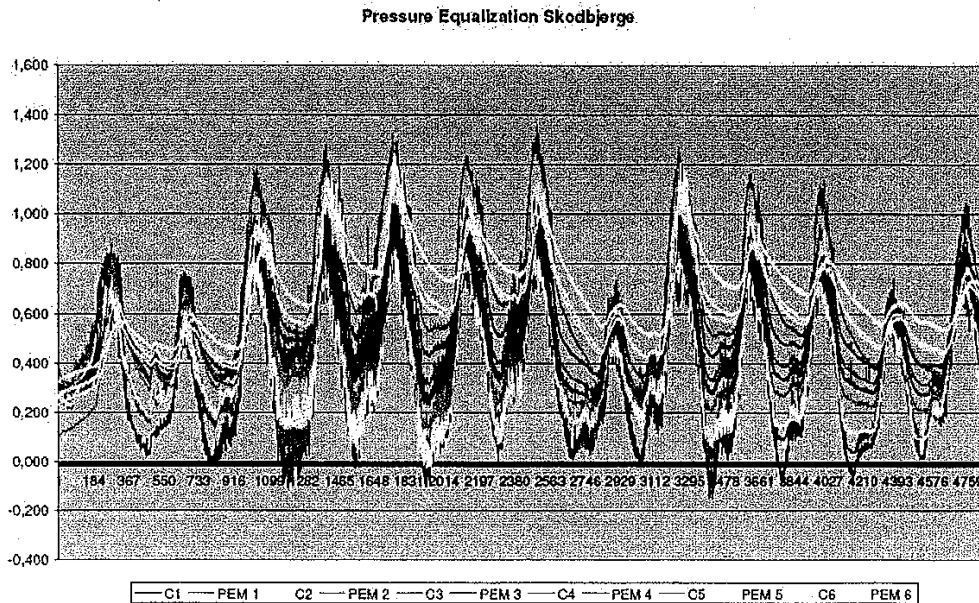
Based on the physical effects of the PEM tubes on the beach described above a separate test was made with water level sensors (Diver), to determine the effect of PEM on the water table in the beach. The test was carried out in the northern part of the Skodbjerg test area in control area 1.

Figure 6.20: Time variation in the whole row of tubes and outside the tubes

Appendix 3 presents the gross-behaviour of the beach, i.e. the dampening of the tidal wave as function of the distance from the coastline as sketched in figure 6.11c. There was a change in the mean Water Sea Level of 35 cm from the first week to the second, due to changes in the weather conditions. That means that the groundwater flow in the second week incorporated an additional 35 cm thick layer of the beach in its flow domain. The analysis of the dampening shows that the dampening characteristics of the beach was the same before and after the implementation of the PEM-tubes, which demonstrates that the PEM-system has no significant drainage effect. The inclusion of the 35 cm layer of beach has not changed the characteristics as well, which demonstrates how uniform the composition of the beach actually is.
