# **Coastal protection performance of the SIC Pressure Equalizing Modules.**

**Results of the three years field test at the southern Holmsland Barrier on the  
Danish North Sea Coast**

by  
**Hans F. Burcharth**  
Prof. dr. techn, dr. h.c.

**2 June 2008**

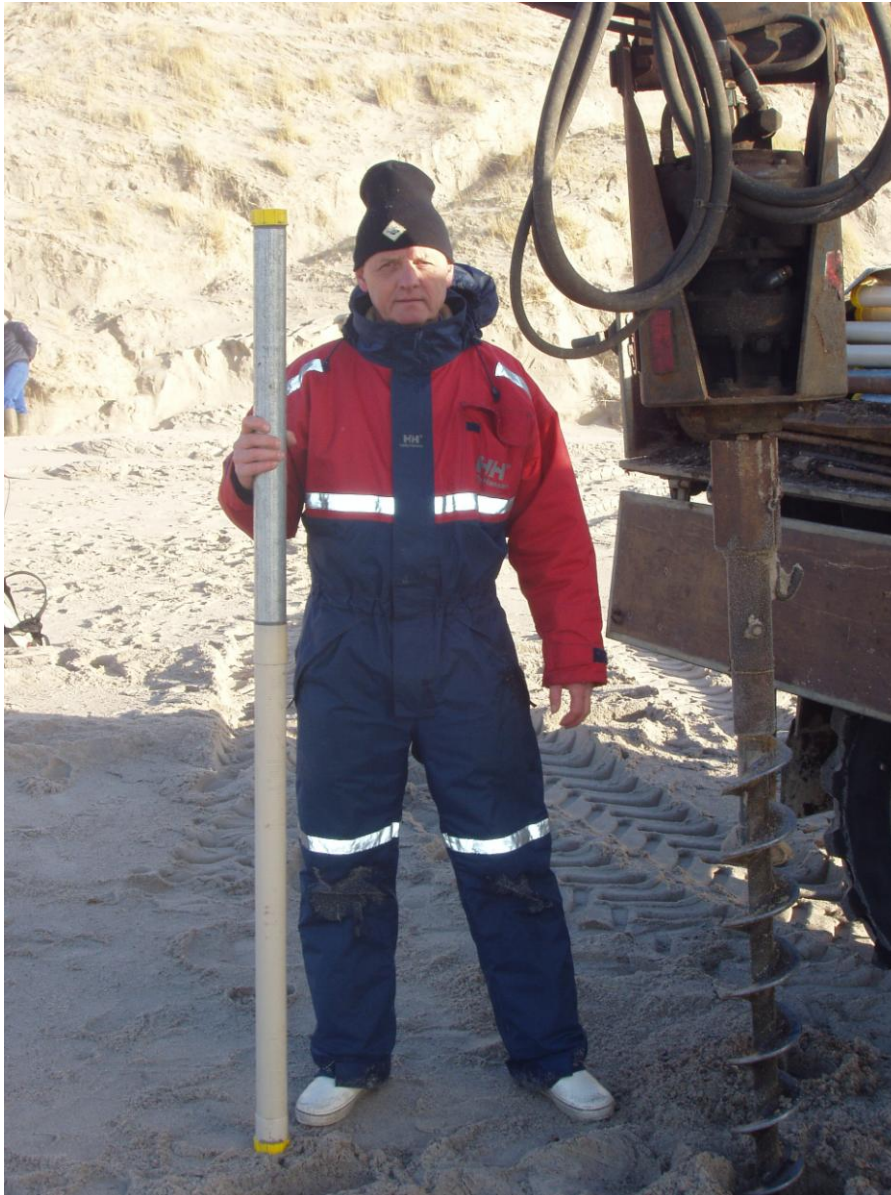
The PEMs used in the present tests are 2 m long circular 63 mm diameter pipes. The upper 0.75 m is metal and the lower 1.25 m is plastic with 0.2 mm slots in the 1 m lowest part. The slots allow water to flow in and out of the pipe, but avoid penetration of sandy beach materials, see photo Fig. 1. The bottom end of the pipe is closed. The top end is semi closed allowing only air and water to go through.

Fig. 1. Photo of PEM pipe (KDI).

Drained water has to go through the drain pipe. In the case of a PEM it implies that the water has to go in and out through the slots solely over the 1 metre perforated height, see Figs. 1 and 2. The upper non-perforated 1 metre of the PEM has no function with respect to drainage and could therefore be omitted without changing the drain capacity. Two conditions in the soil must be fulfilled if a vertical drain like a PEM should function:

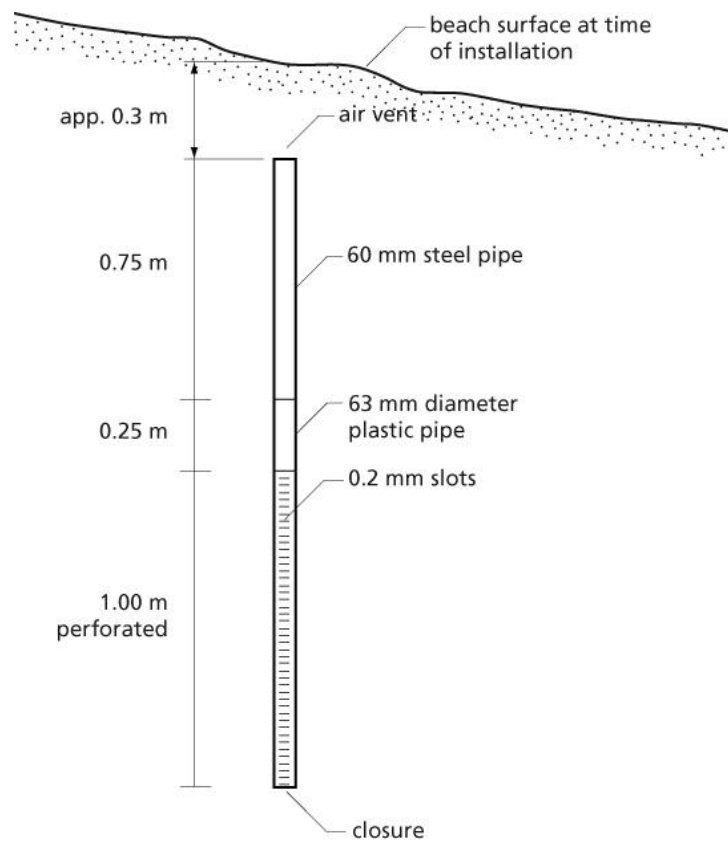
Fig. 2. Installed PEM.

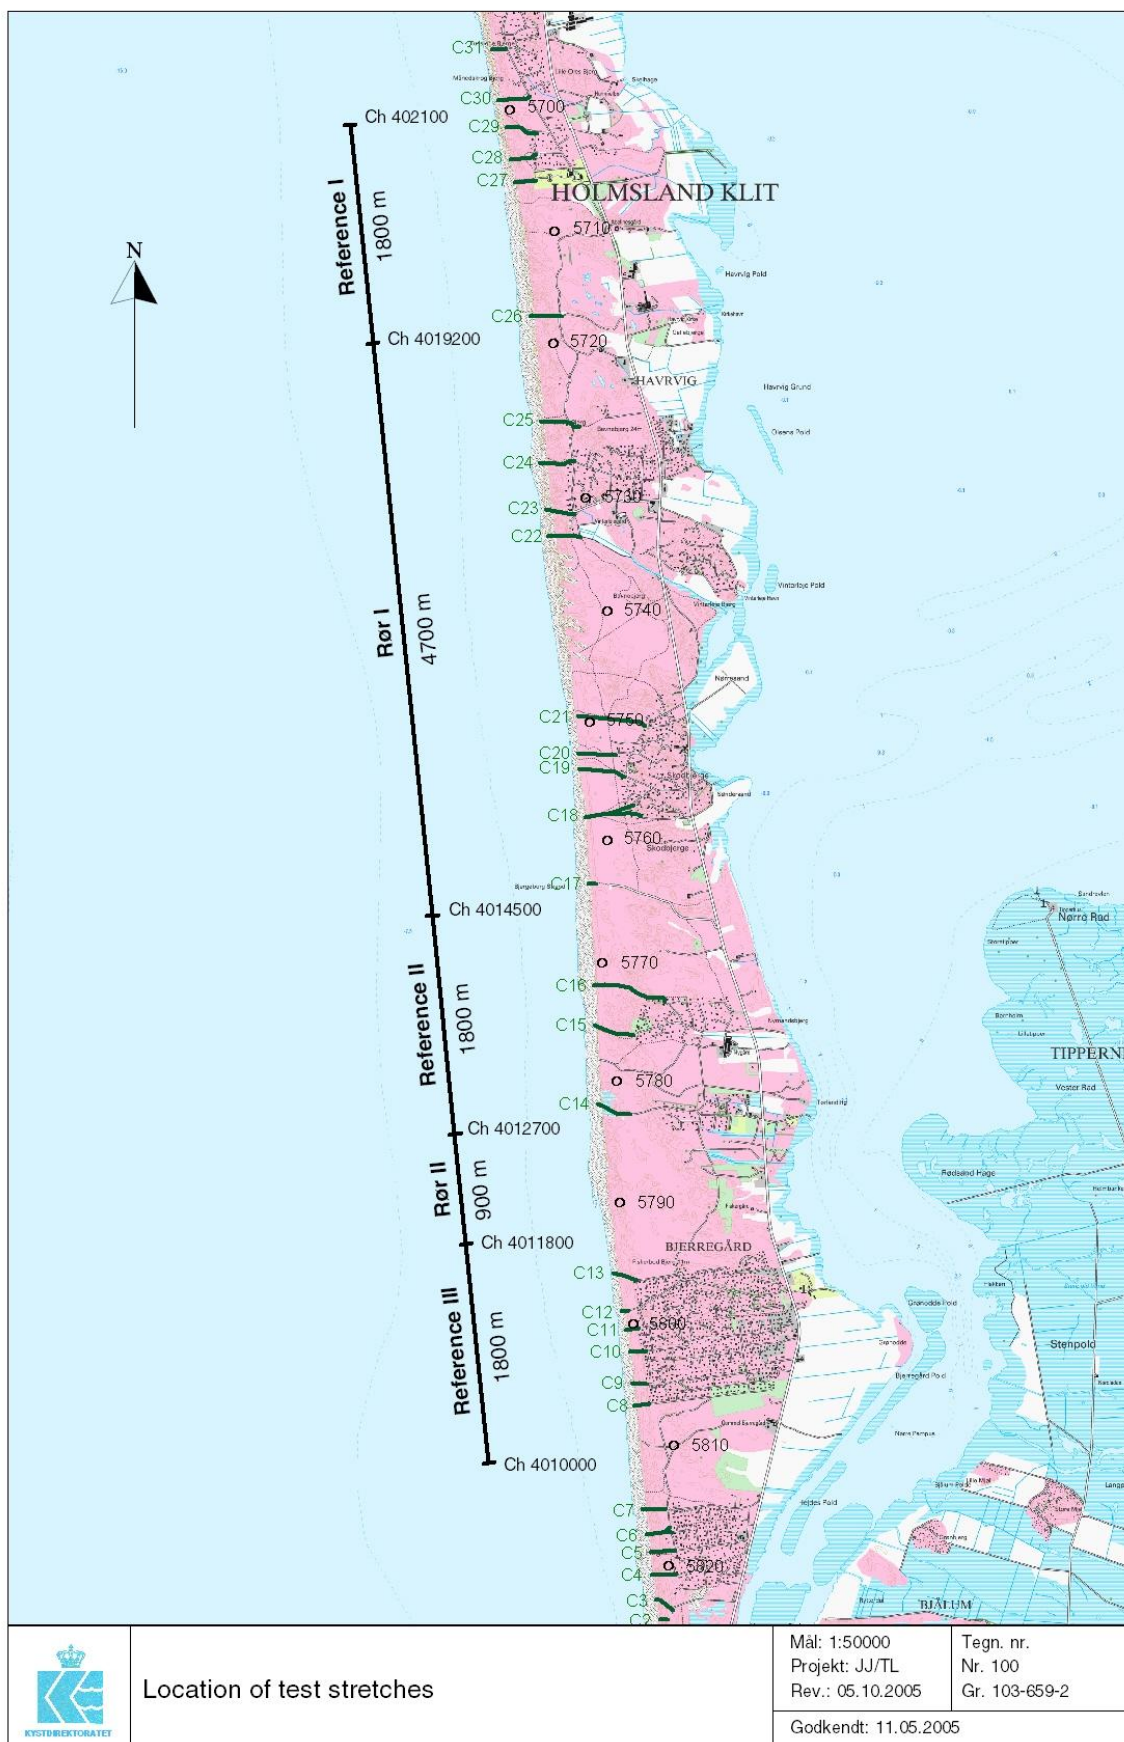
Fig. 6. Location of test stretches.

JF proposed to include an approximately 1 km stretch with drains in the south part of the test site. This proposal was accepted. The final division of the test site in stretches with and without drains as decided in a meeting 16.12.04 is shown in Fig. 6. From this it is seen that two stretches of 4.7 km (Rør I, chainage 4019200 - 4014500) and 0.9 km (Rør II, chainage 4012700 - 4011800) respectively were drained, and three stretches of 1.8 km (Reference I, chainage 4021000 – 4019200), 1.8 km (Reference II, chainage 4014500 – 4012700) and 1.8 km (Reference III, chainage 4011800 – 401000) respectively were left undrained.

A field study of the pressure in the tubes and in the surrounding sand was performed in the spring of 2006 in order to get some insight in the functioning of the drain system. The location was the northern part of Ref. I, see Fig. 6. The program was carried out with additional consultancy of Dr. Peter Engesgaard, Geological Institute of University of Copenhagen. The details and the analysis of

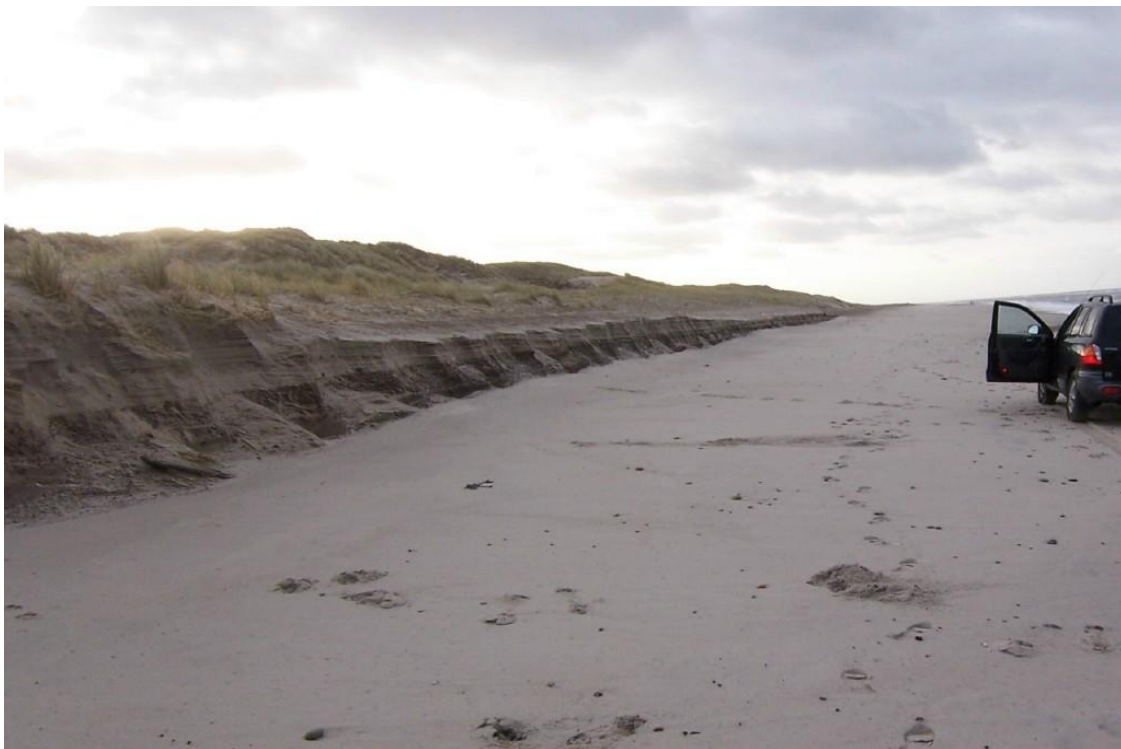
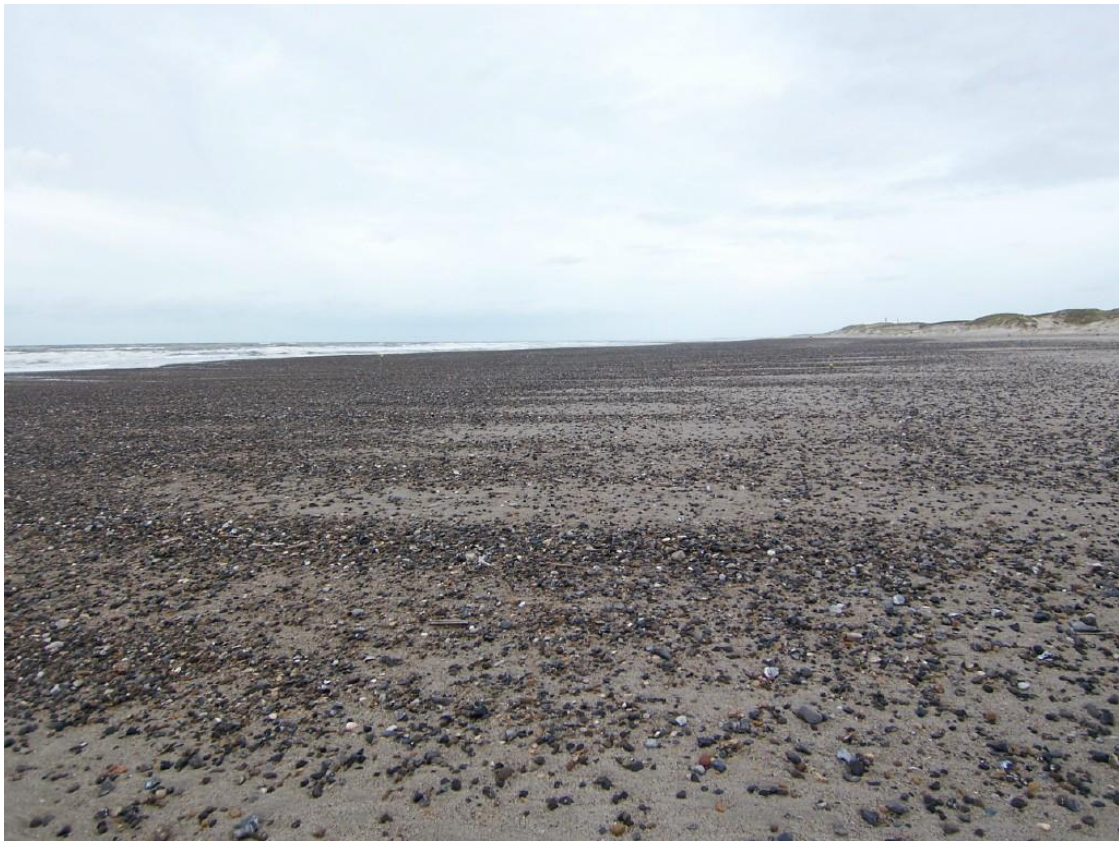
The beach generally appears stratified as both waves and wind sort the materials. Eroded dunes also reveal stratification of former depositions, see Fig. 7.

Fig. 7. Stratified depositions in dune and on the beach. (Photos Hans F. Burcharth).

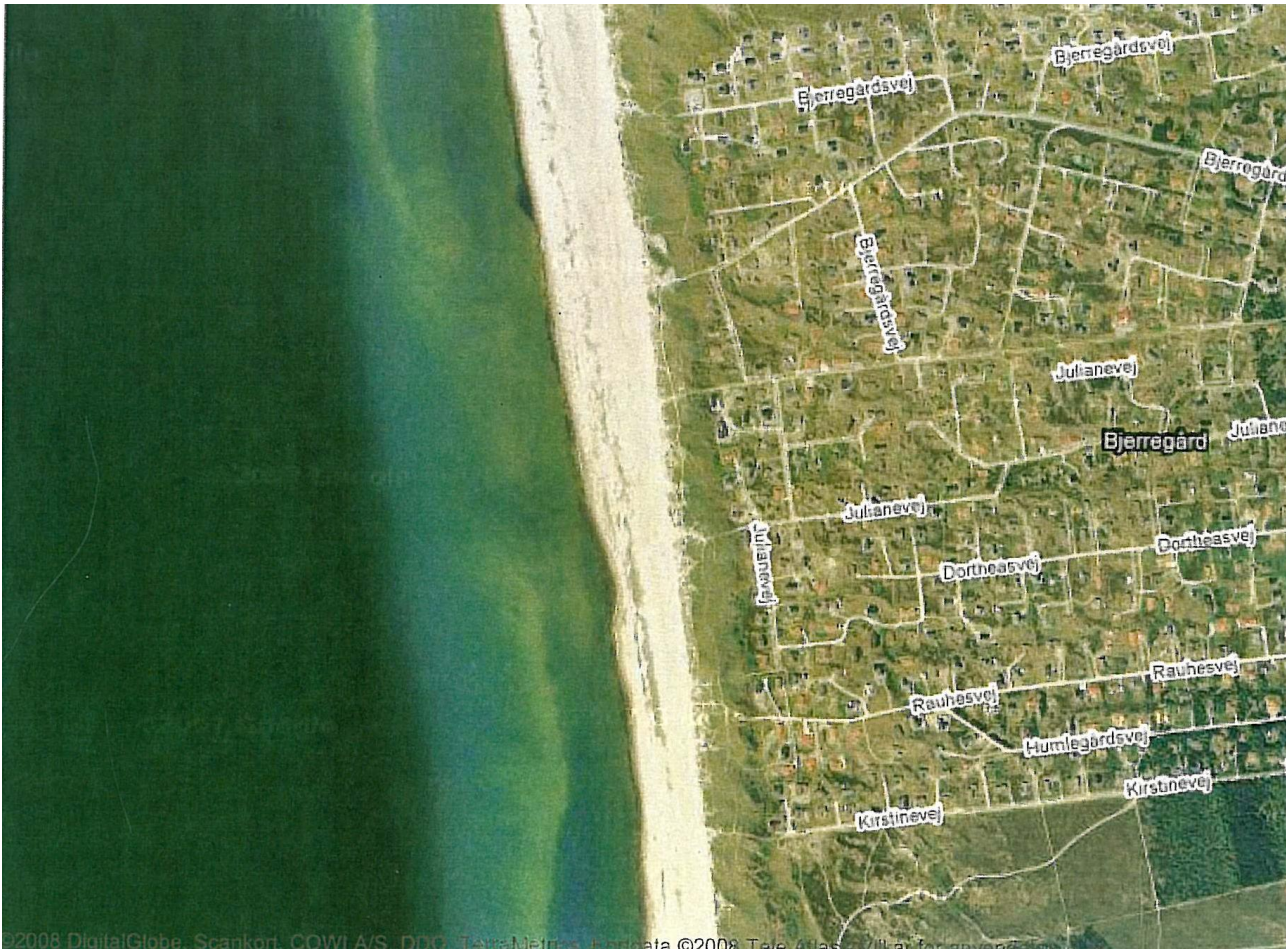
Fig. 11. Aerial photos showing the effect of holes in bars on coastline formation (Digital Globe Scankort, COWI A/S).

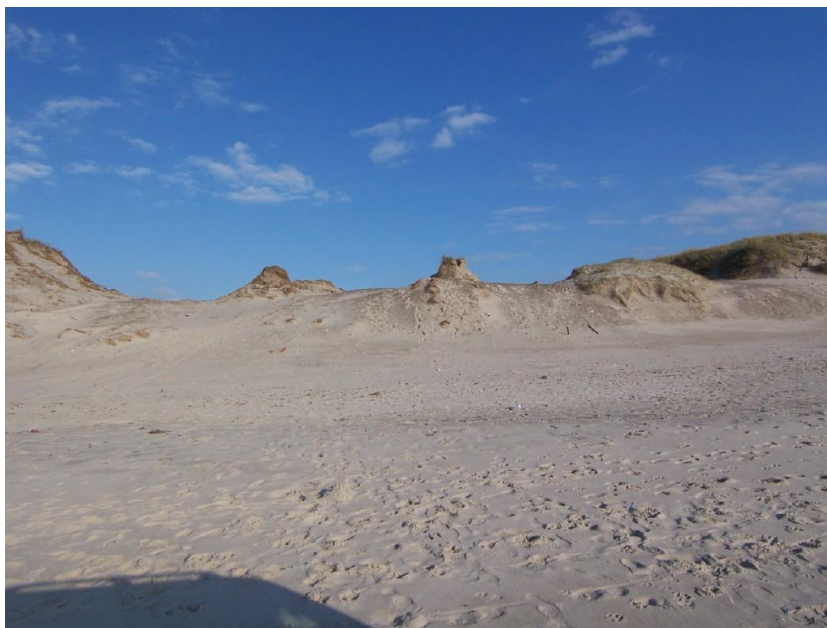
The heights of the dunes along the test site are in the range 10-20 m above mean sea level except for a stretch in Rør I, with heights 5-8 m where three large wind holes were deliberately allowed to develop in order to explore the natural sand formations in the hinterland. No dune erosion took place here in the test period due to a wide and high beach. Actually a built-up of the dunes was observed as a lot of sand was transported from the beach to the hinterland. Fig. 14 shows a photo of one of three wind holes.

Fig. 14. Study area in the middle of Rør 1 for natural development of wind holes in the dunes (Photo Hans F. Burcharth).

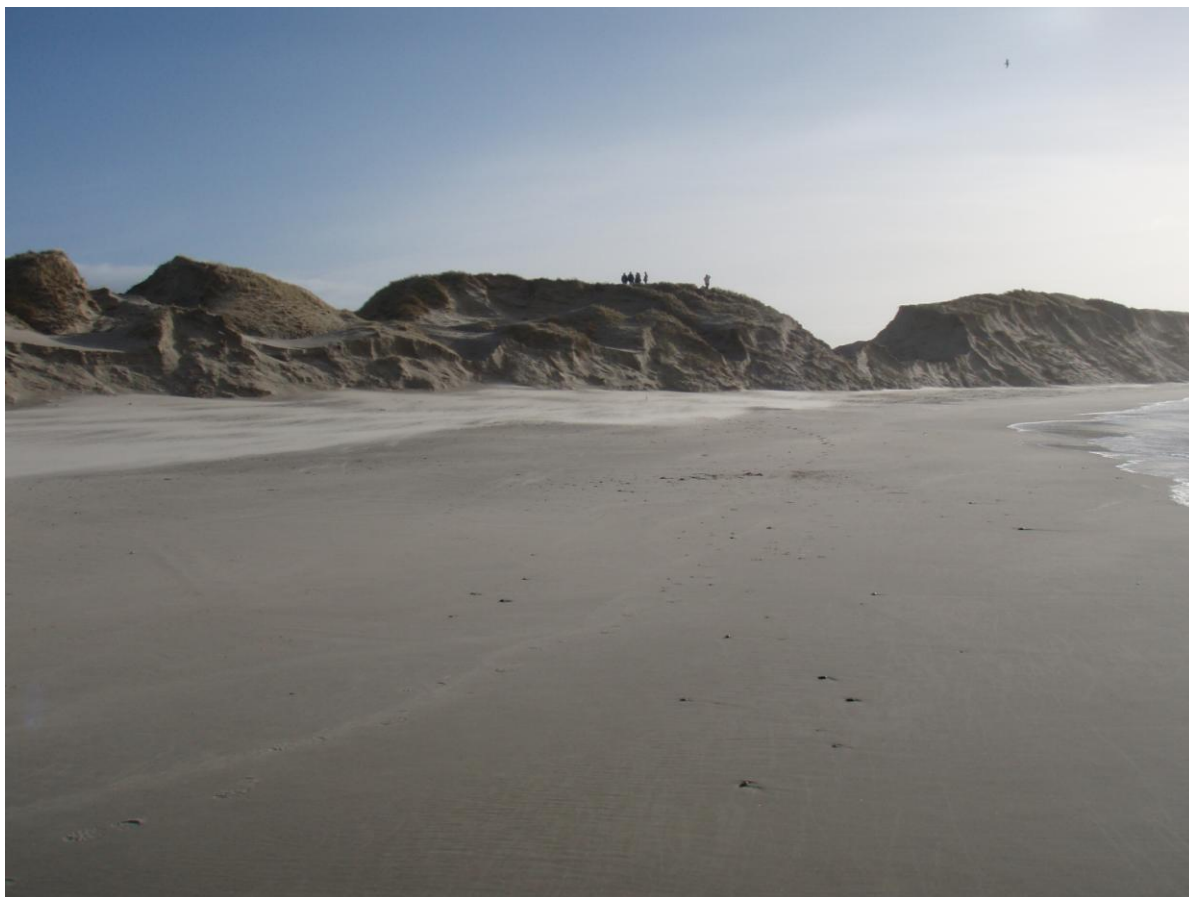
Significant dune erosion took place only on a 500 m stretch in Ref II and a 300 m neighbour stretch in Rør I where also large wind holes developed during the January 2007 storms. This coincides very well with the lack of outer bar in front of the stretches; cf. Fig. 12, which allows larger waves to enter and erode the nearshore zone. Fig. 15 show a photo of the wind holes in the northern part of Ref. II, taken after the storms in January 2007.

Fig. 15. Wind holes in dunes in the northern part of Ref. II, taken after the storms in January 2007. (Photo KDI).

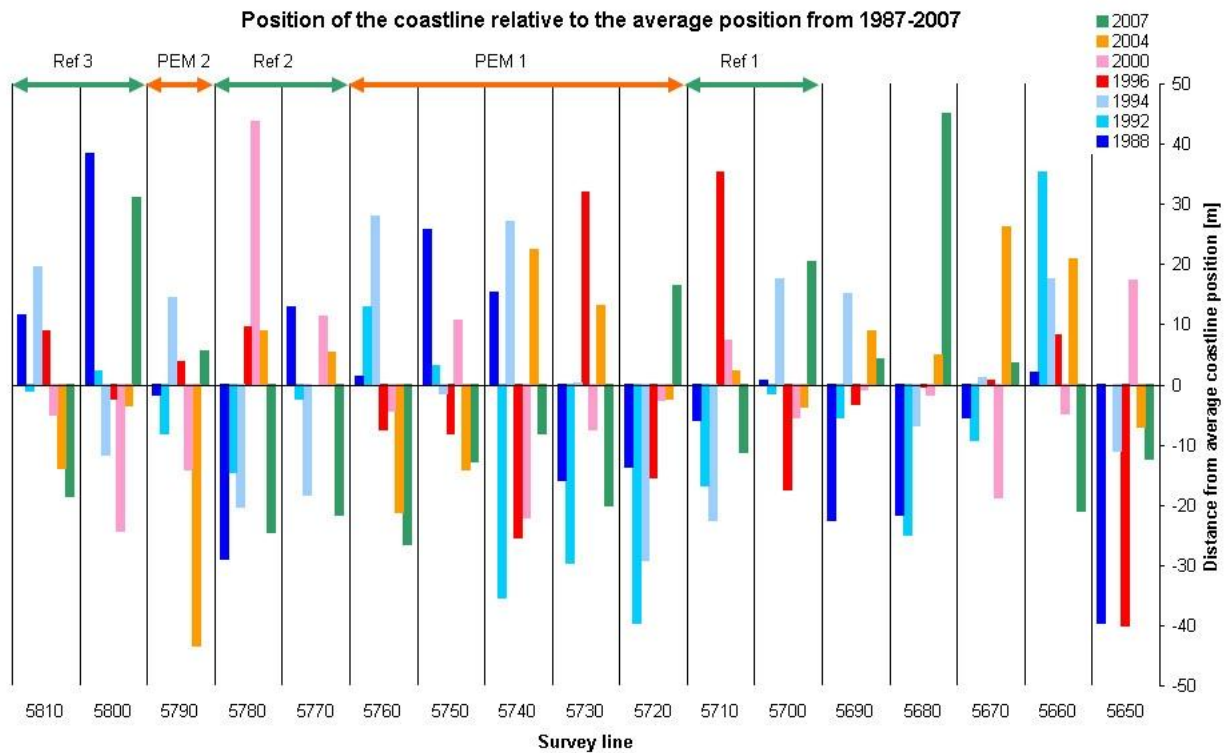
Fig. 17. Coastline positions relative to average position, 1987–2007 (KDI).

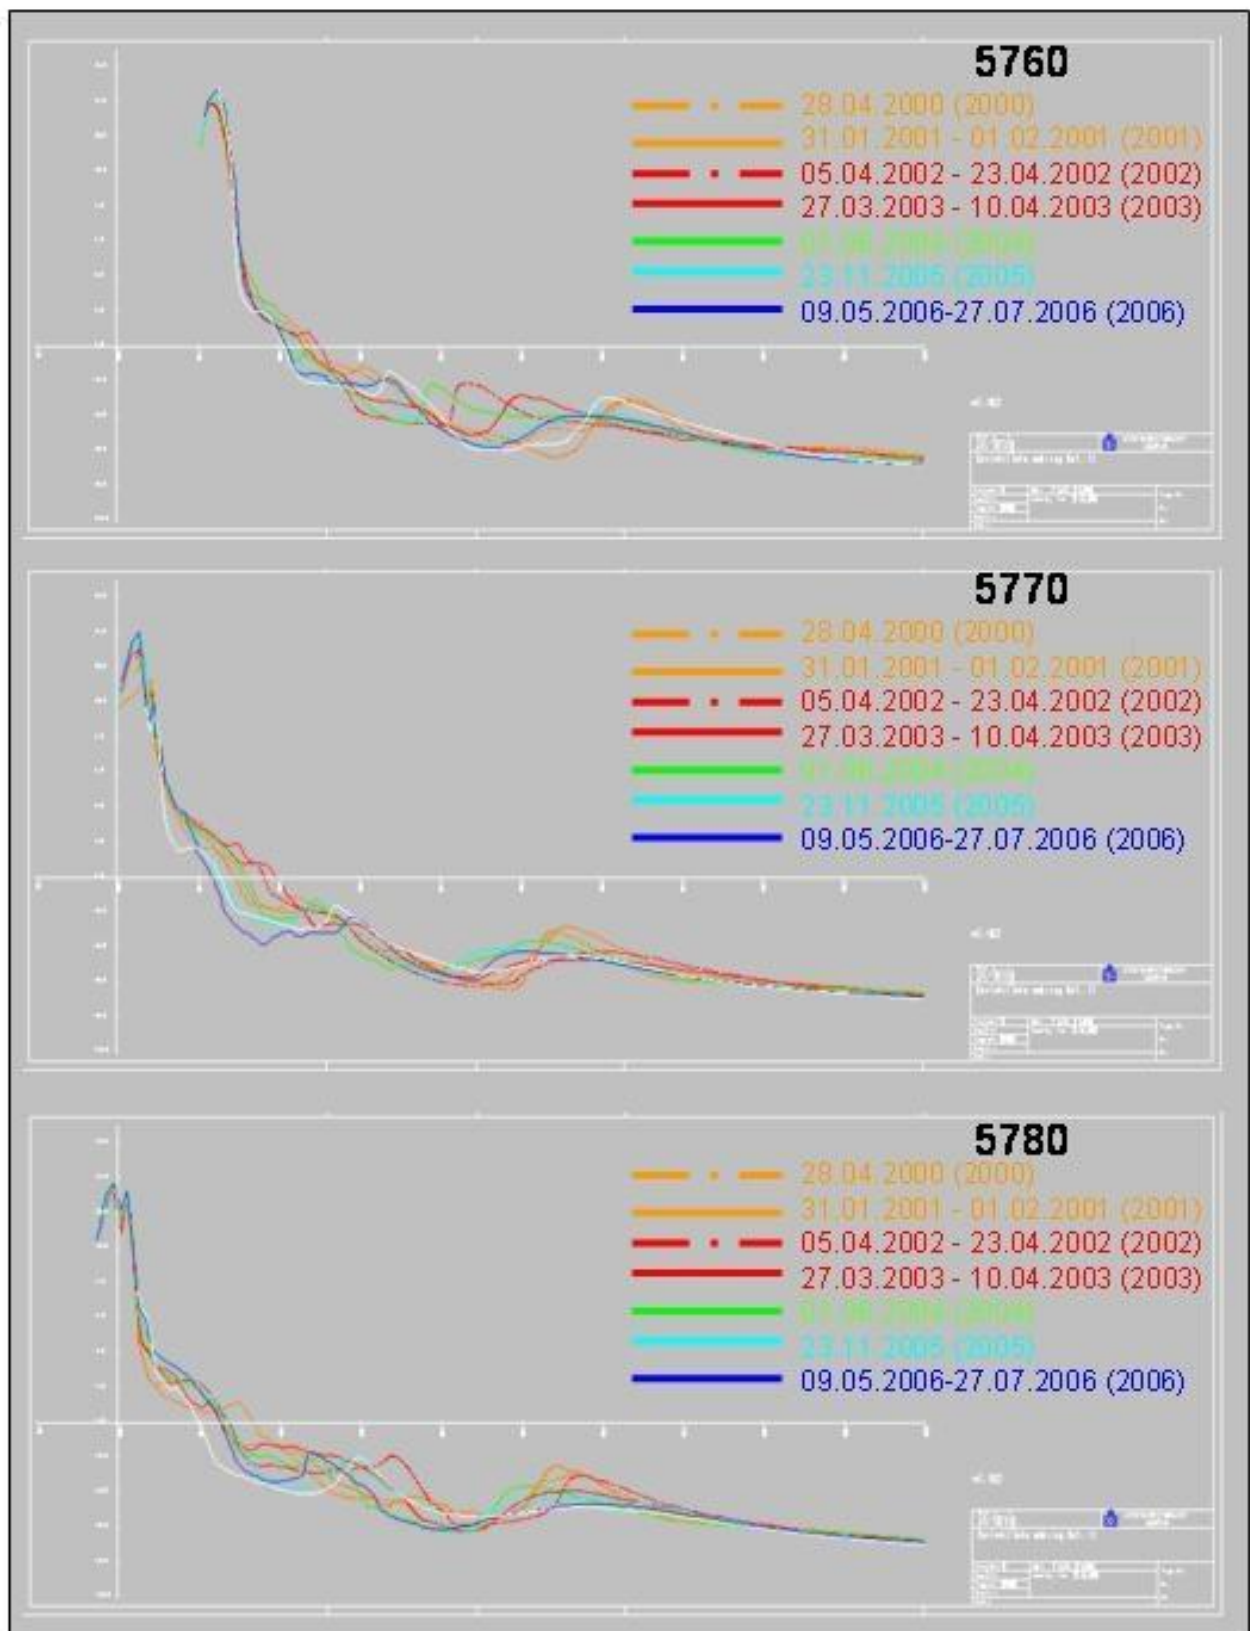
The reason for the significant erosion in Ref. II and southern part of Rør I in the test period is most probably the hole in the outer bar. This hole was not present in the former years as is seen in Fig. 18 which shows the coastal profiles in the period 2000-2007. Actually a high outer bar protected Ref. II in the years 2000-2002.

Fig. 18. Depth sounding profiles 2000-2007 in south of Rør I and in Ref. II, (KDI).

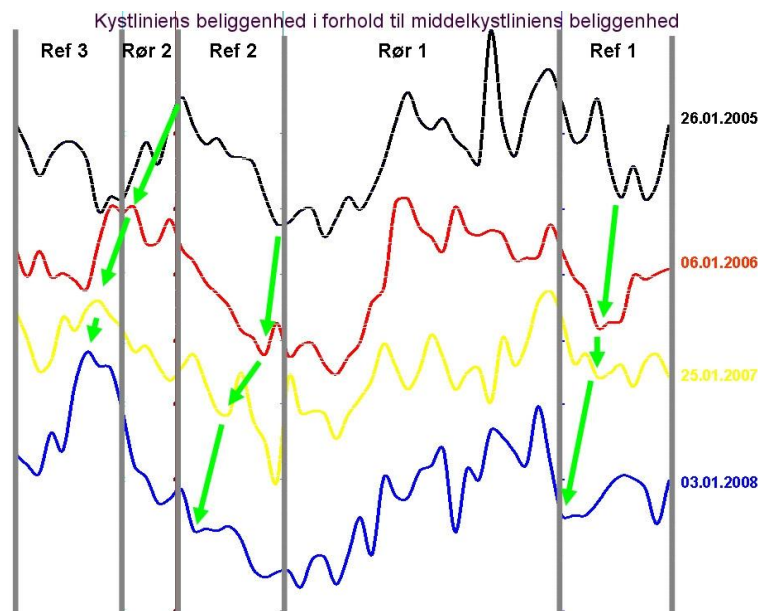
Fig. 19 shows an attempt to verify if such moving undulations exist along the test site by depicting positions of the coastline for the period 26.1.05 - 3.1.08. A southbound shift of the coastline planform can be identified. The migration velocity seems to be app. 500 m/year.

Fig. 19. Movements of the coastline planform, 26.1.05 - 3.1.08 (KDI).

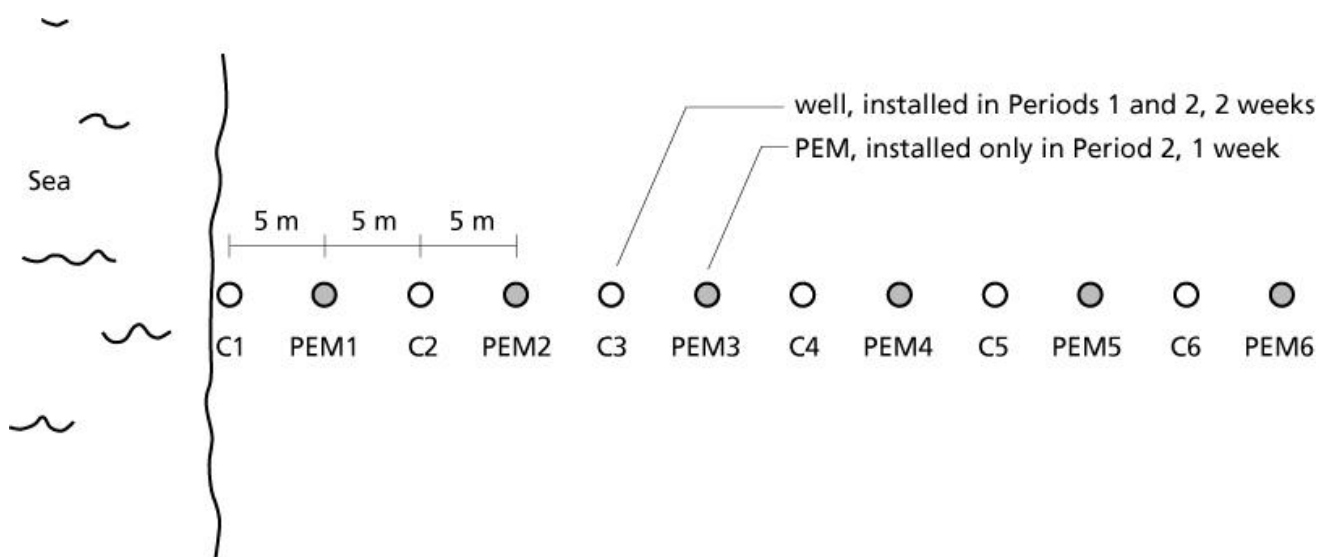
The experiment was divided into two periods: Period 1, one week with only wells installed (6 cm diameter pipes with pressure transducers placed in the mid level of a 10 cm screens app. 2.3 m below the beach surface and 10 m in between them). Period 2, one week with PEMs installed in between the wells, i.e. 5 m distance between wells and PEMs. Pressure transducers were placed at the bottom of the PEMs. The lay-out of one line is shown in Fig. 21.

Fig. 21. Lay-out of one line in the field study of pressure variations with and without PEMs.

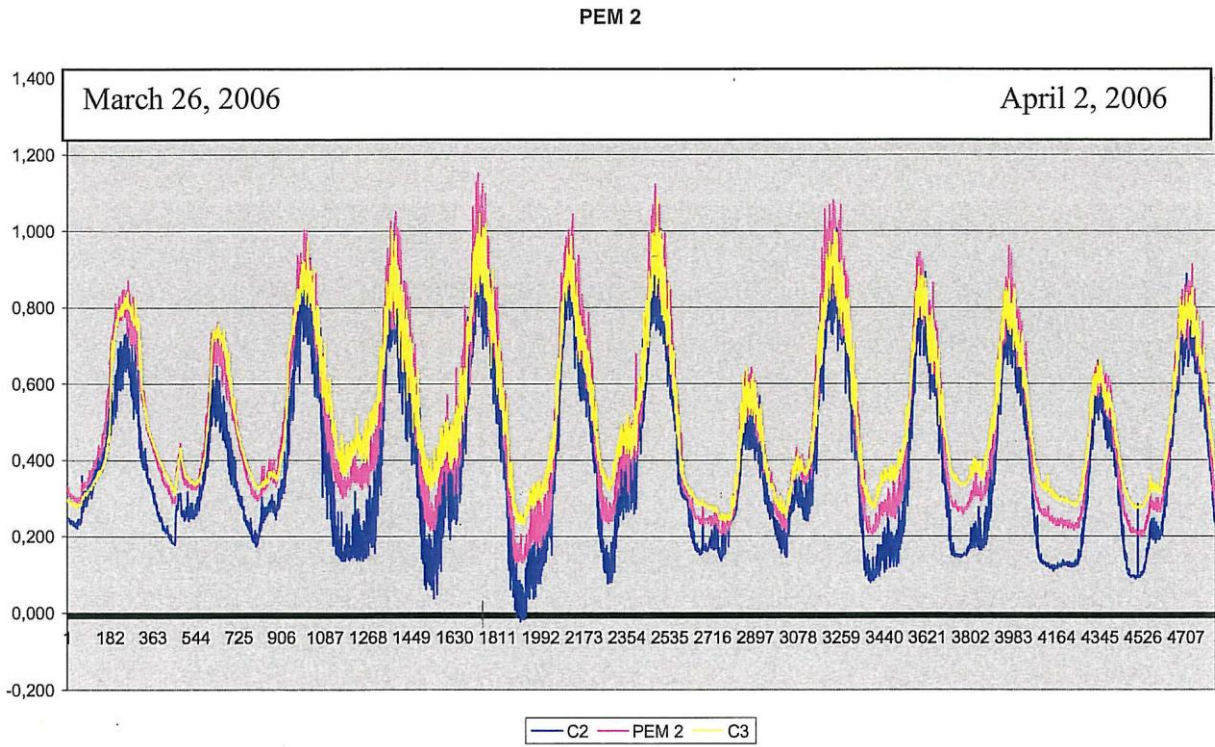
SIC studied the difference in heads between each PEM and the two neighbour wells. Fig. 23 shows an example from the lower part of the beach.

Fig. 23. Variation in hydraulic head in PEM 2 and neighbour wells C2 and C3, (SIC, 2007).

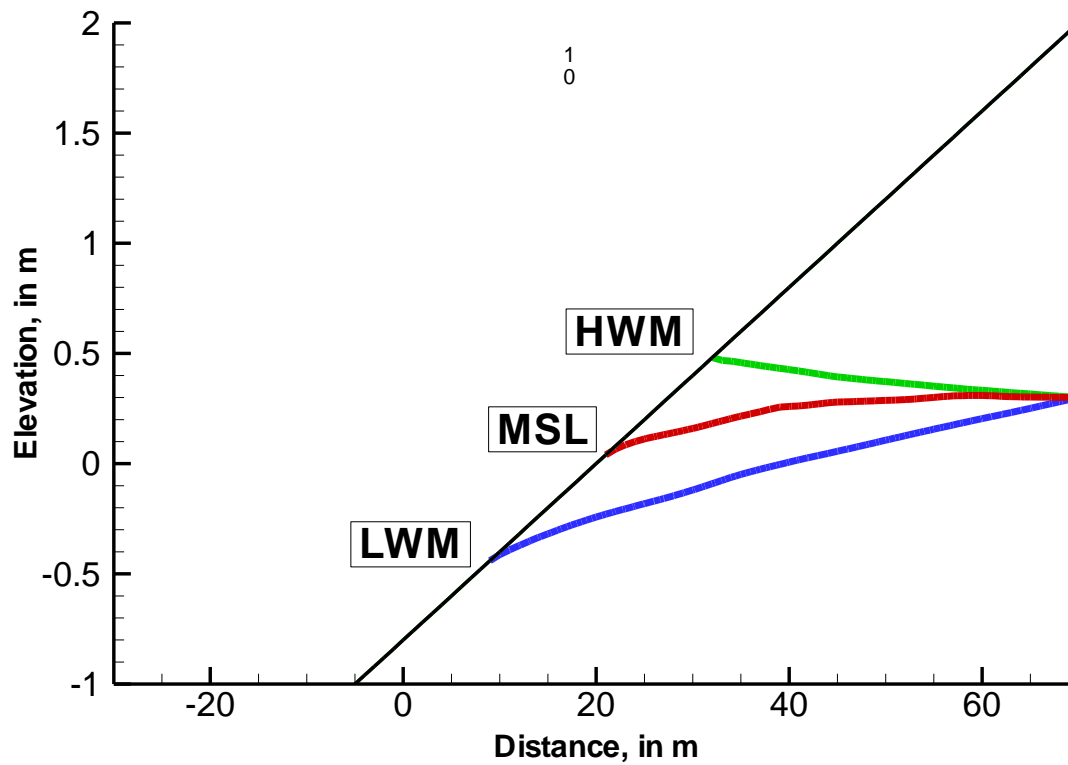
All results correspond to the quasi-steady state after 50 repetitions of the tidal cycle shown in Fig. 25.

Fig. 25. Simulated water table at low, mean and high tide for the homogeneous case (Engesgaard, 2008).

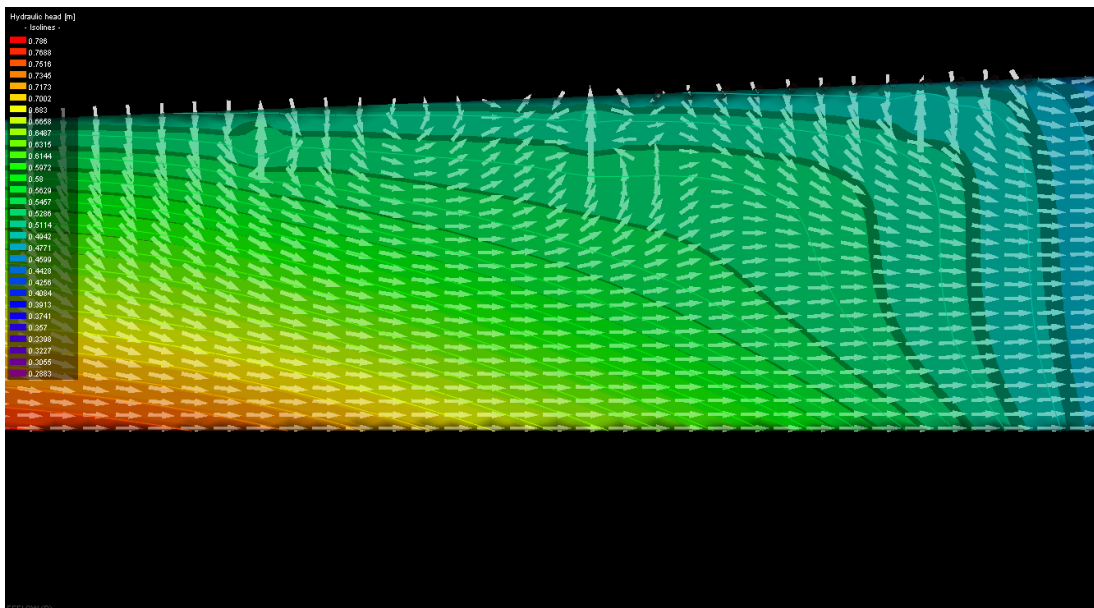
Same figure at high tide. The effect of the PEMs on the velocity distribution is much more apparent. Again all PEMs show upward flow, despite that flow just outside the PEMs can be downward. The left-most PEM actually shows a circulation, where flow moves down the PEMs and back up through the PEMs. The head distribution around the bottom and top of the PEMs confirm that flow is into the PEM at the bottom and out through the PEM. It is not clear why this circulation comes about. Perhaps a combination of buoyancy effects and flow driven by forced convection (head gradients; notice that heads increase toward bottom. At the middle PEM the flow distribution is clearer. Flow diverges upward, enters the bottom of the PEM and exits at the top. At the right most PEM there is again flow down along the PEM, but now part is (apparently) diverted up through the PEM again and parts is flowing towards the landside. Still we see the characteristic head distribution indicating flow into the PEM and out of the PEM.

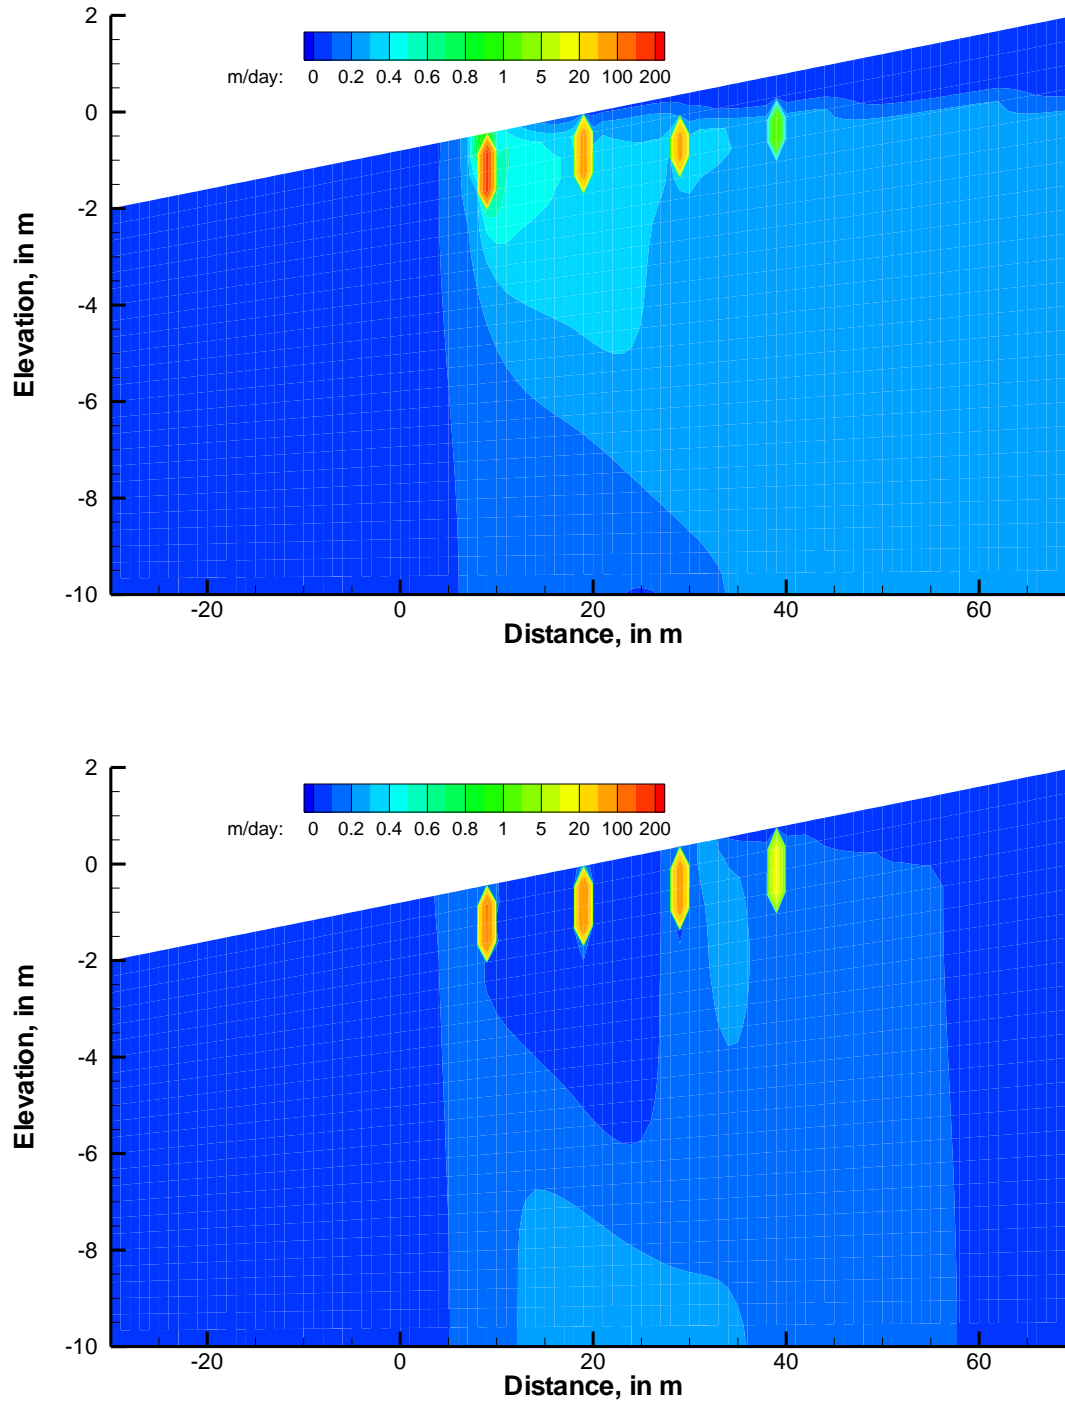
Fig. 28 shows the spatial distribution of the flow velocities in a homogeneous beach.

Fig. 28. Distribution of flow velocities in a homogeneous beach. Flow directions not shown. Upper figure low tide. Bottom figure high tide (Engesgaard, 2008).

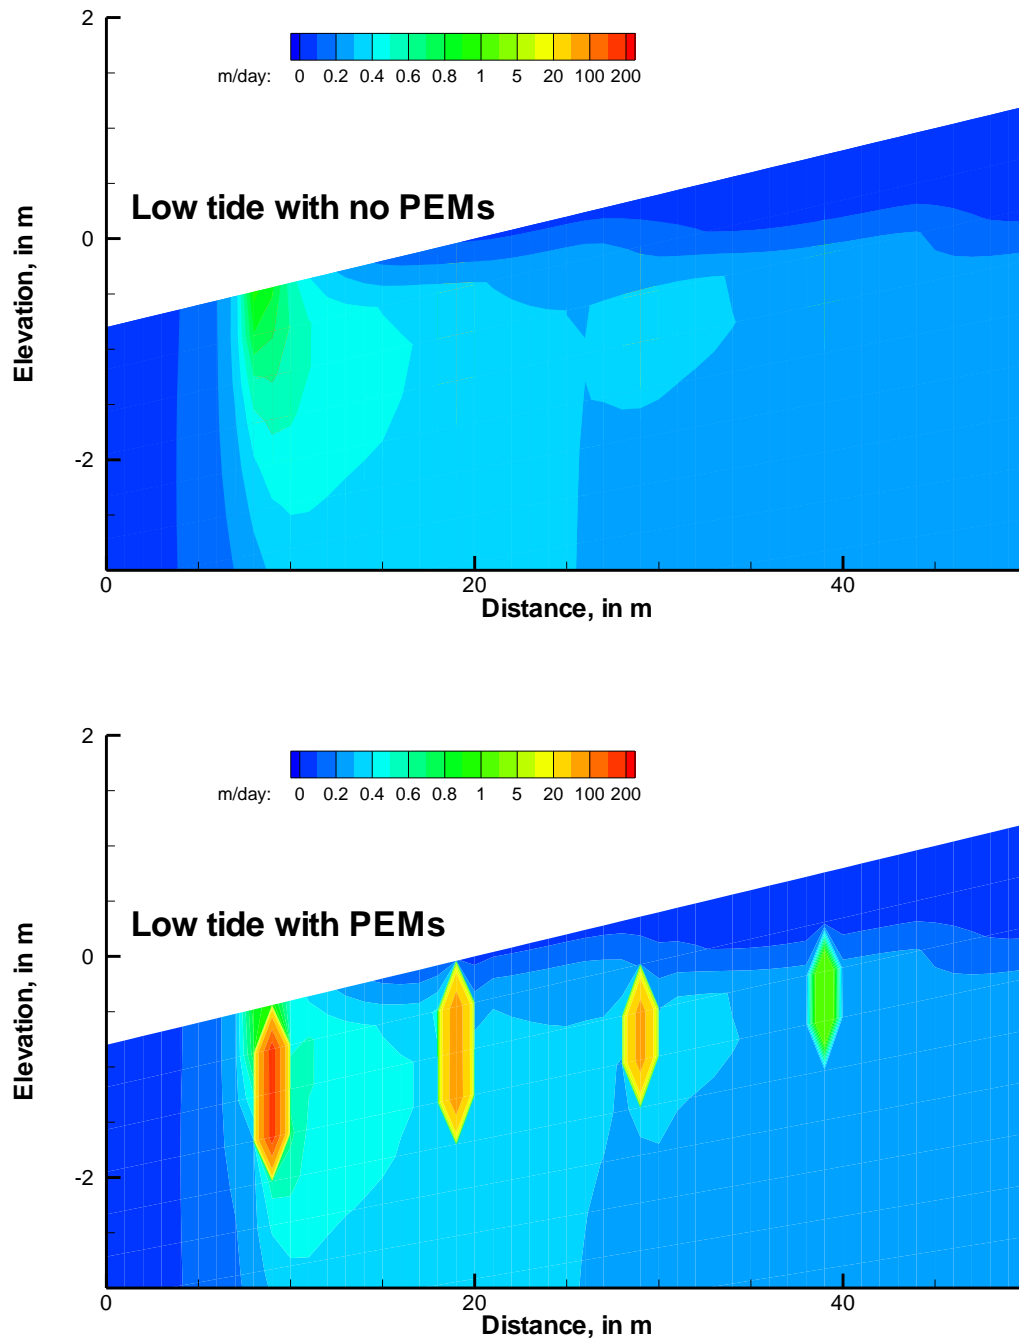
It should be noticed that the flow when leaving the PEMs is reduced to the same order of velocities as those in the flow field without PEMs. This indicates that no efficient drainage takes place.

Fig. 29. Velocity distribution at low tide in homogeneous beach with and without PEMs (Engesgaard, 2008).

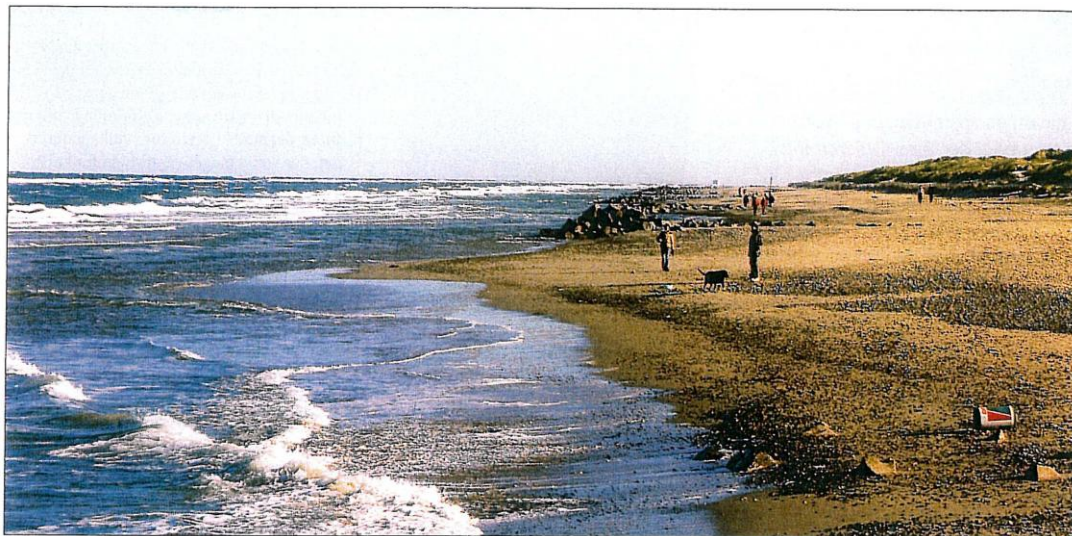
Fig. 32. SIC photo of sand groin in front of a row of PEM's (Poul Jakobsen, 1999).

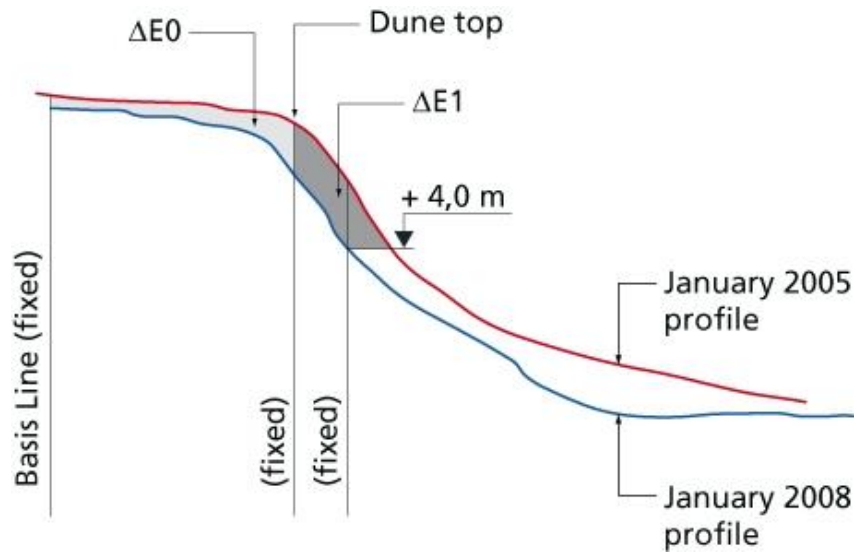
Fig. 39. Definition of E-parameters.

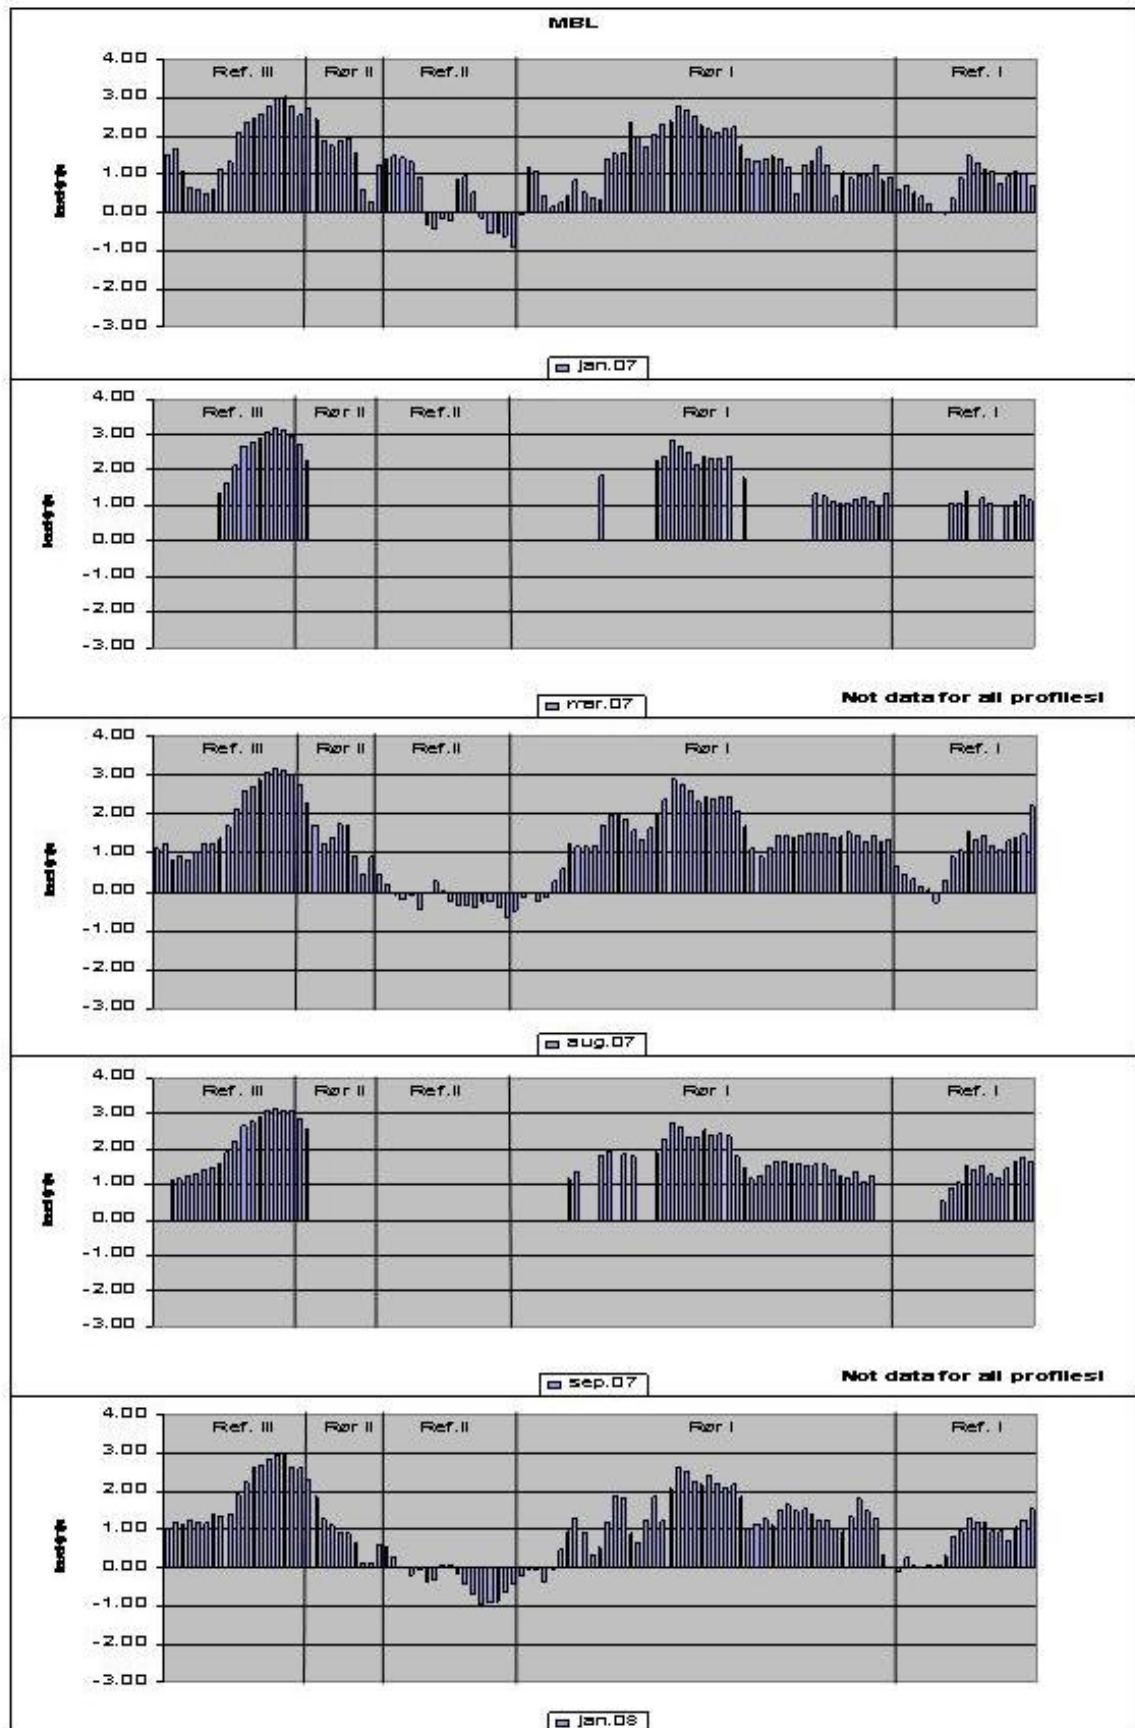
Fig. 44. MBL January, March, August, September 2007 and January 2008 (KDI).
