# **Coastal protection performance of the SIC Pressure Equalizing Modules.**

**Results of the three years field test at the southern Holmsland Barrier on the  
Danish North Sea Coast**

by  
**Hans F. Burcharth**  
Prof. dr. techn, dr. h.c.

**2 June 2008**

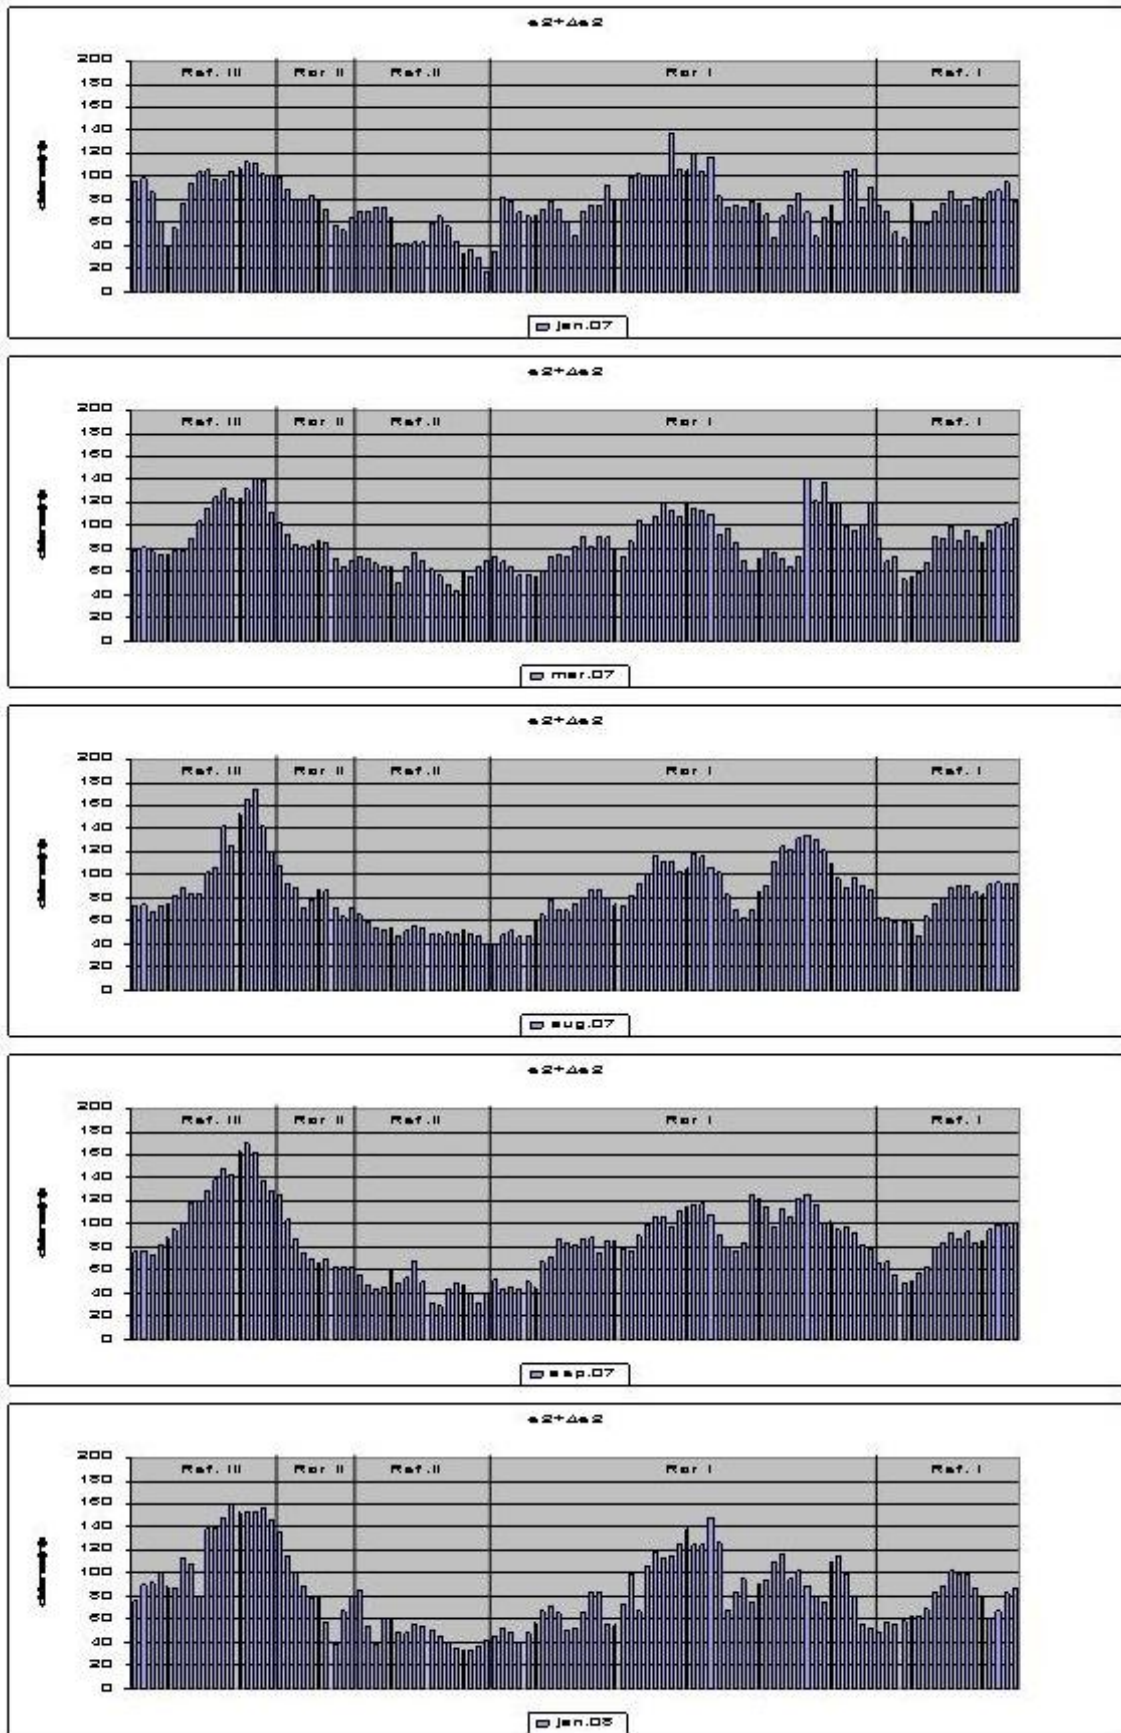
Fig. 47. Beach widths January, March, August, September 2007 + January 2008 (KDI).

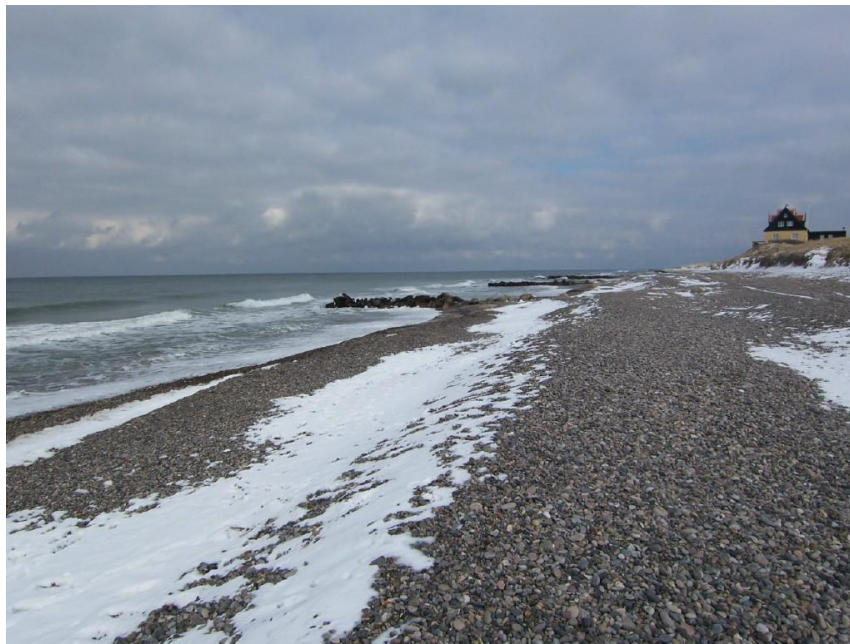
Fig. 57. Example of groins. (Photo Hans F. Burcharth).

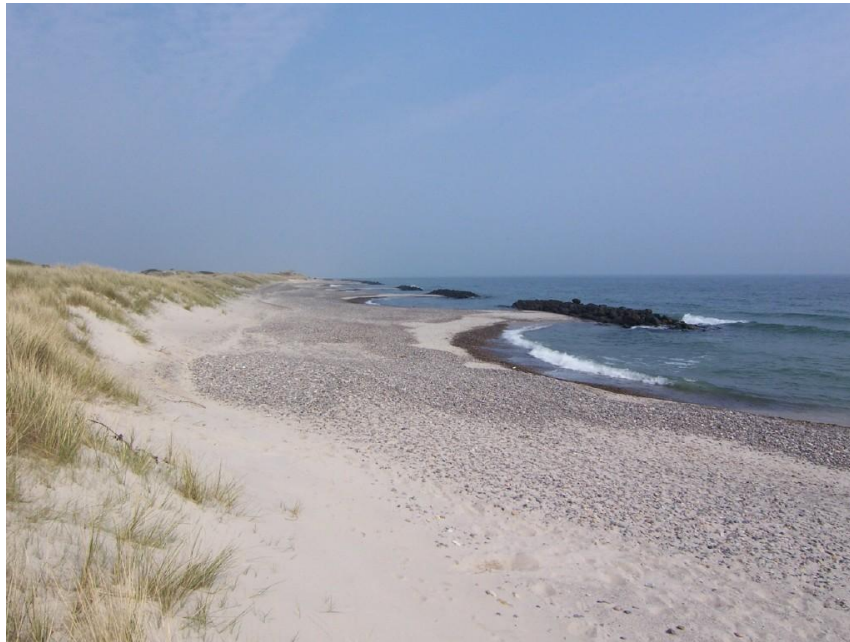
Fig. 58. Example of shore-parallel detached breakwaters. (Photo Hans F. Burcharth).
