Der er sparret 41,4 mio. Kr efter at SIC projektet er overgået til permanent drift d. 8 januar 2008

## **MODELING OF FLOW THROUGH A VERTICAL PERFORATED PIPE IN THE BEACH, AND THE MORPHODYNAMIC INTERPRETATION: THE PRESSURE EQUALIZATION MODULE SYSTEM.**

Jørgen Fredsøe<sup>1</sup>, Peter Engesgaard<sup>2</sup> and Per Sørensen<sup>3</sup>

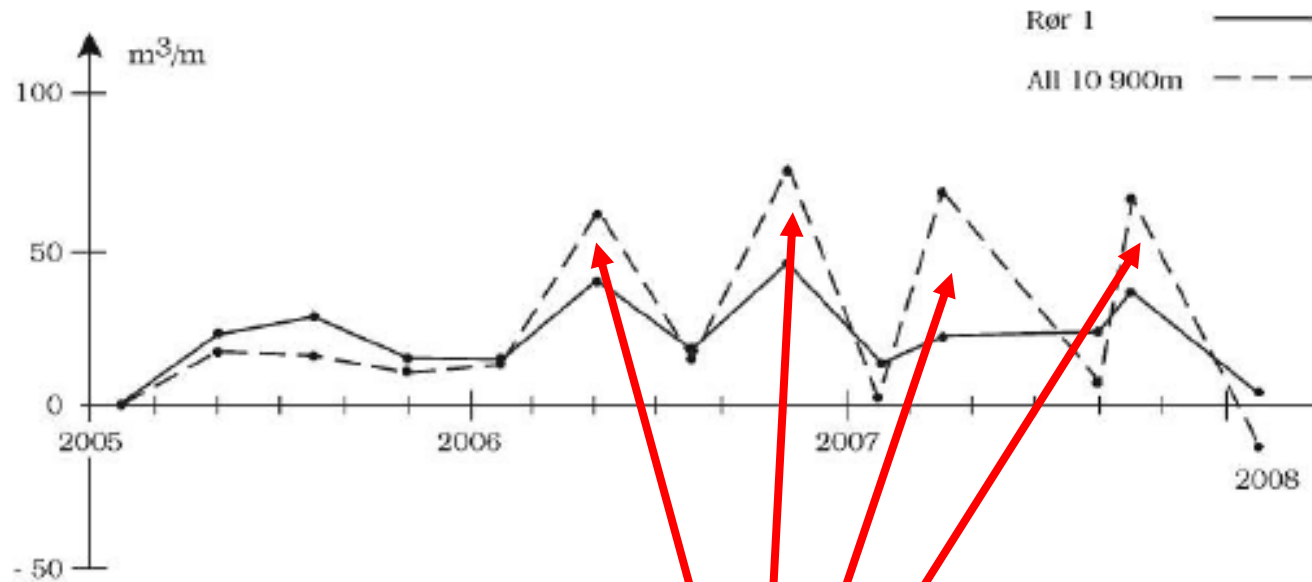
Figure 17: Temporal Variation in beach volume: The beach volume changes so much that the conclusion depends on the cut of the test. Sep 2007: +35 cbm/m in front of rørl, Jan 08: 0 cbm/m. On the total test stretch (dashed line in the figure) you have in average Sep 07: +67 cbm/m and Jan 08: -15 cbm/m. The values are positive because the test began just after the big storm January 8<sup>th</sup> and 9<sup>th</sup> 2005.

Dato	04.05	07.05	10.05	01.06	04.06	07.06	10.06	01.07	04.07	08.07	09.07	01.08
Måned. år												
Strækning	m <sup>3</sup> /m	m <sup>3</sup> /m	m <sup>3</sup> /m	m <sup>3</sup> /m	m <sup>3</sup> /m	m <sup>3</sup> /m	m <sup>3</sup> /m	m <sup>3</sup> /m	m <sup>3</sup> /m	m <sup>3</sup> /m	m <sup>3</sup> /m	m <sup>3</sup> /m
Ref. I	13,4	2,6	-12,2	-11,5	-6,9	-18,2		-32,5	24,4	-12,8	38,3	-36,3
Rør I	22,3	28,8	17,5	16,7	39,9	18,5	43,2	11,5	21,1	21,3	34,5	0,3
Ref. II	-9,5	-32,2	-42,3	-54,6	-41,3	-64,7		-104,8		-150,3		-163,8
Rør II	45,0	58,3	68,1	93,3	91,7	87,3	99,9	37,5	184,6	27,2	206,7	-25,7
Ref. III	25,2	29,3	38,2	54,4	93,2	81,5	118,2	104,3	188,0	113,0	139,2	114,8
<b>Middel, total</b>	18,5	17,9	11,4	14,2	60,4	16,2	74,1	4,0	68,2	4,9	66,8	-14,5

Tallene i (Middel total) er opgivet i kubikmeter /meter og kan derfor omregnes til volumen på den samlede strækning på 11 km og det giver nedenstående resultat

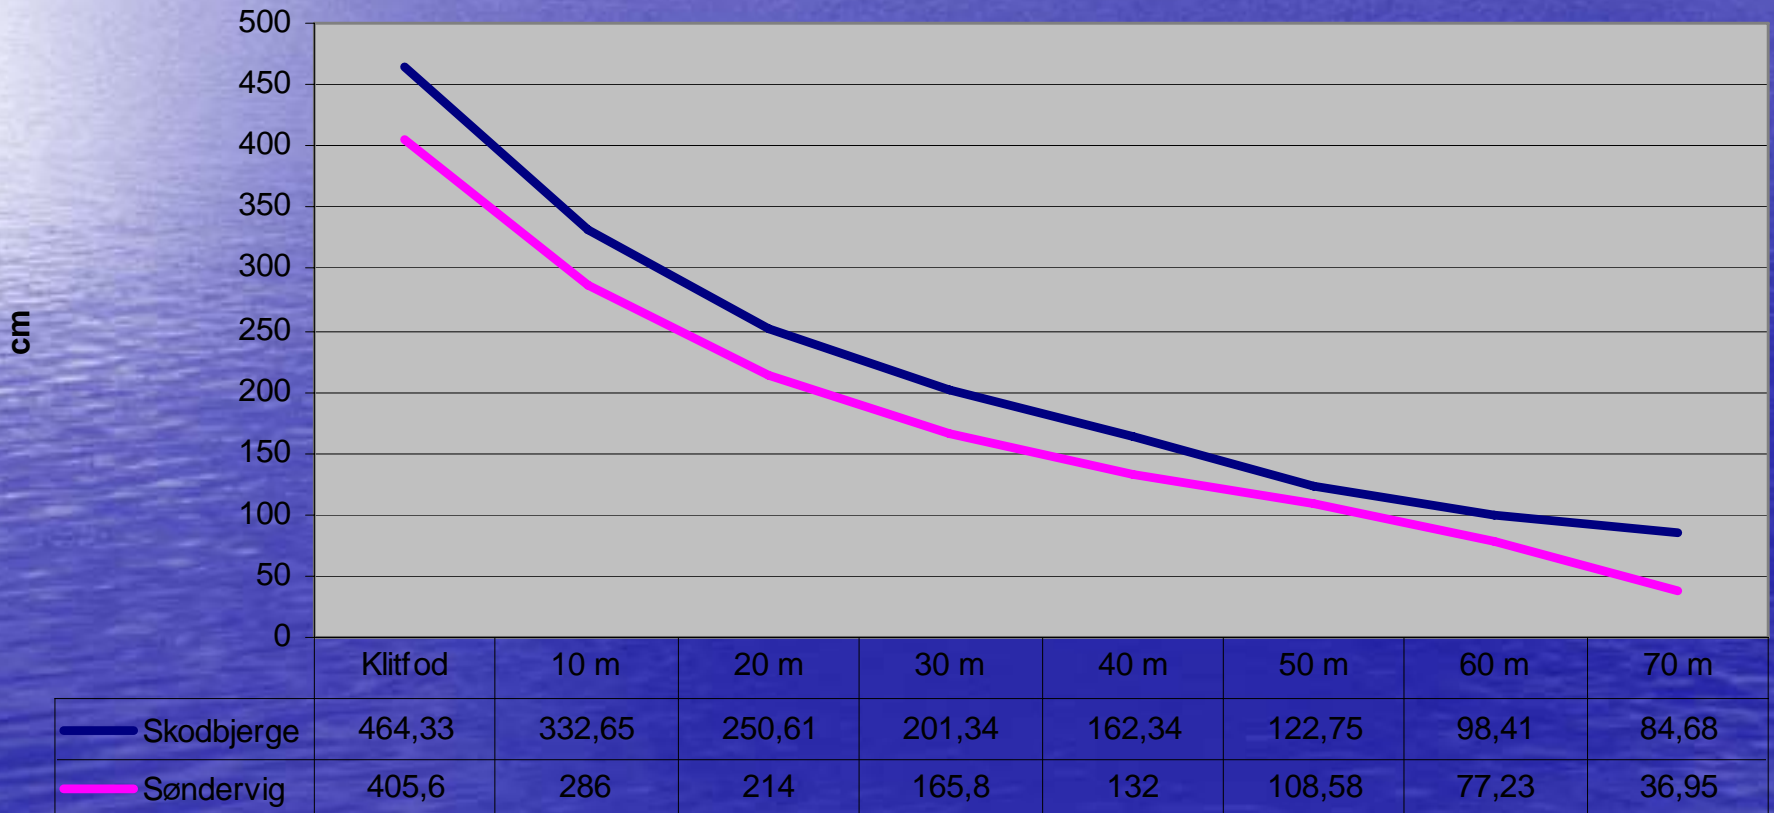
### Skodbjerge sammenlignet med Søndervig

— Skodbjerge — Søndervig

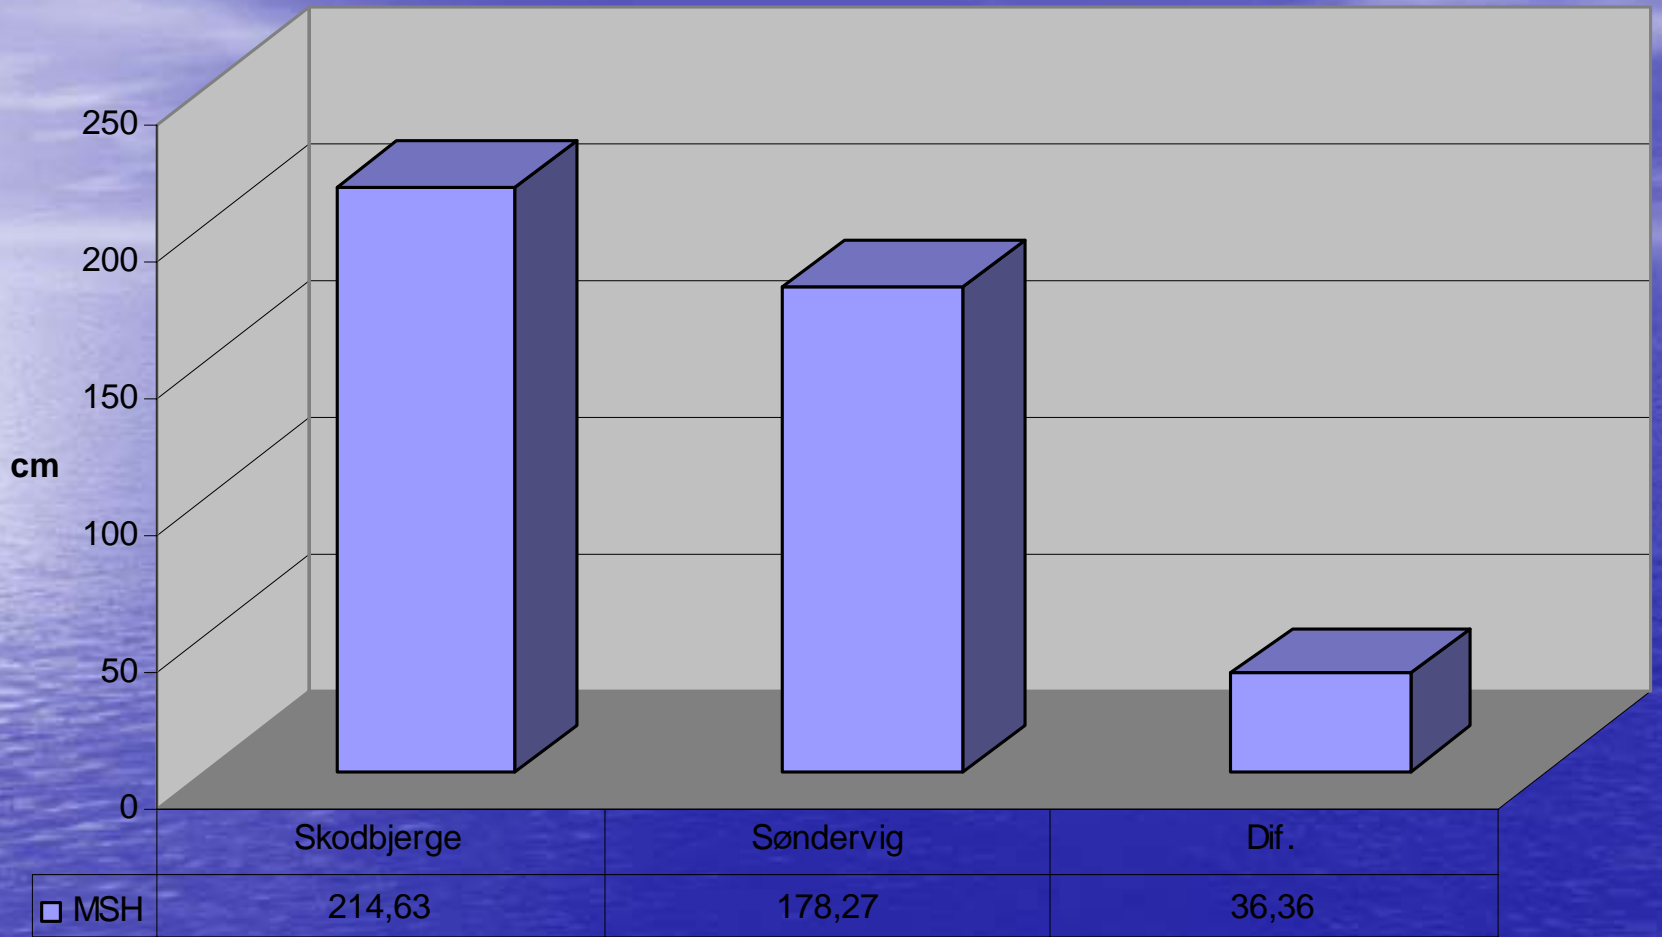
# Middelstrandhøjde i 70 meters bredde

□ MSH

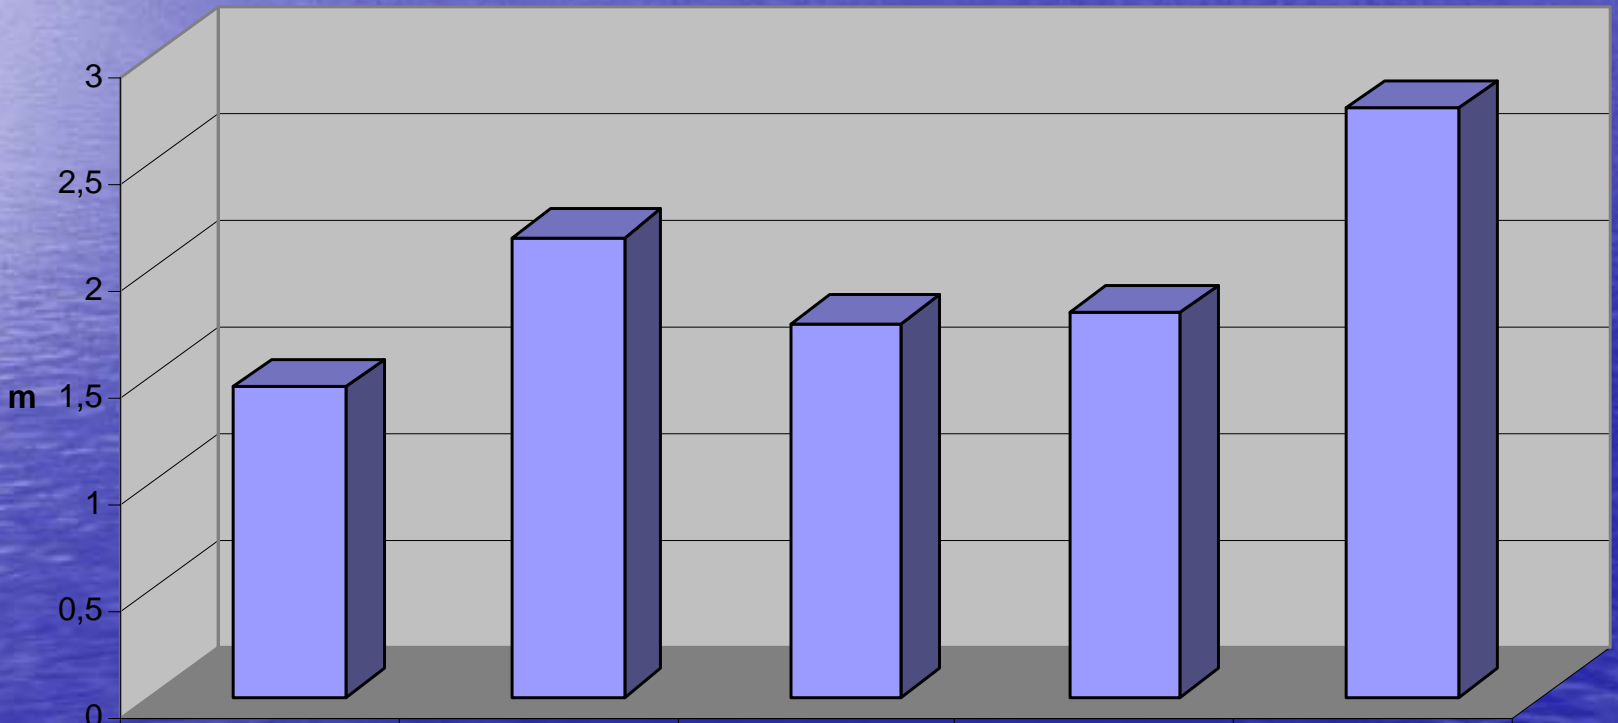
### Middelstrandhøjde i 70 meters bredde

□ middelstrandhøjde

Ref 1

Rør 1

Ref 2

Rør 2

Ref 3

1,45

2,15

1,75

1,8

2,76
