ENVIRONMENTALLY FRIENDLY COASTAL PROTECTION BASED ON VERTICAL DRAINS

Poul Jakobsen and Claus Brøgger^{1 2}

A Field test over 11 km with the SIC vertical drain system was carried out in January 2005 up till January 2008 and placed at Skodbjerge at the Danish west coast. Already after 6 month has the vertical drain system stabilized the beach in an equilibrium profile. The average beach level from the dune foot and 100 m. wide was after 3 years up to 157 cm higher in the drained areas in relation to the reference area 2. The erosion was stopped in the drained area's, and the sand drift increased to the dune system over the next 3 years. The sand drift from the beach to the dune system is calculated to 69-76 cubic meters pr. meter along the coastline in the drained areas over 3 years.

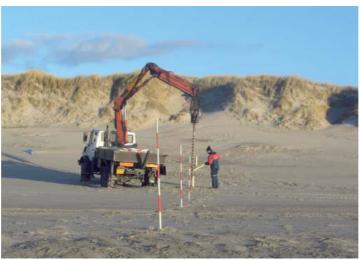
Fig. 7

The PEM modules are placed in a matrix along the coast line, with a distance at 100 meters between the rows and 10 meters in the cross.

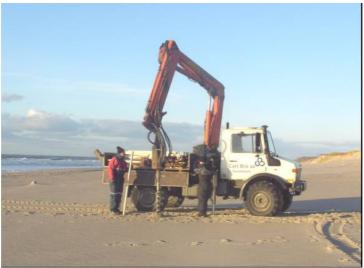
Fig. 8

The PEM modules are 175 cm long and are submerged 25 cm under the beach surface and are normally not visible at the beach. There are max 11 PEM modules in each row, because we don't like the beach wider than 100 meters.

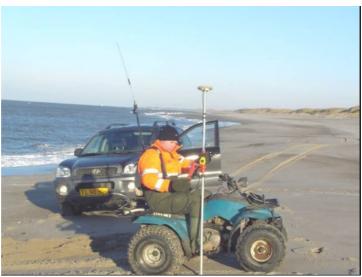
Fig. 9

The survey program is quarterly with 13 surveys over 3 years. There is 100 meters between the survey lines at the beach and the tolerance is below 2 cm. The survey and data processing are done by Carl Bro A/S Denmark.

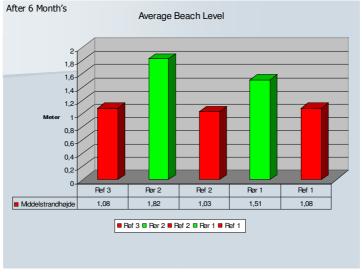
Fig. 14

Already after the first 6 month the results of the vertical drains was significant in relation to the reference areas.

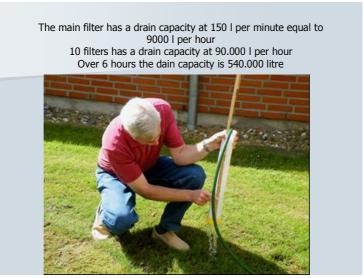
Fig. 19

The drain capacity at the main filter is tested by water flow with tap water. The test shows the main filter has a drain capacity at 150 l per minute.

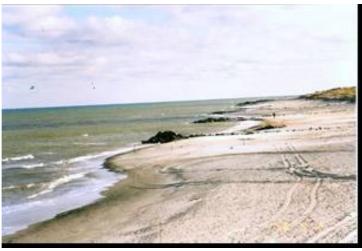
Fig 20

One row with vertical drain tubes Fig. 20 generates here a sand groin by Old Skagen in 1999.

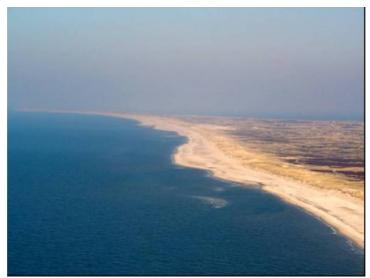
Fig. 22

In fig. 22 we see the effect of the drain tubes by Skodbjerge in the PEM area 2 after 6 month in July 2005.
