**Accident Investigation Board
Denmark**

HCLJ510-000433

Accident to Bombardier DHC-8-400,
registration LN-RDK,
at Aalborg Airport (Denmark),
on 9 September 2007

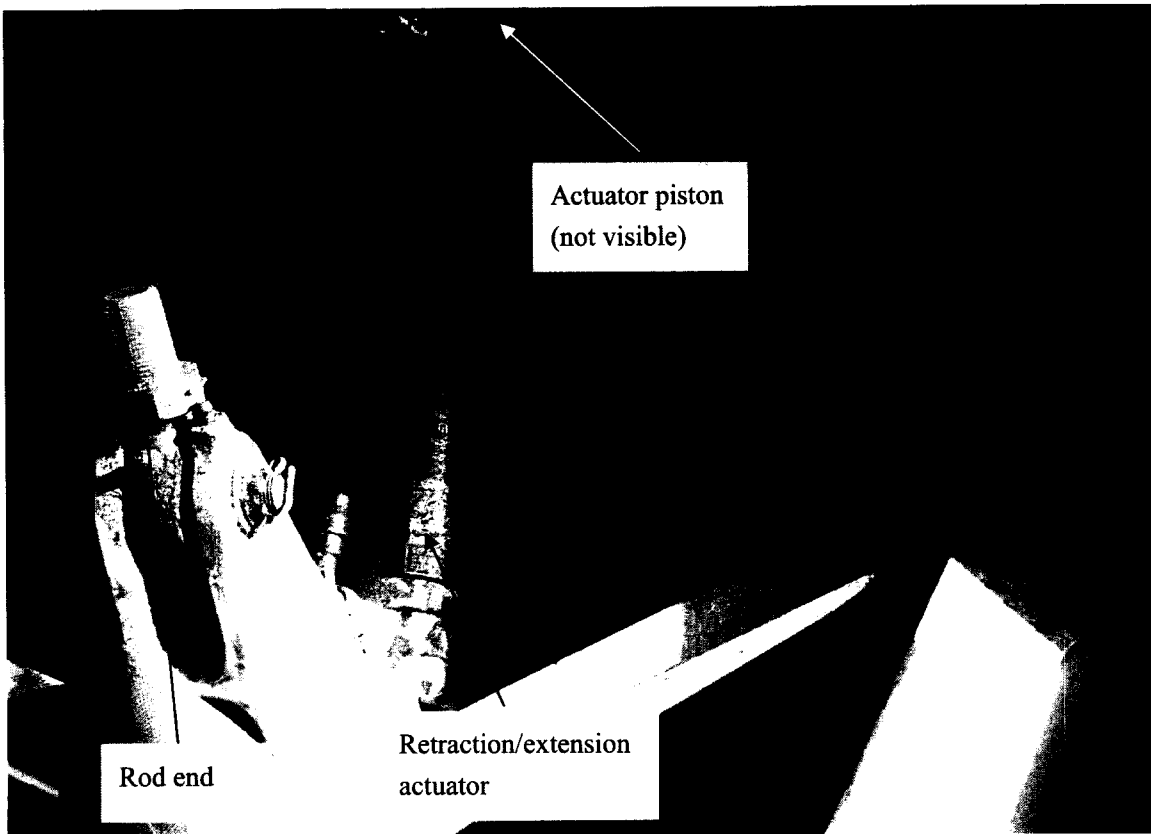
Fig. B. Right MLG retraction/extension actuator

The retraction/extension actuator was found with the rod end separated from the retraction/extension actuator piston rod. Due to its weight and mounting design the retraction/extension actuator was found up-side down (figure B).

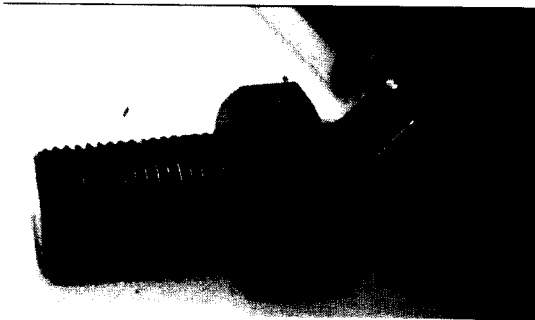
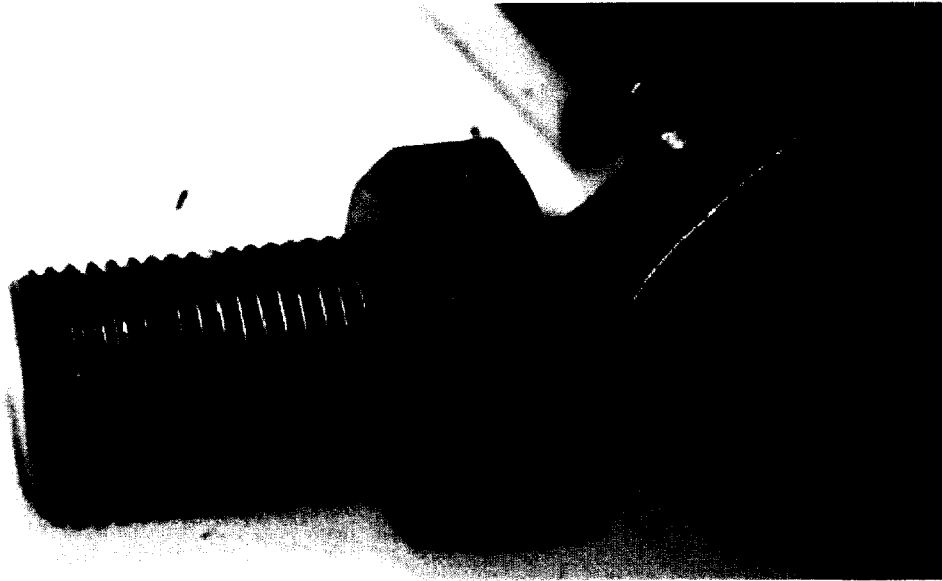
Figure 30: Rod end (as dismantled).

It was noted that the lock wire was intact and in place before dismantling. The lock nut could easily be moved on the rod end, but there was remarkably more resistance while unscrewing the rod end from the piston rod. The rod end threads shown in figure 30 appeared undamaged as did the piston rod threads at first glance from the outside. However, cleaning and longitudinal sectioning of the piston rod revealed some metal loss, figure 31. The left piston also features less corrosion at the position of the rod end key way as shown in figure 32. While corrosion attacks were obvious there was also evidence of some mechanical contact marks in the thread tops.

rod. The rod end threads shown in Figure 30 appear undamaged as did the piston rod threads at first look from the outside. However, cleaning and longitudinal sectioning of the piston rod revealed some metal loss, c.f. Figure 31. The left hand piston also features less corrosion at the position of the rod end key way as shown in Figure 32. Figure 33 shows the thread's appearance in more detail. While corrosion attacks are obvious there is also evidence of some mechanical contact marks in the thread tops.

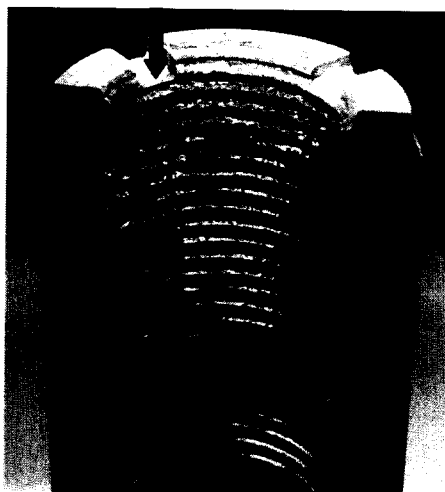
Figure 32: Overview of piston rod section showing less corrosion in the key way area (at arrow).

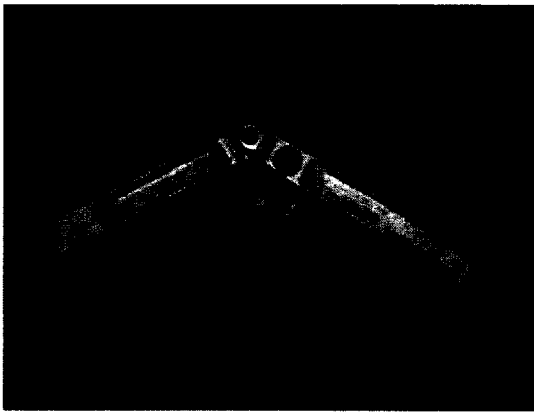
- Sequence 2, 3 and 4: The right MLG extended under undamped free fall conditions on approach to EKYT with sufficient kinetic energy to cause failure of the stabilizer joint lugs. This failure rendered the stabilizer incapable of safely locking the right main gear in the 'down' position, (indication of 'unsafe' gear was given).

Sequence 1: Gear up position

Sequence 2: Gear in transit (Free fall).

Sequence 3: Gear down position.

Sequence 4: Failed stabilizer joint lugs due to free fall.

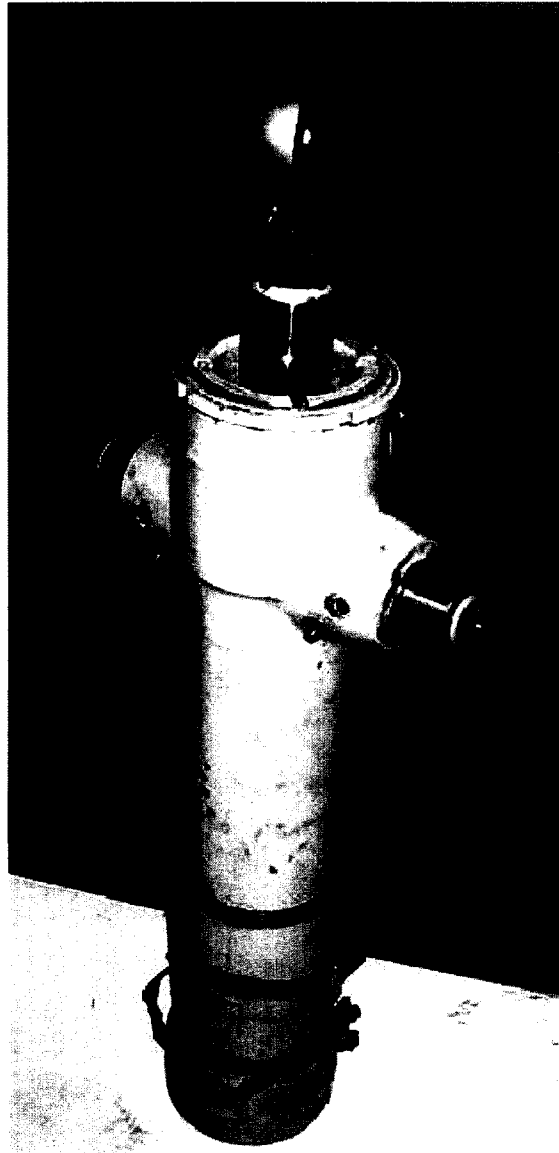
Figure 1: View of right hand retract actuator with piston rod and rod end at top.

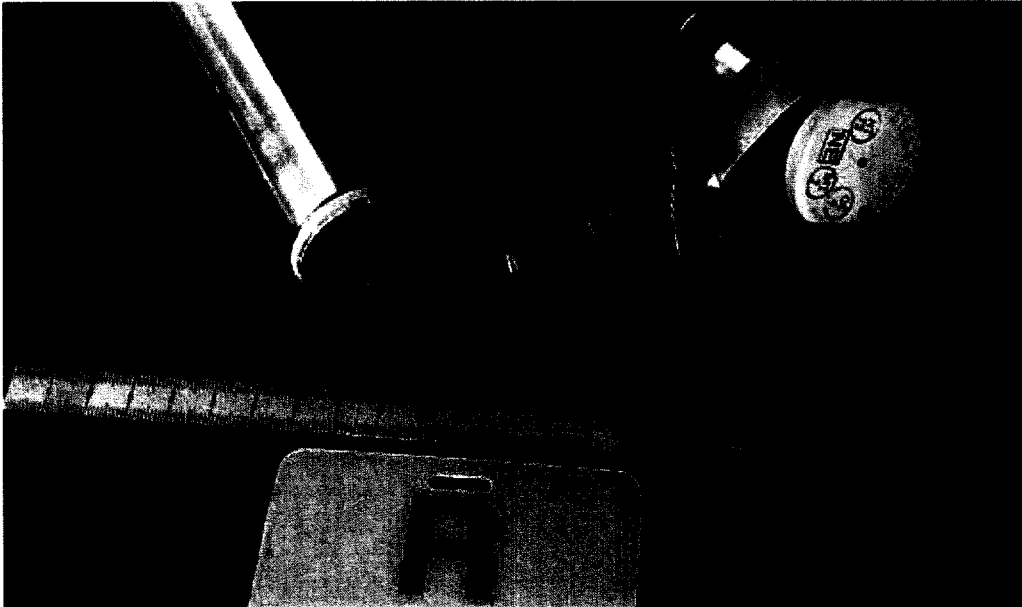
Figure 2: Threaded parts of piston rod and rod end in “as received” condition.

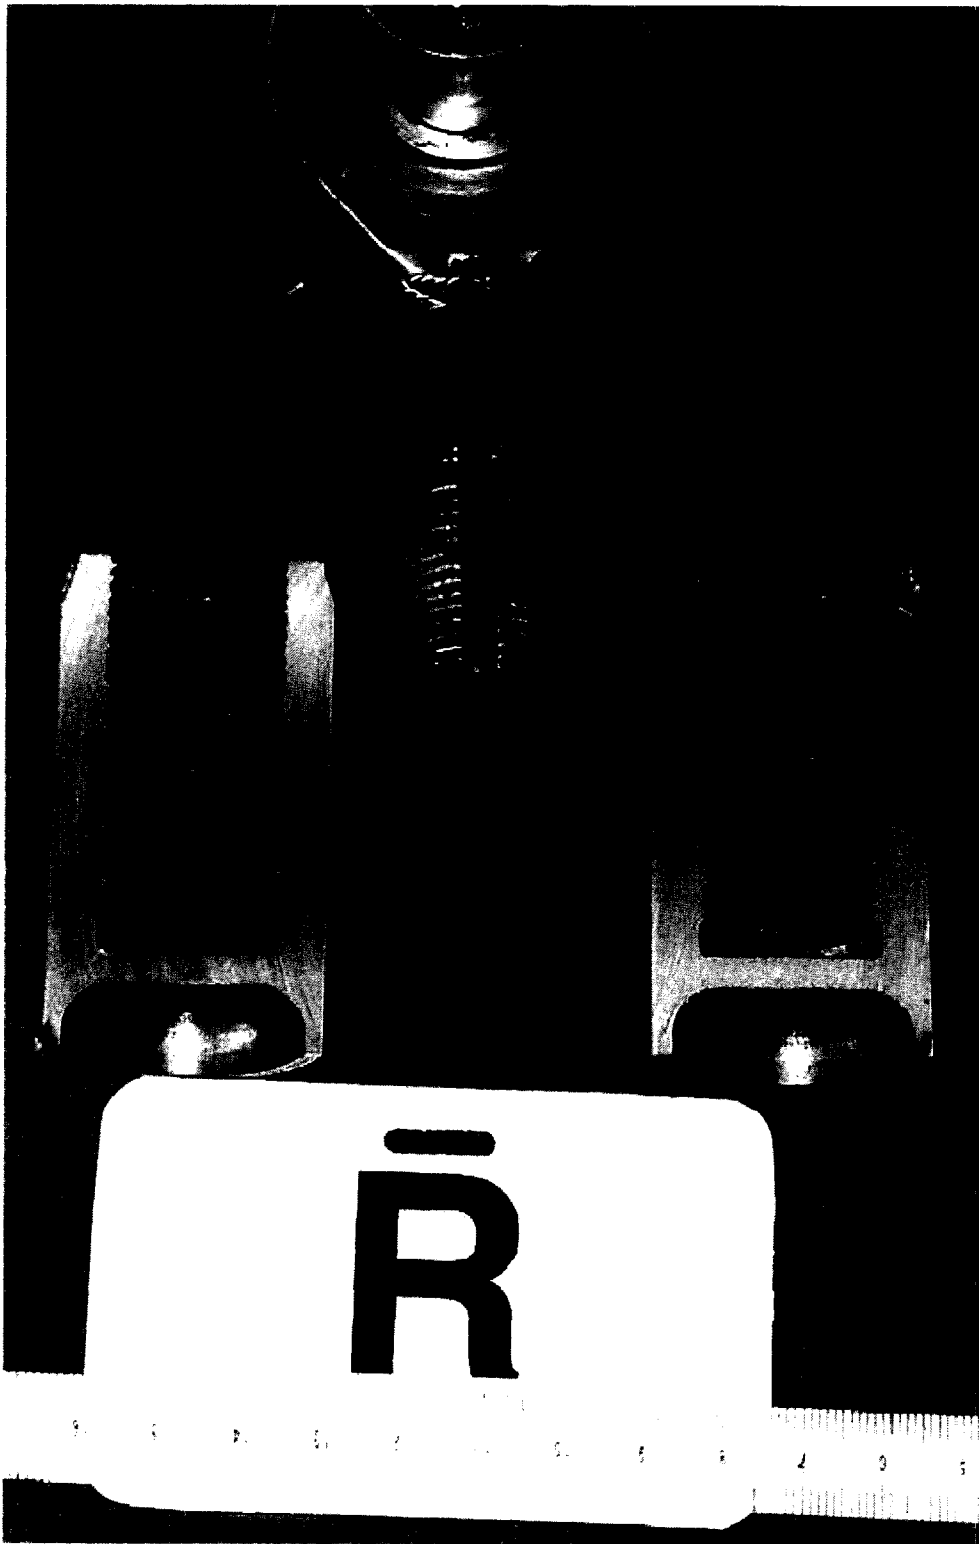
Figure 3: Longitudinal sectioning of piston rod end.

The threaded piston rod end was sectioned longitudinally as shown in Figures 3, 4 and 5. Figure 6 shows a section of the piston rod before and after cleaning. It is evident that the female threads were severely damaged and partly eaten away by corrosion. Figures 7 and 8 show a scanning electron microscope image and a longitudinal section through some of the severely damaged threads. Figure 9 shows tearing and shearing of the remaining thread profile tips at the mouth of the piston rod during final pull out of the rod end. Figures 10 and 11 show the appearance in the non-engaged part of the threads. The contours of the non-engaged threads appear intact but at closer view it is evident that corrosion has also occurred in these parts.

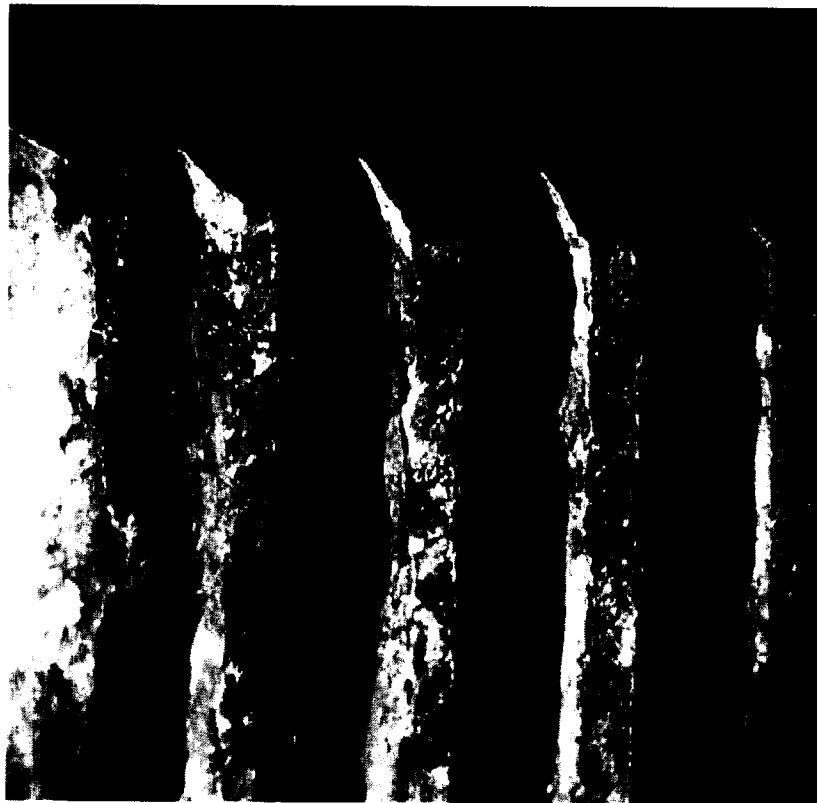
Figure 10: View of threads near bottom of piston rod. The arrow points to the last engaged thread.

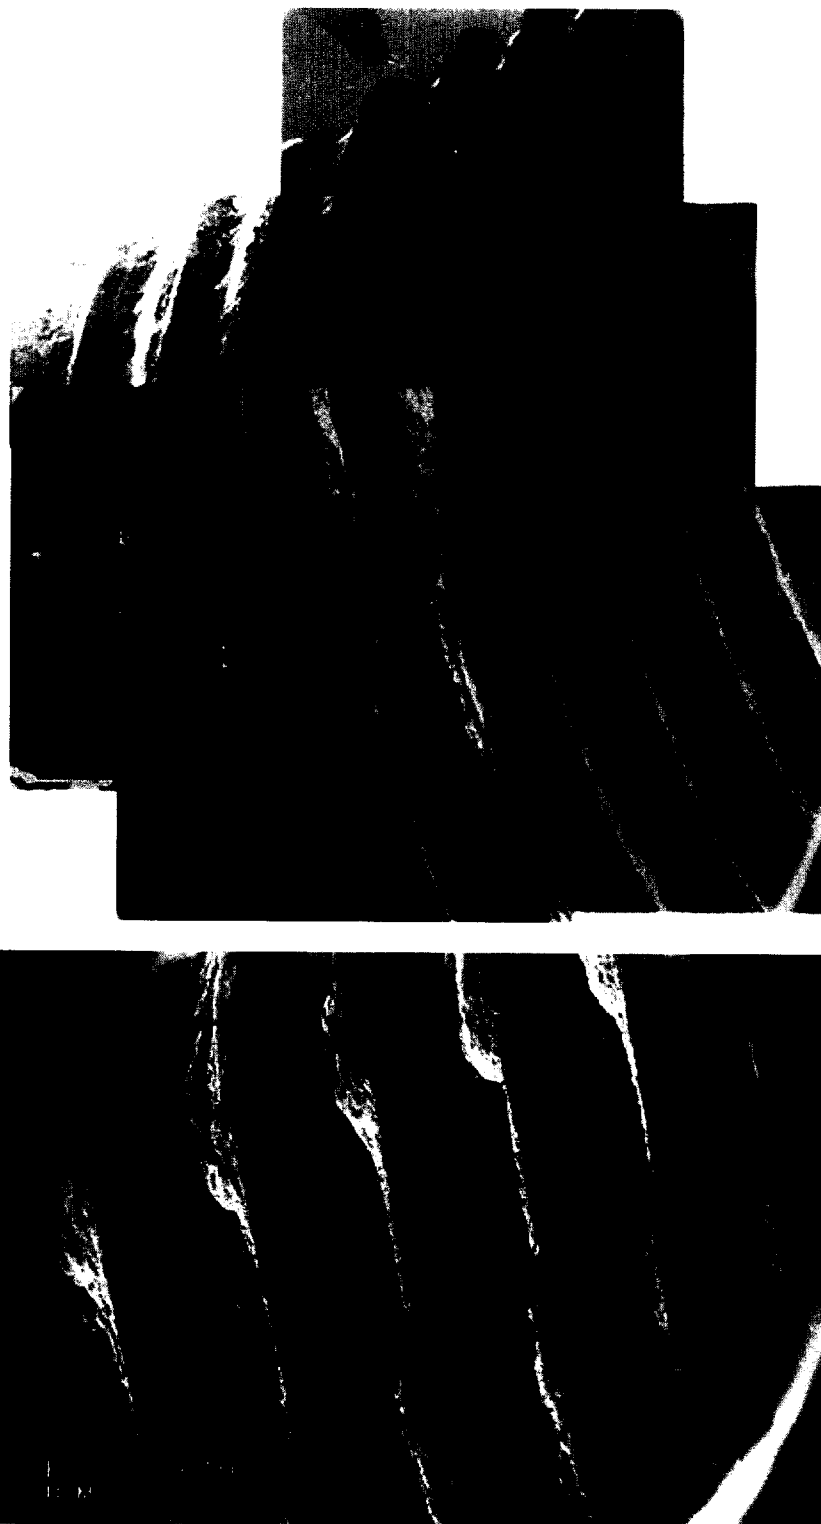
The thread areas coinciding with the position of the key way in the rod end (visible in Figure 3) are less attacked by corrosion, but corrosion attacks are still apparent, c.f. Figures 12 and 13.

Figure 13: Scanning electron microscope images of same area as in previous figure.

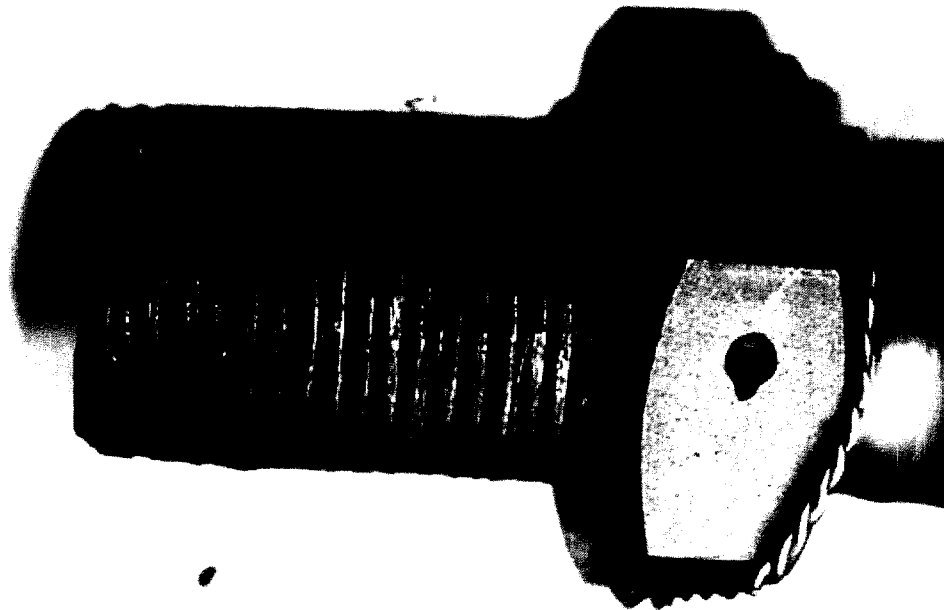
Figures 17 and 18 show the appearance of the rod end male thread. The thread valleys are filled with a dry powder-like product and metallic ligaments. A longitudinal cut of the male thread is shown in Figure 19. The thread tops appear slightly deformed and the very top is partly sheared off as illustrated in Figure 20. The slight concaveness of the flank at the arrow in Figure 19 is caused by wear, i.e. polishing contact with opposing material (or corrosion products). This is further evidenced in Figure 21 by way of oblique light mirror reflections from the polished, concave thread flanks.

Figure 17: Right hand actuator rod end in as received condition.

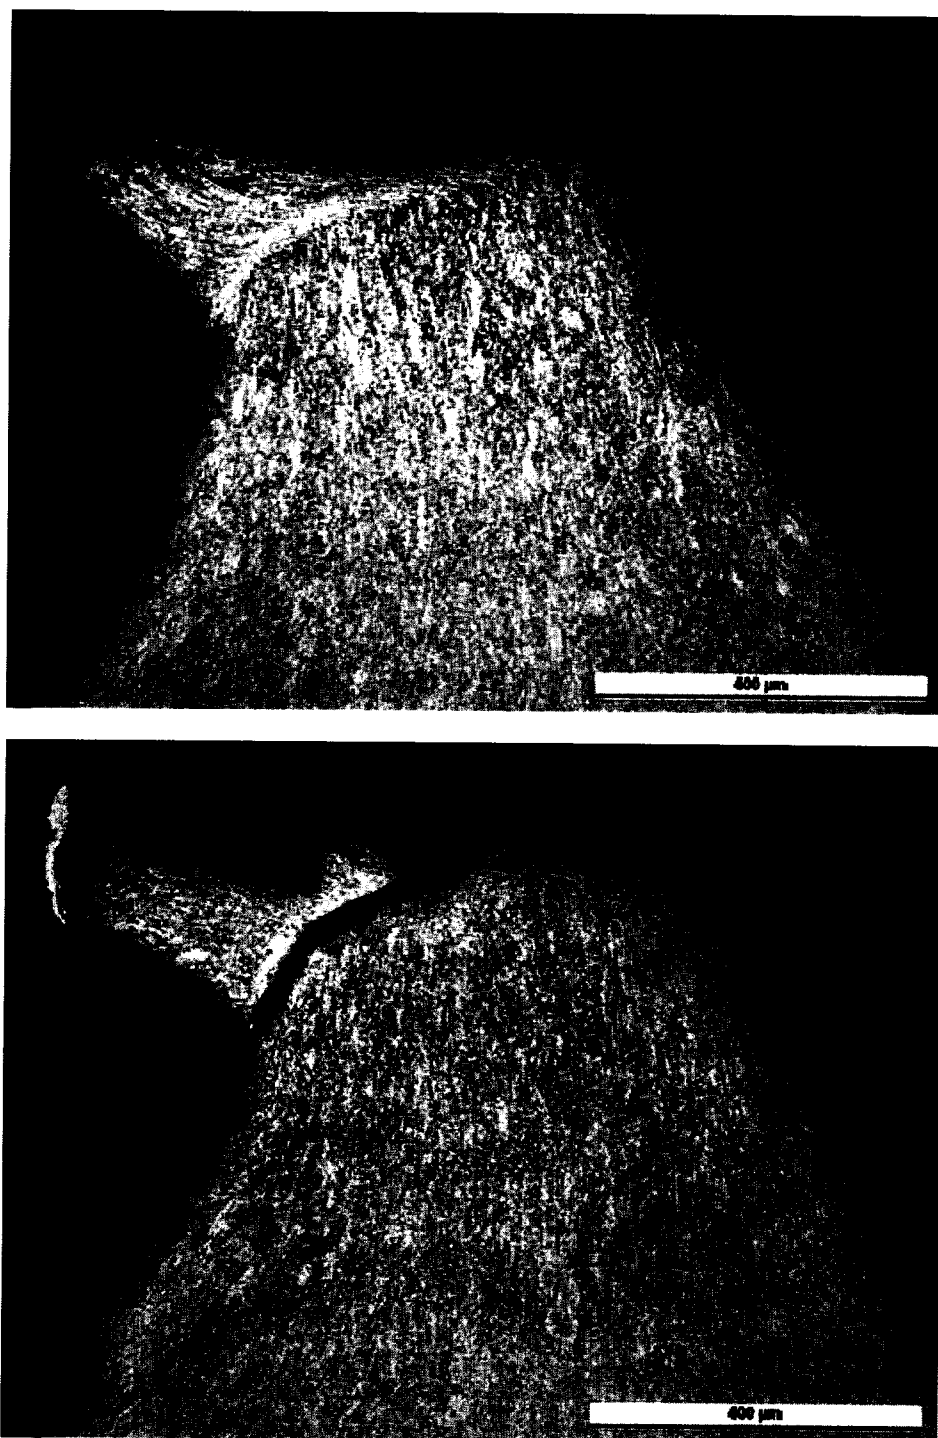
Figure 20: Metallographic sections through threads.

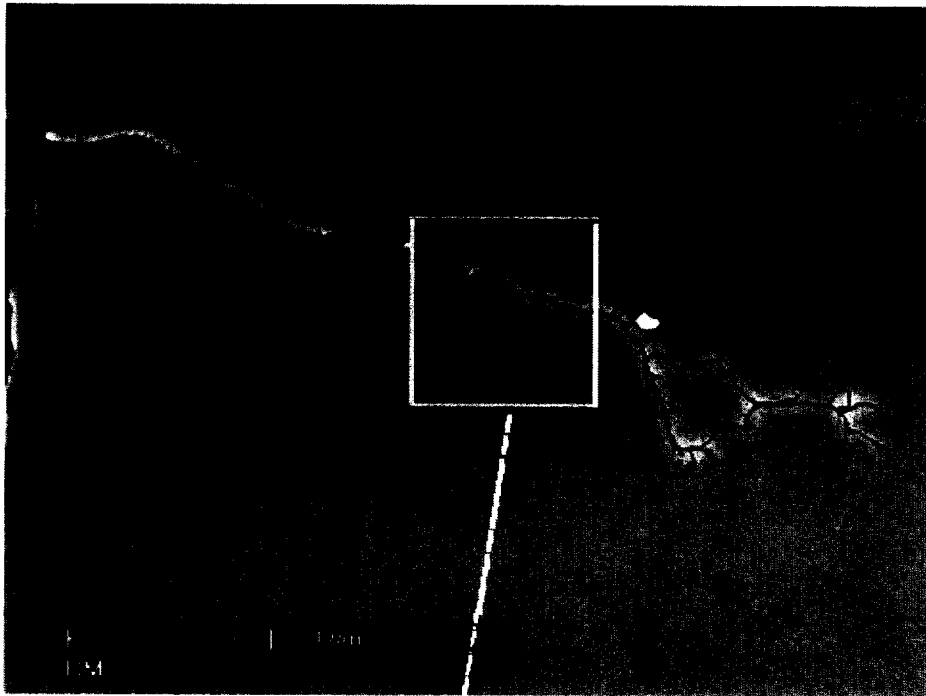
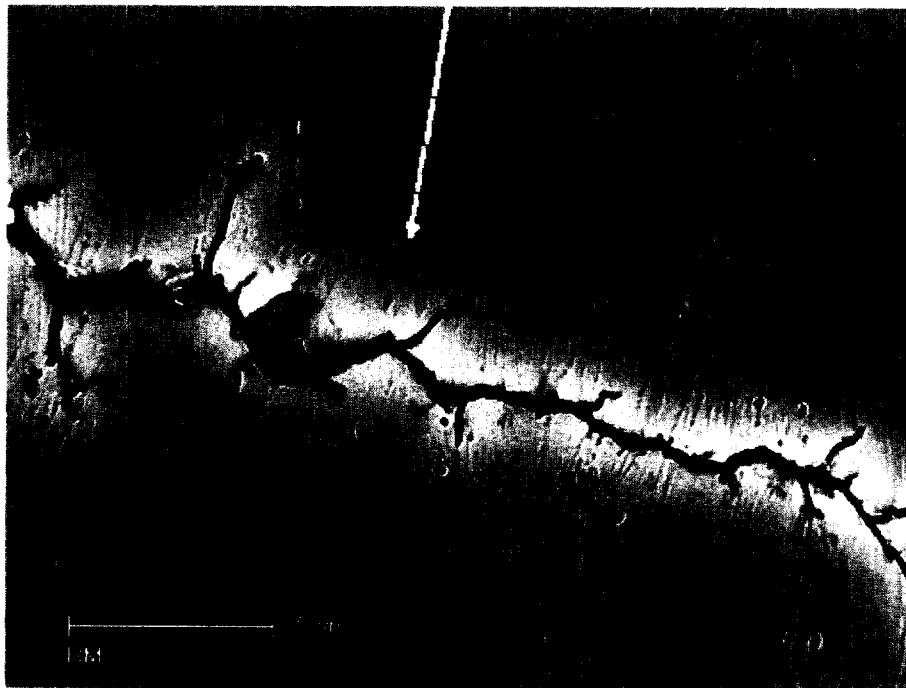
Figure 25: Higher magnifications of part of crack in Figure 24.

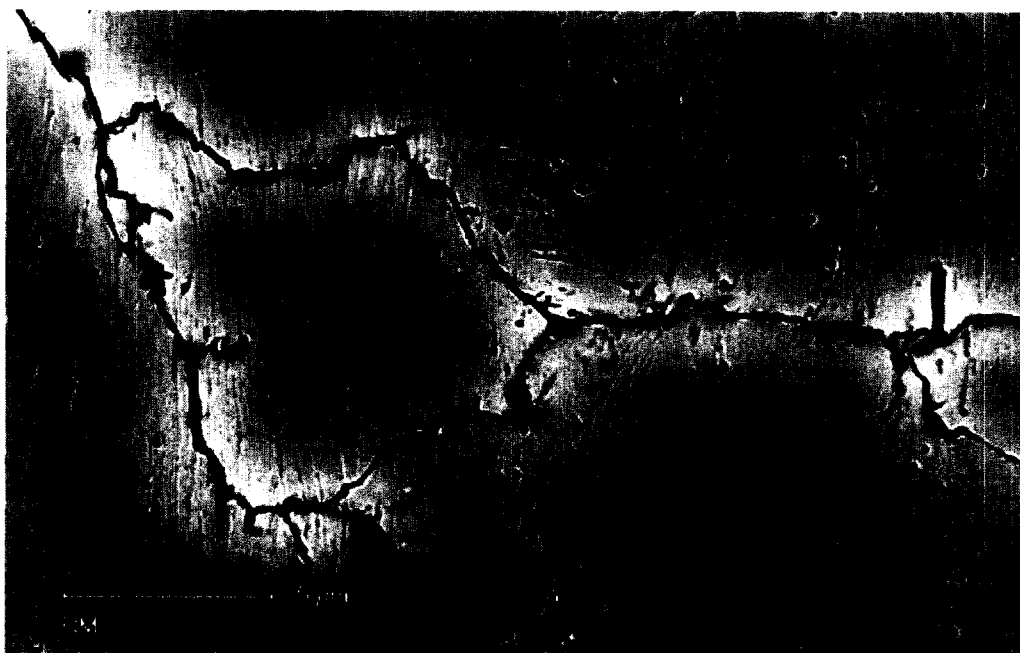
Figure 26: Higher magnification near crack tip.

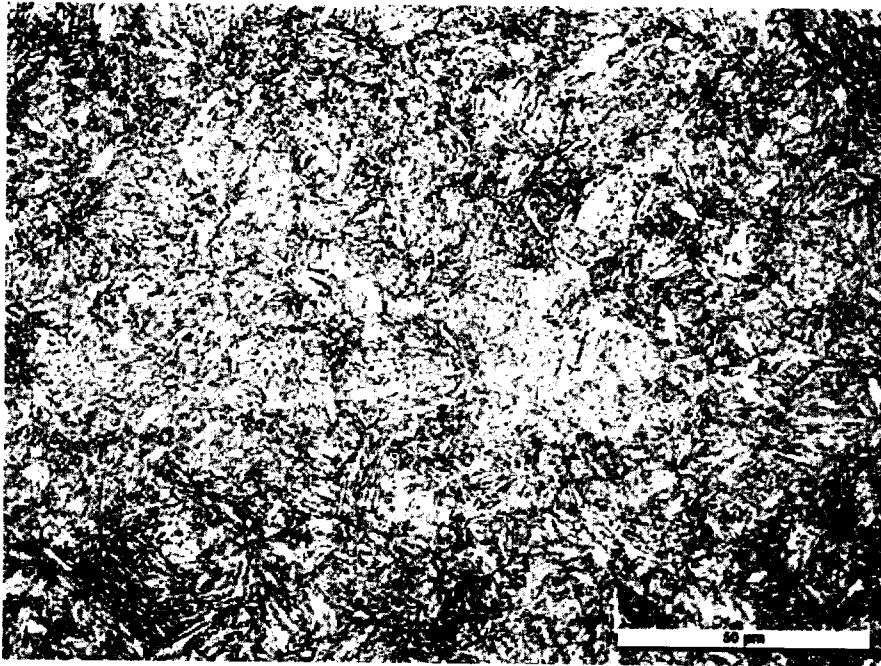
The piston rod and the rod end were analysed by emission spectrometry. The results are shown in Appendices 1 and 2. The rod material corresponds to 4340 material and the rod end is made of 12% Cr stainless steel with ~8% Ni. The microstructures are shown in Figures 27 and 28. It consists of tempered martensite in both cases. The Vickers hardness of the materials is ~ 420 for the piston rod and ~ 410 for the rod end.

Figure 27: Microstructure of piston rod material featuring uniformly tempered martensite.

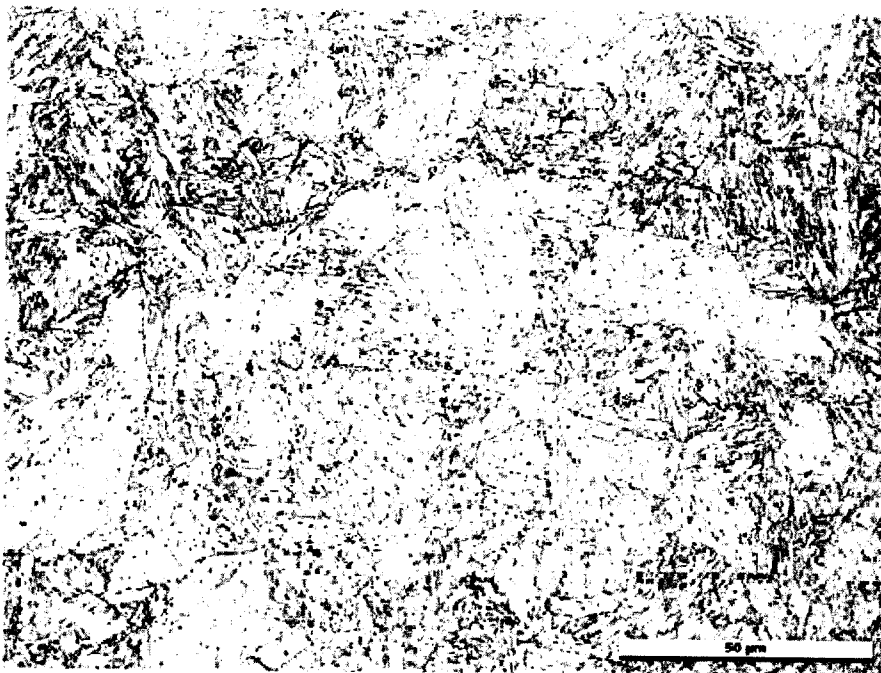
Figure 28: Microstructure of rod end material featuring uniformly tempered martensite.

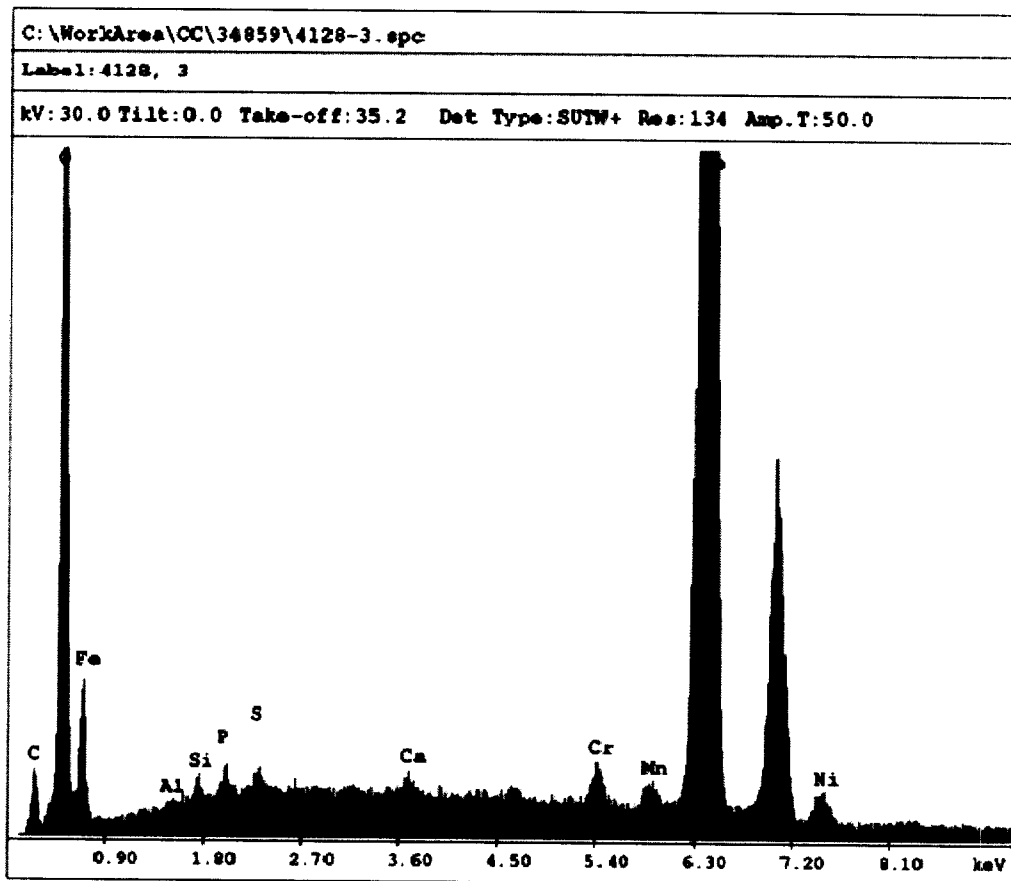
Corrosion products in the female threads were analysed by energy dispersive x-ray analysis in scanning electron microscope. The products consist mainly of Fe and O (iron oxide) with small amounts of Si, P, S and Ca, c.f. Figure 29.

Figure 29: Energy dispersive x-ray analysis of corrosion products retrieved from piston rod threads.

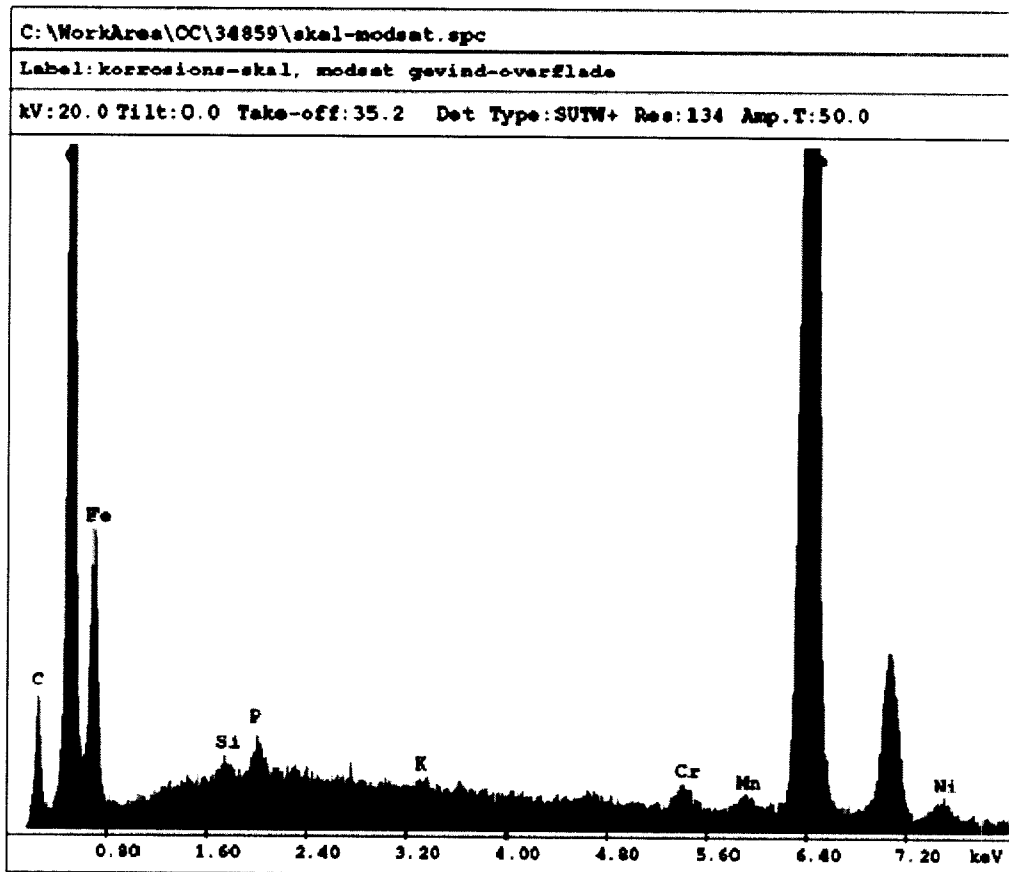
The rod end threads were partly filled with a hard brittle compound that could be easily plied out by a small screw driver, see Figure 34. Energy dispersive analysis of the plied-out compound is shown in Figure 35. It contains large amounts of Fe and O (iron oxide) and small amounts of Si, P and K.

Figure 35: Energy dispersive x-ray analysis of brittle scales from rod end thread.

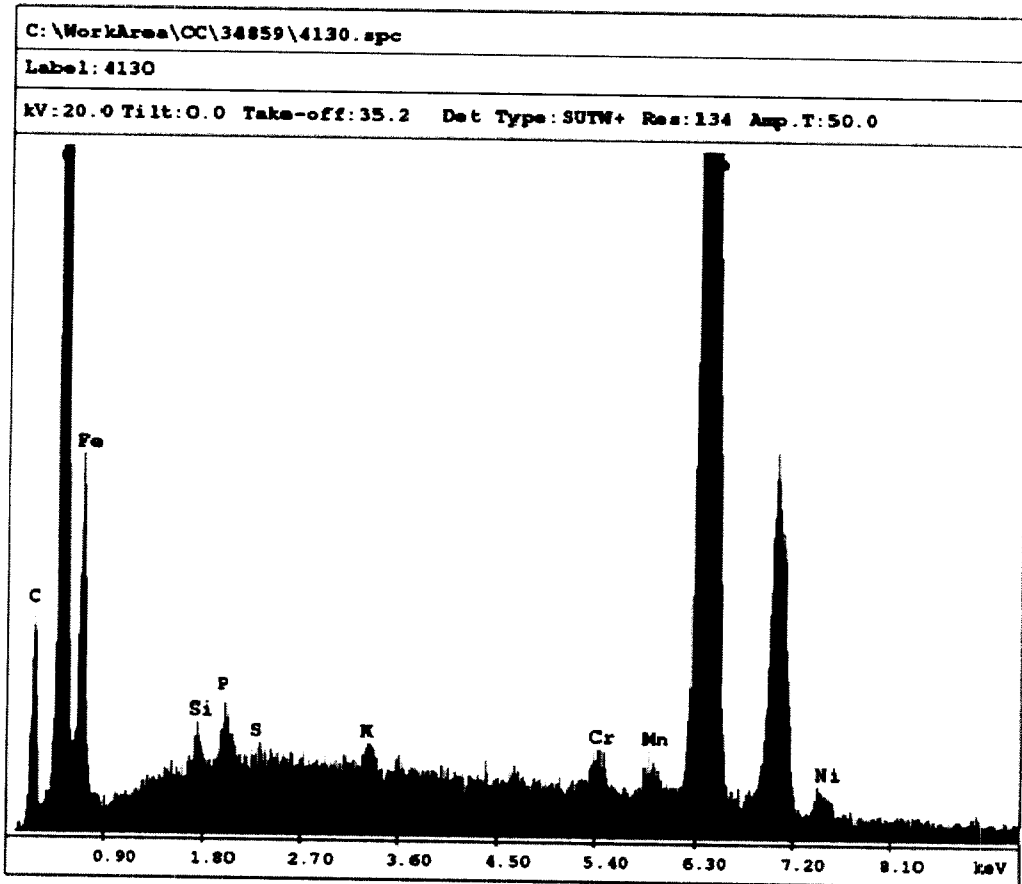
Energy dispersive analyses of corrosion products from the key way and greasy compounds collected outside the piston rod at the lock nut, c.f. Figure 47, are shown in Figures 48 and 49 respectively. In both cases large amounts of iron oxide (Fe and O) and some carbon (C) are found. Also small amounts of Si, P and S are present. In the key way products there were small amounts of (K). In the greasy compound there was Al, Cd, K and Ca.

Figure 48: Energy dispersive x-ray analysis of corrosion products retrieved from key way in rod end.

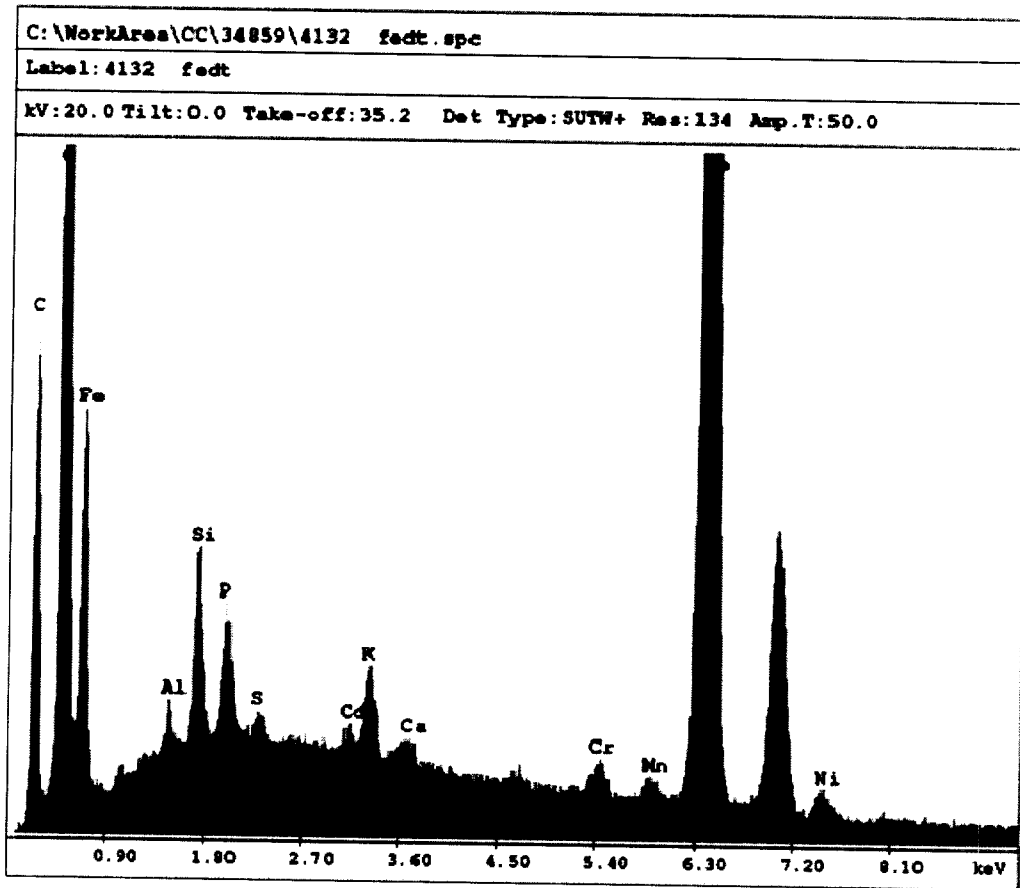
Figure 49: Energy dispersive x-ray analysis of grease compound retrieved from out side lock nut area in rod end.
