**Accident Investigation Board  
Denmark**

**Final Report  
HCLJ510-000449**

Accident to Bombardier DHC-8-402  
Registration LN-RDI  
At Copenhagen Airport Kastrup (Denmark)  
On 27 October 2007

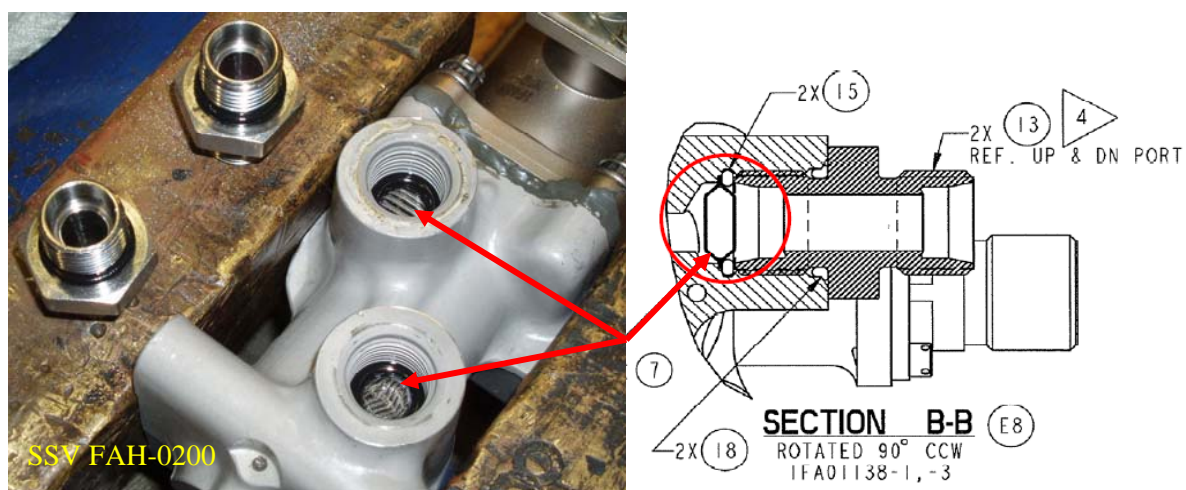
The SSV S/N FAH-0200 that replaced S/N FAH-0083 on the 16<sup>th</sup> October 2007 was examined without leading to any findings or remarks. The O-rings P/N NAS1611-110 and the filter elements were in place in both the up and down port of the valve as shown below.

The filter element (7) and O-ring (15) in place in the up and down ports of the valve.  
The filter element and the O-ring are held in place by the union, flareless tube (13).

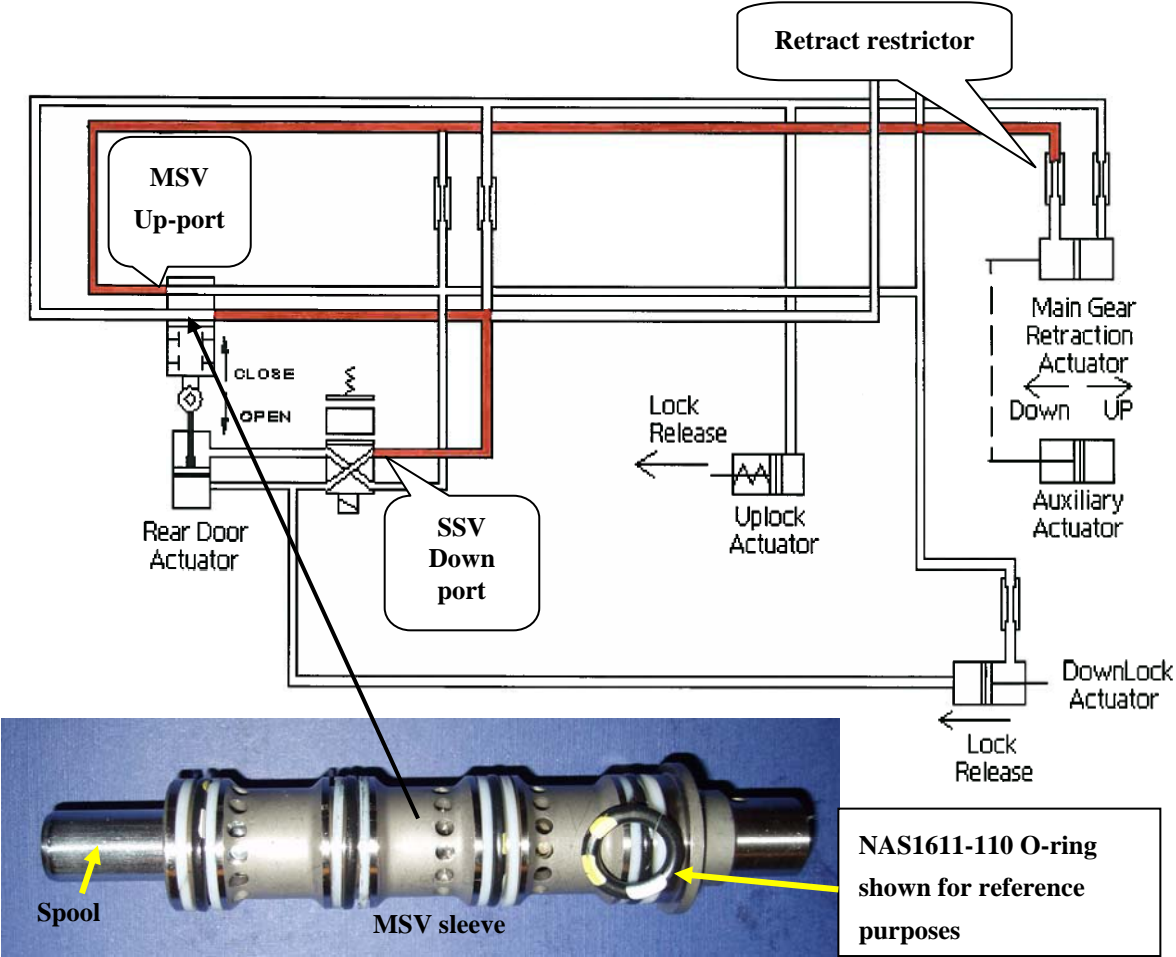
The analysis showed that while some of the hydraulic tubes would allow free passage of a rogue O-ring, other of the valve components, such as the Mechanical Sequence Valve (MSV) were of such a design that the O-ring could not pass through.

The review of the hydraulic system revealed that the rogue O-ring from the SSV down port was able to travel between the SSV and the MSV and between the MSV and the Retract Port Restrictor installed on the MLG Retraction/Extension Actuator. This is shown on the following drawing by red colored lines. The sleeve was removed from the MSV. It was determined that the diameters of the sleeve holes at the up and down ports were less than the diameter of the NAS1611-110 O-ring. Furthermore the space inside the sleeve is minimized by the moveable spool operated by the Rear Door Actuator (illustrated below).

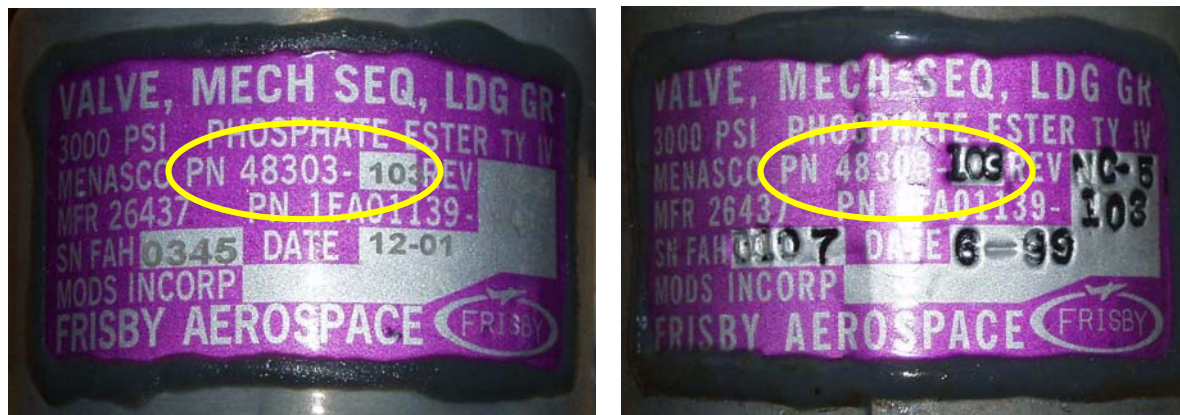
The identification plates fitted to the MSV's describe the valves as MSV Valve Body P/N 48303-103 regardless of the type of Unions/Reducers that were installed.

The following pictures show the identification plates fitted to the MSV S/N FAH-345 and FAH-0107.

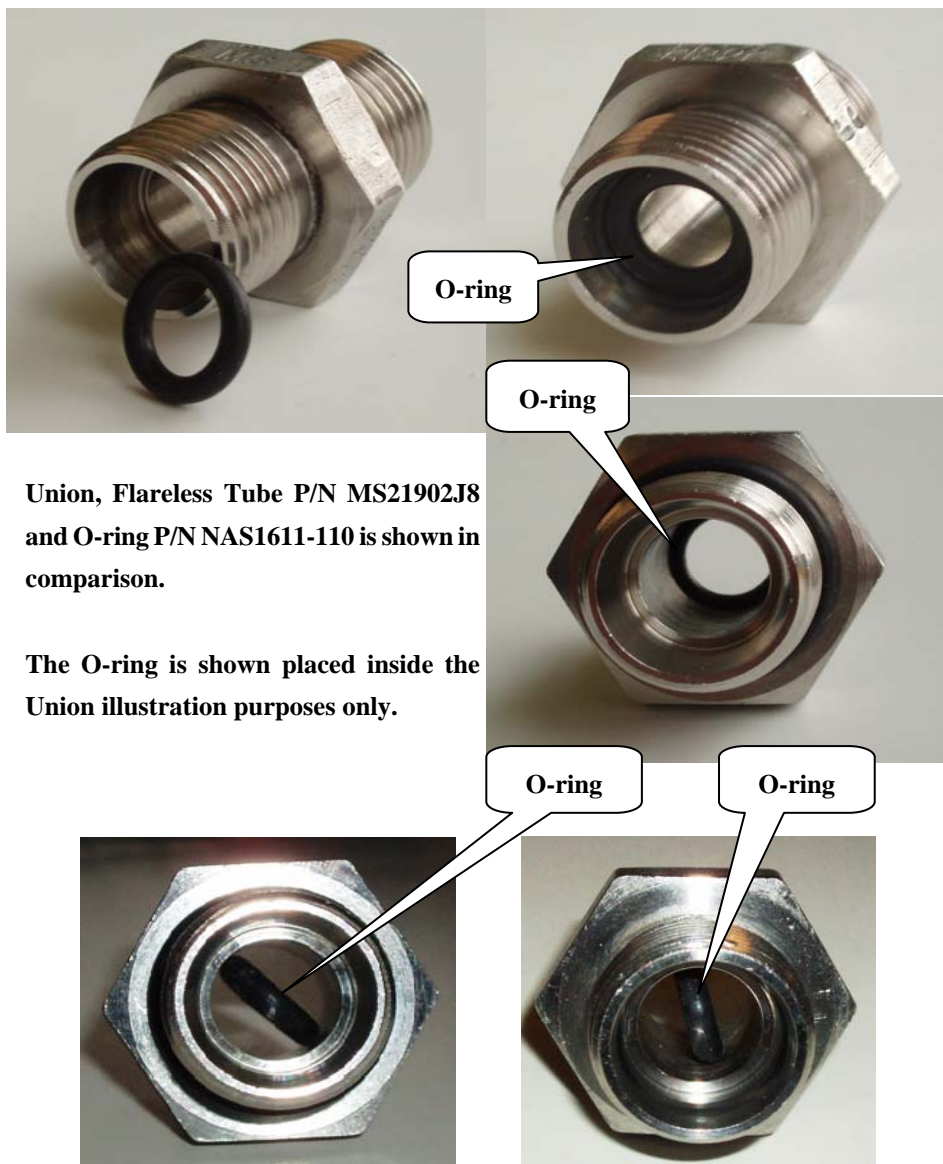
The four Unions were of the same type and size therefore the mechanic fitted the Unions to the MSV in random order.

To illustrate that it was possible for an O-ring NAS1611-110 to be transferred via the Unions, the AIB placed an O-ring inside the Union as shown in the pictures below.

**Union, Flareless Tube P/N MS21902J8 and O-ring P/N NAS1611-110 is shown in comparison.**

**The O-ring is shown placed inside the Union illustration purposes only.**

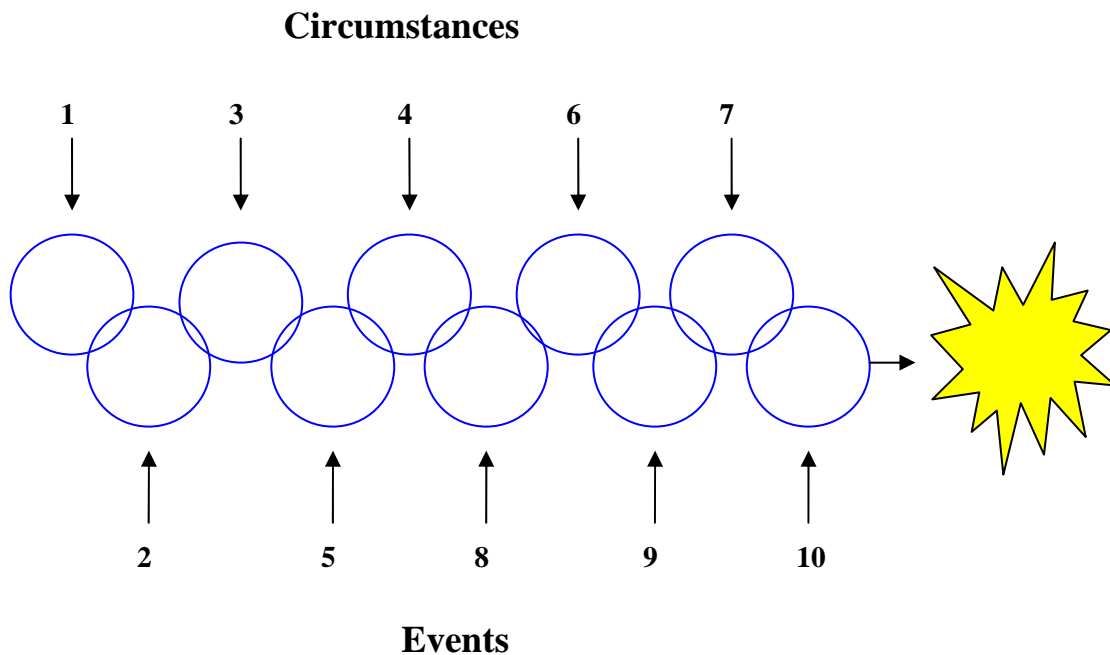
If the chain was broken by removing one of the chain-links (circumstance or event) in the chain leading to the accident this accident would not have occurred. For instance with reference to item number 3; if the operator had the MLG MSV P/N 48303-5 on stock this accident would not have occurred.

The numbers pointing at the chain refer to the number of the factors divided into circumstances and events.

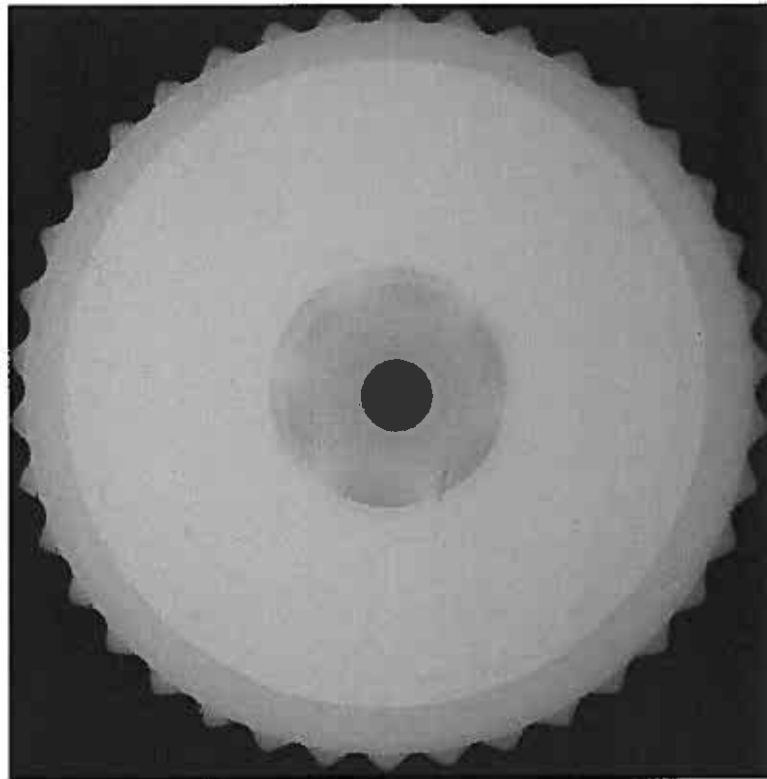
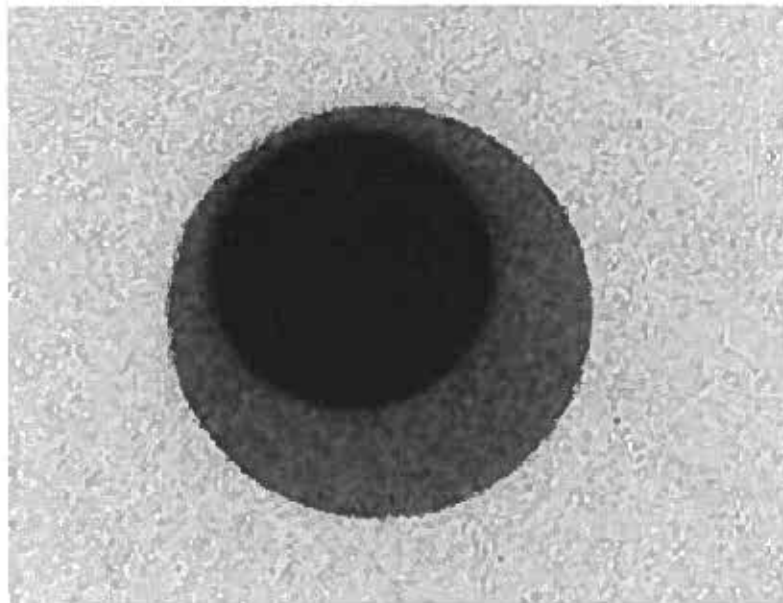
The flow restrictor was x-rayed in axial and transverse directions using voltages ranging from 200 kV down to 25 kV. The x-ray images obtained at low voltages, Figures 4 and 5, did not reveal presence of any metallic particles or other x-ray absorbing material in the flow channels or orifices.

**Figure 4:** X-ray images of flow restrictor X-rayed in longitudinal direction from Port A. The lower image shows the two orifices at higher magnification.

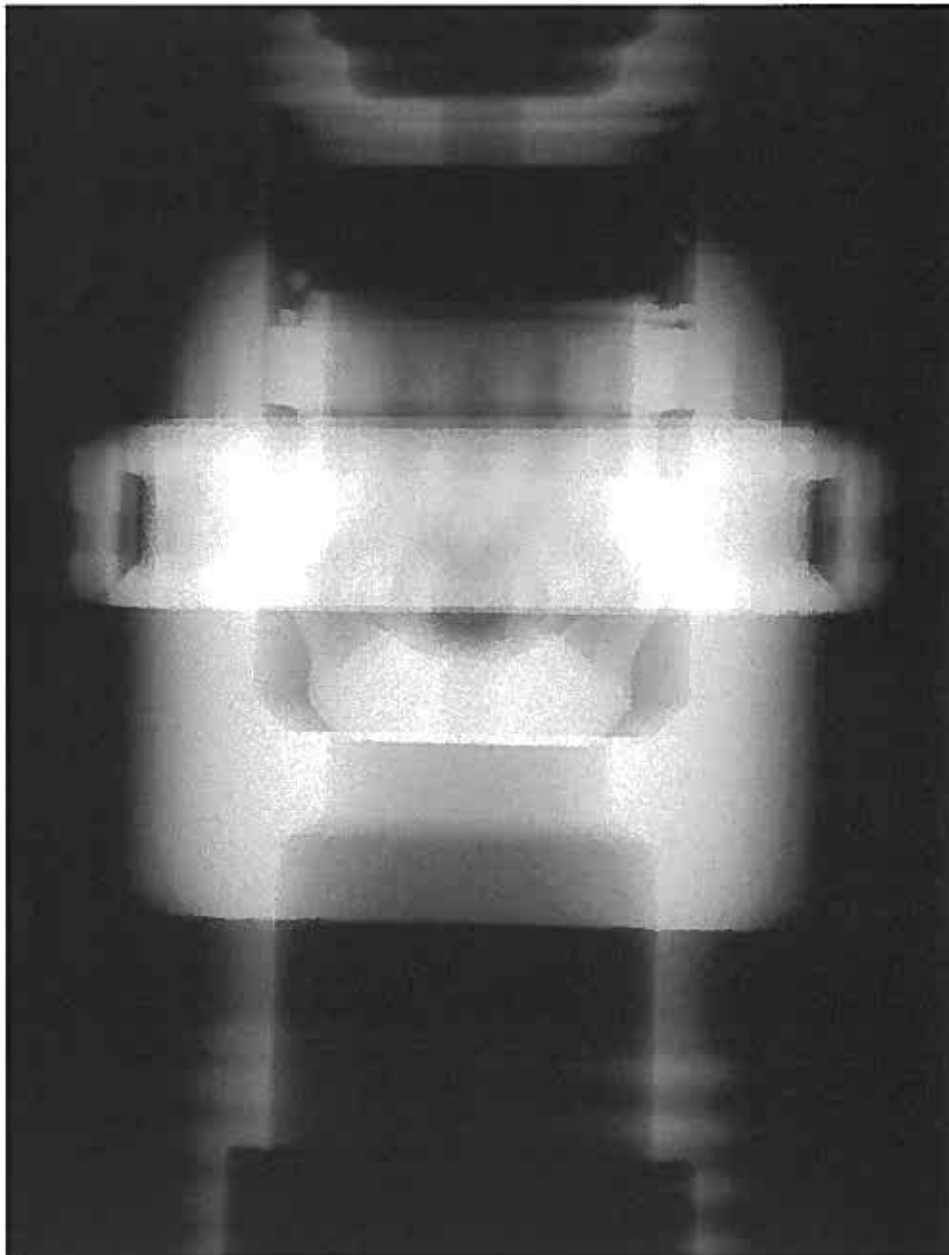
Figure 5: X-ray in transverse direction.

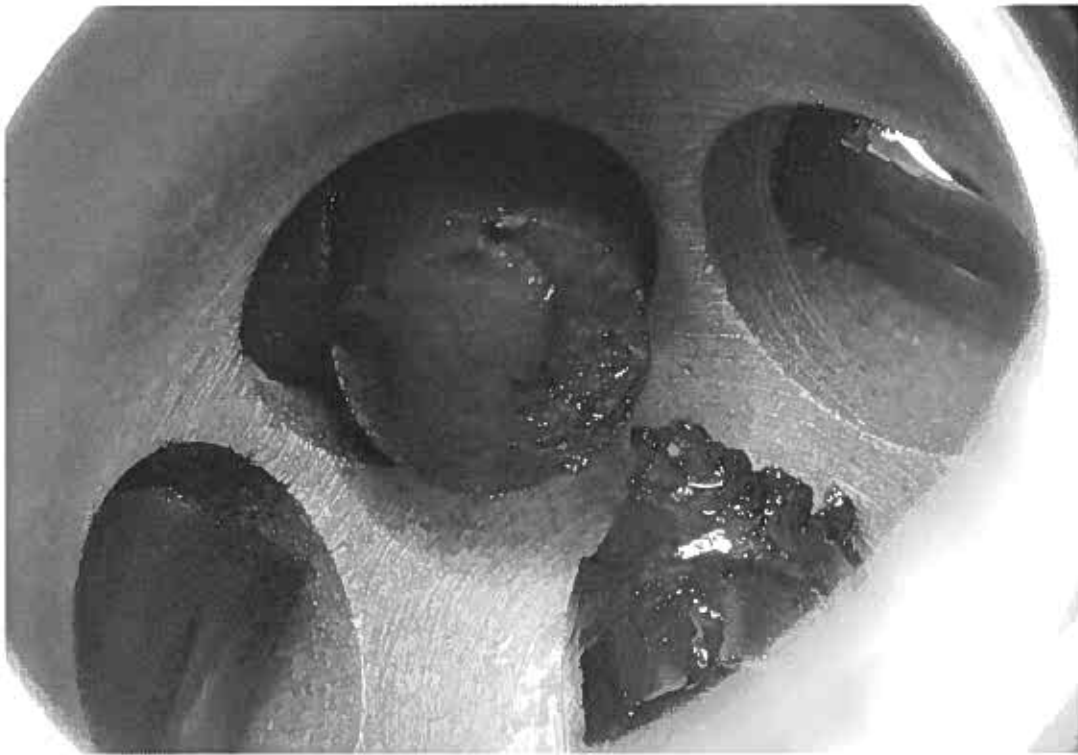
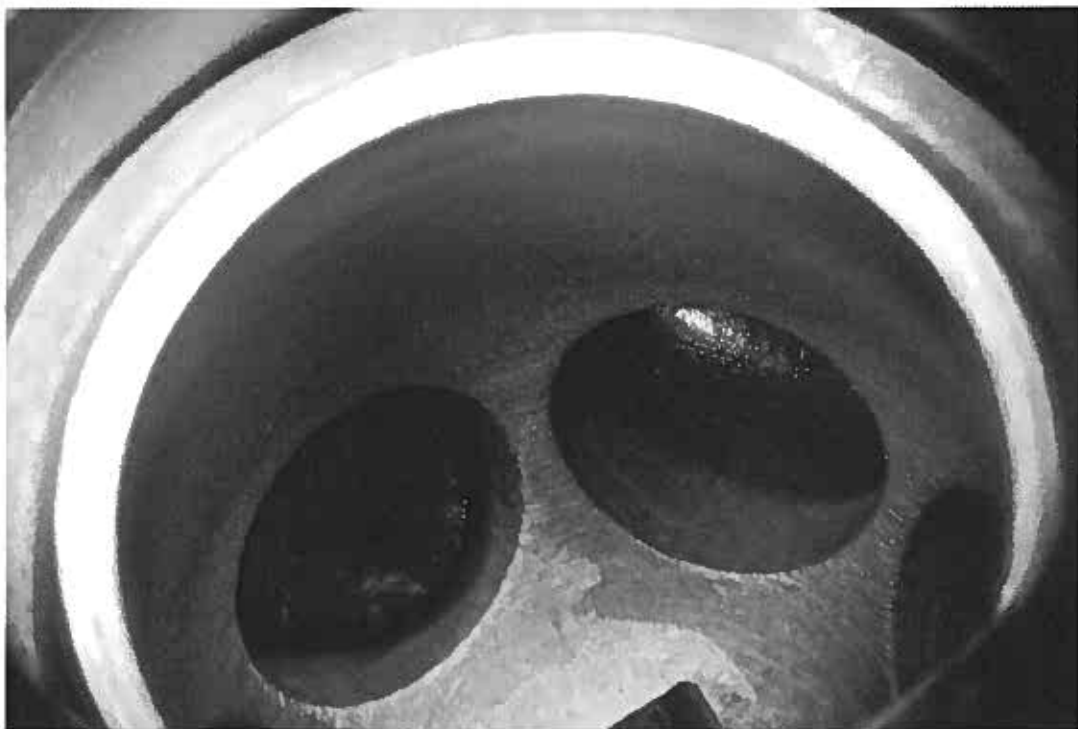
Disassembling the restrictor and removing the A port orifice allowed a view of the valve interior, c.f. Figure 6. A broken O-ring is partly emerging through one of the flow relief holes and the central orifice hole is blocked by a piece of O-ring material. In addition it appears that O-ring material is trapped between the valve cone and the housing thus blocking the flow relief holes. Forcing the valve cone out of the housing revealed 3 pieces of an O-ring, c.f. Figure 7. Together with a fourth piece that was easily plied free from the

Figure 6: View from A port inside valve cone.

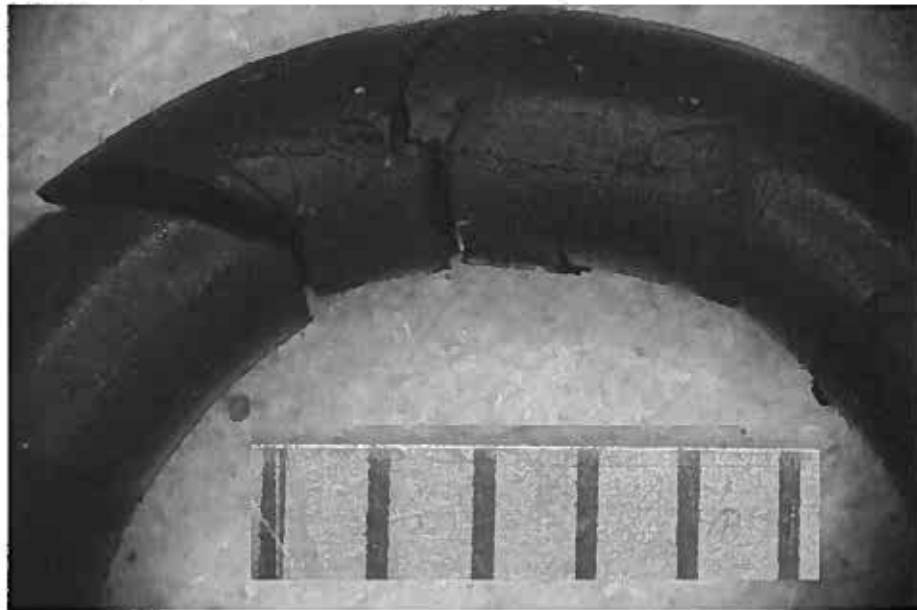
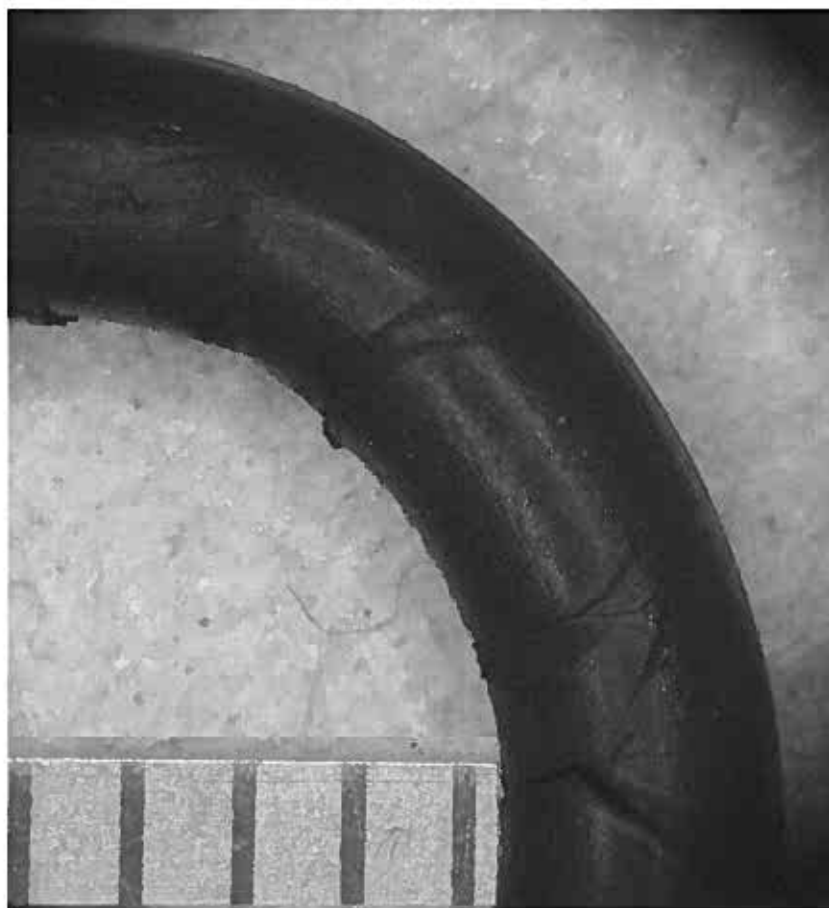
The O-ring surface shows signs of being in intimate contact with the valve cone thus producing circular punch cuts in the O-ring corresponding to the size and spacing of the flow relief holes in the valve cone. Figures 10 to 13 show examples of the punch cuttings, and squeeze and chewing marks in the O ring surfaces. Some of the punch cuts are more than halfway through the O-ring as illustrated in Figure 14. The striation patterns in the free ends of the O-ring pieces shown in Figure 15 are evidence of stepwise progressing punch cuts.

Figure 10: View of retrieved O-ring. Scale bar division is 1 mm.

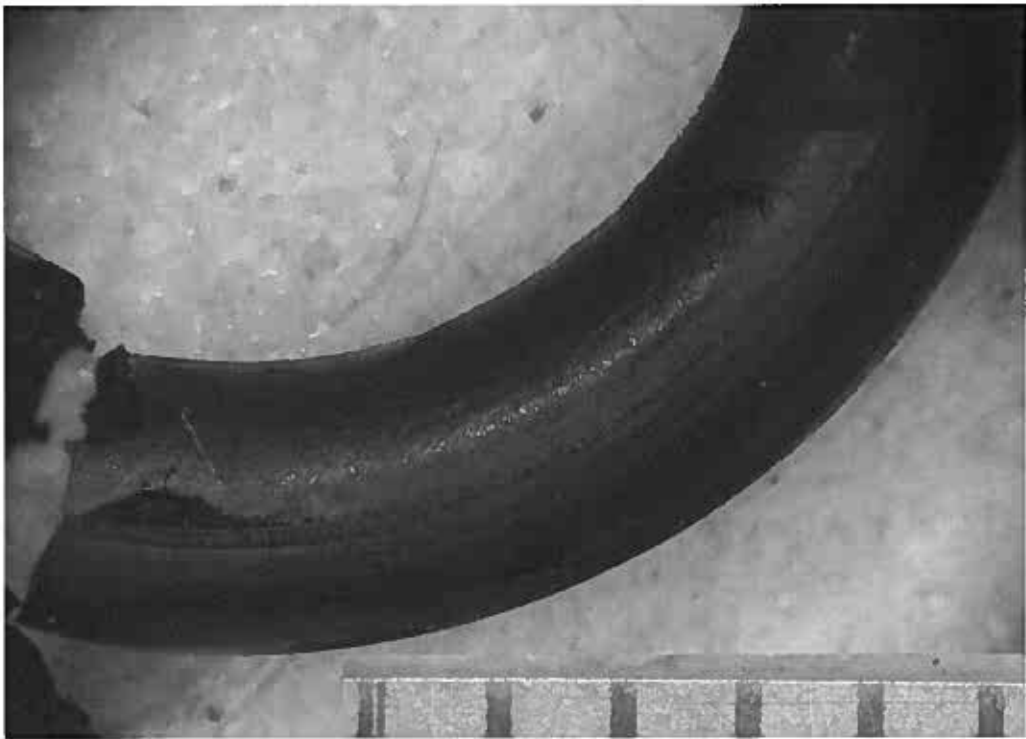
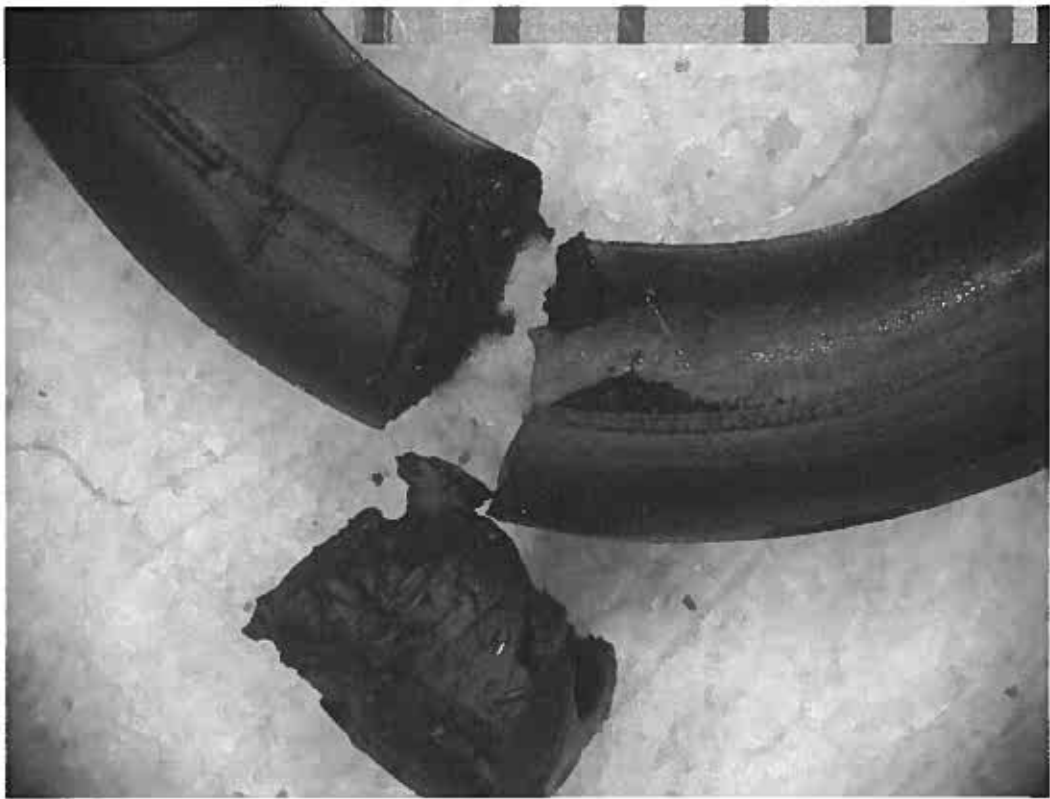
Figure 11: View of retrieved O-ring. Scale bar division is 1 mm.

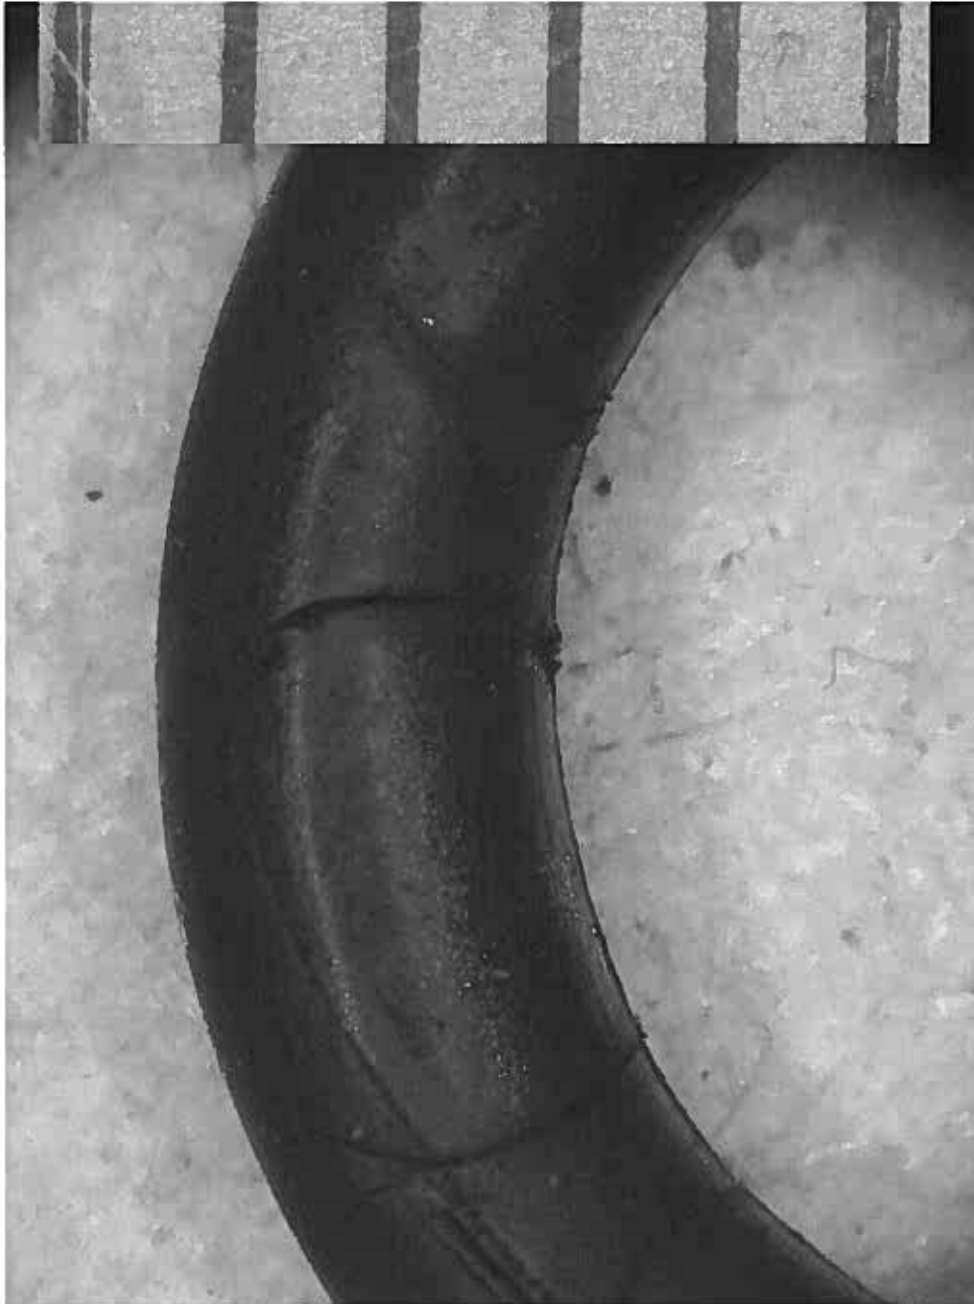
Figure 12: View of retrieved O-ring. Scale bar division is 1 mm.

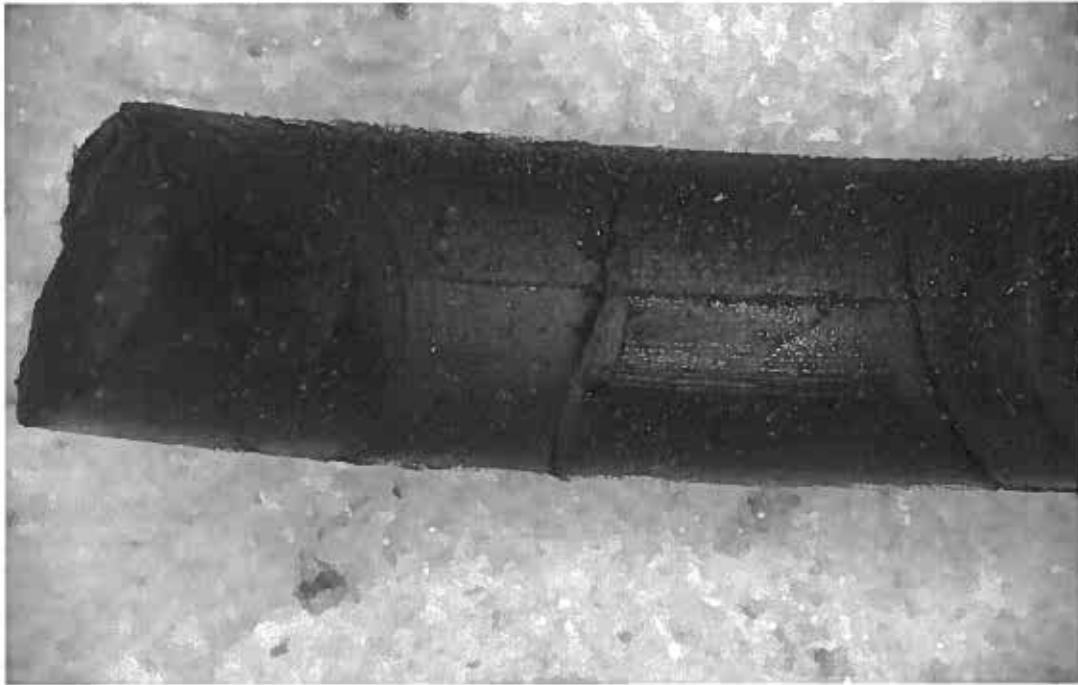
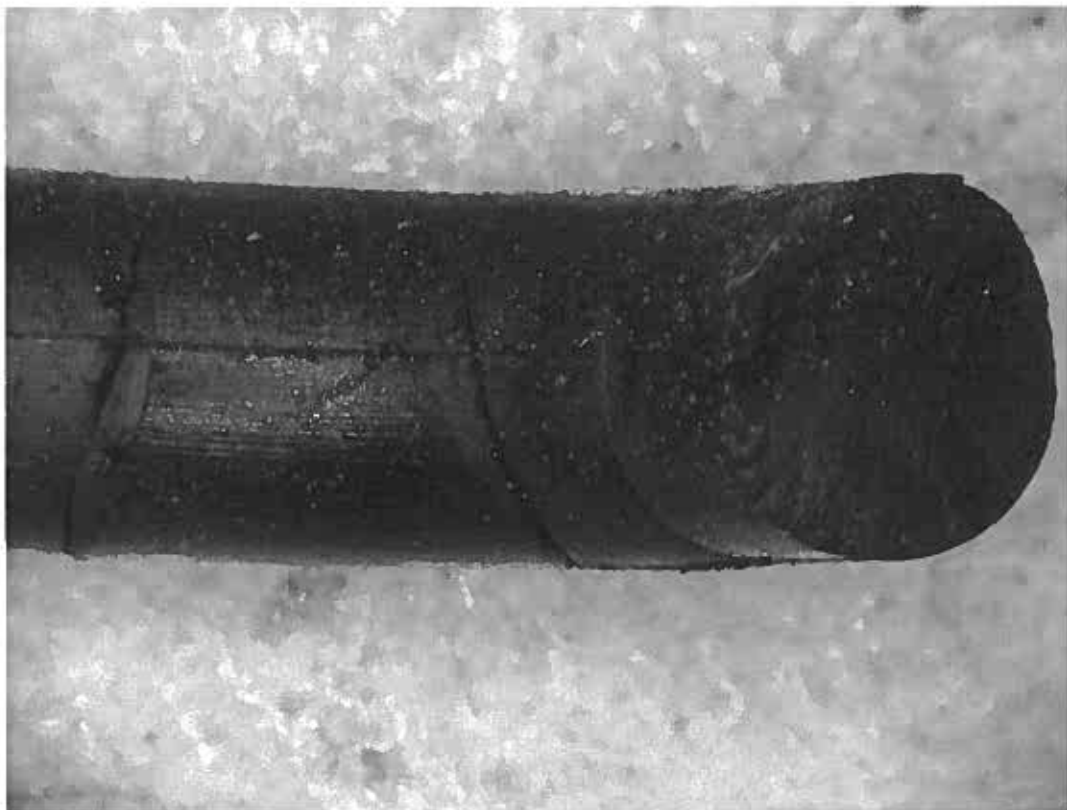
**Figure 13:** View of retrieved O-ring.

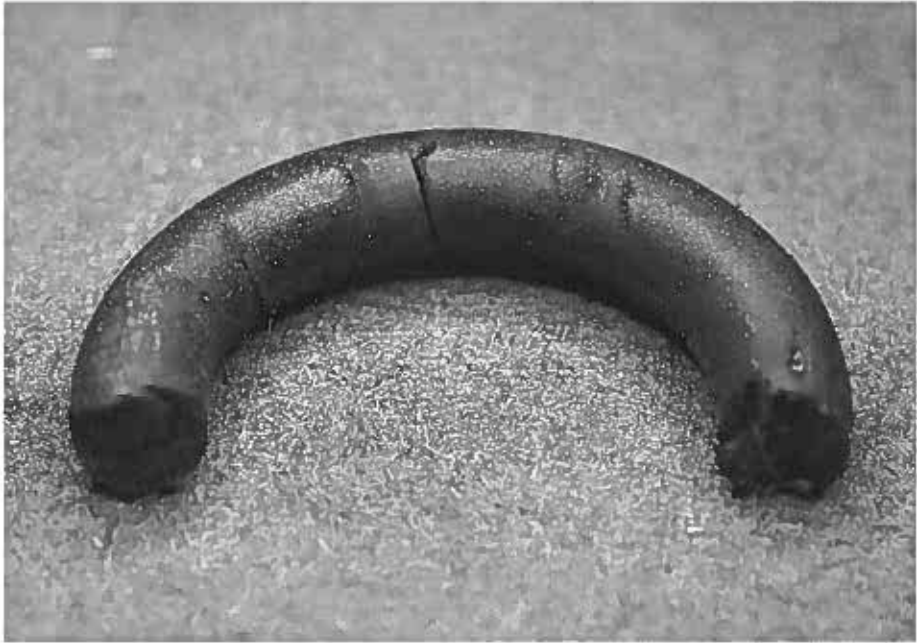
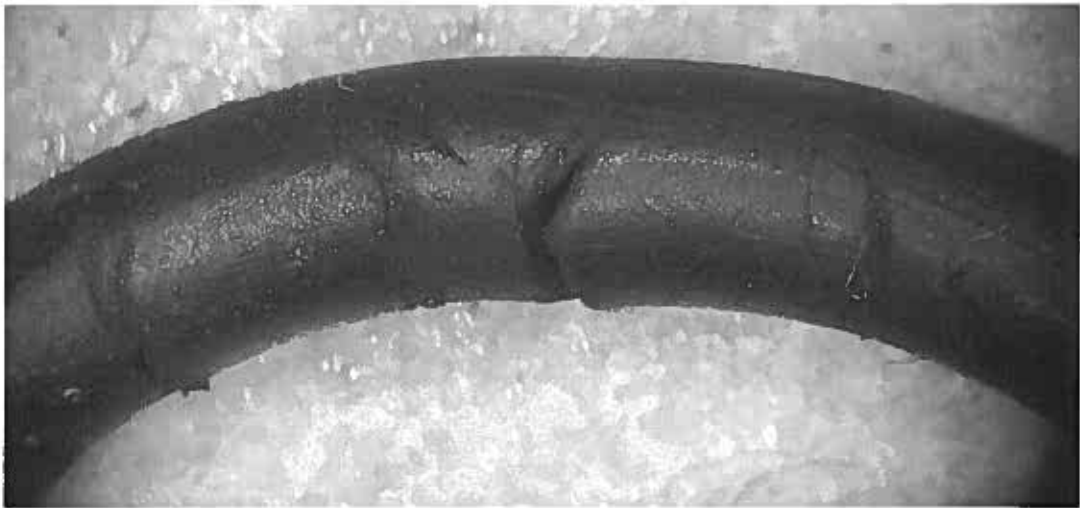
Figure 14: Illustration of punch cut depths in O-ring.

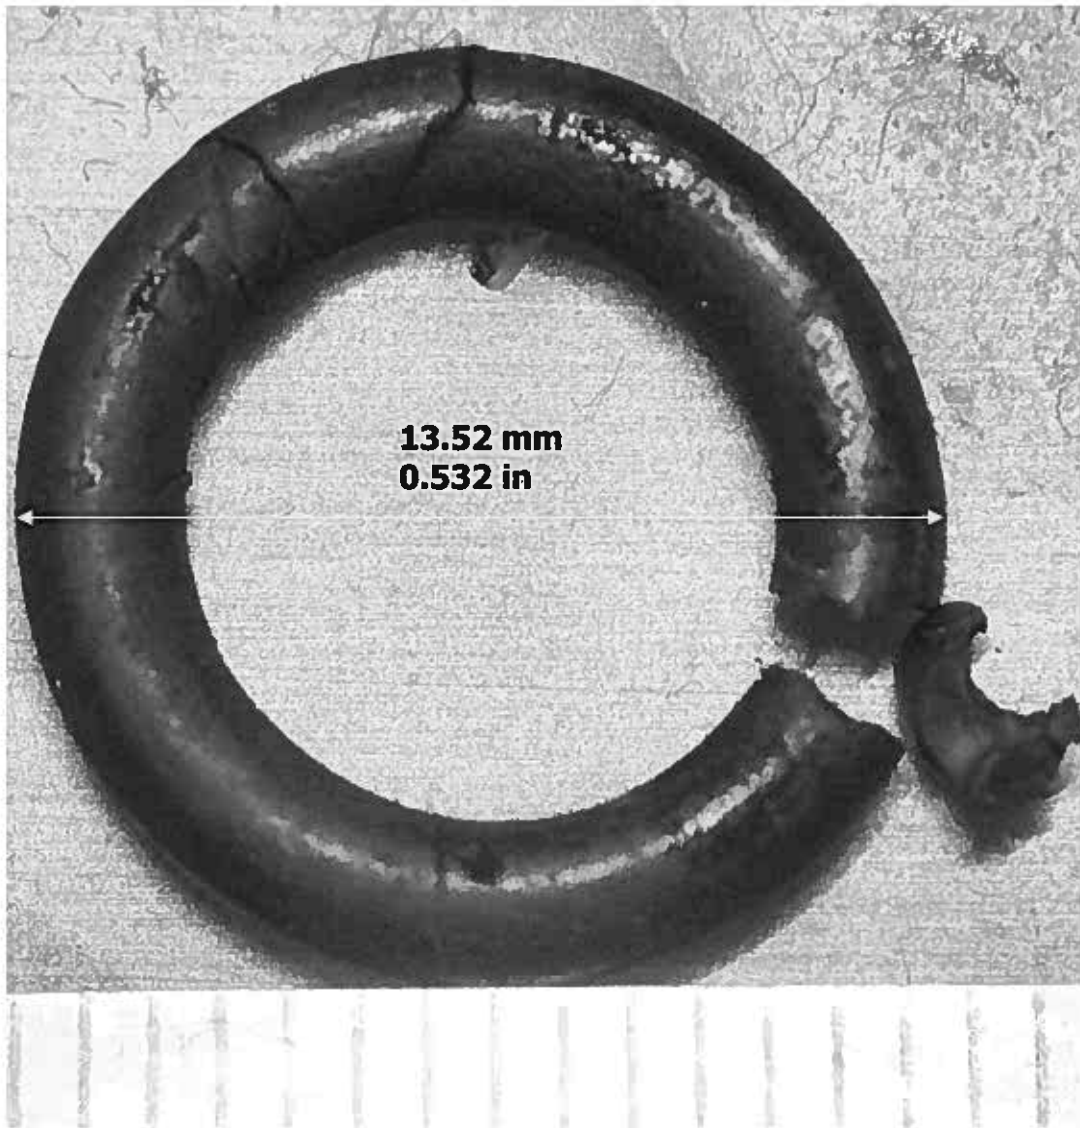
The dimensions of the O-ring as estimated in Figures 16 to 19 are:

Figure 16: Reassembled O-ring. Estimation of outer diameter.

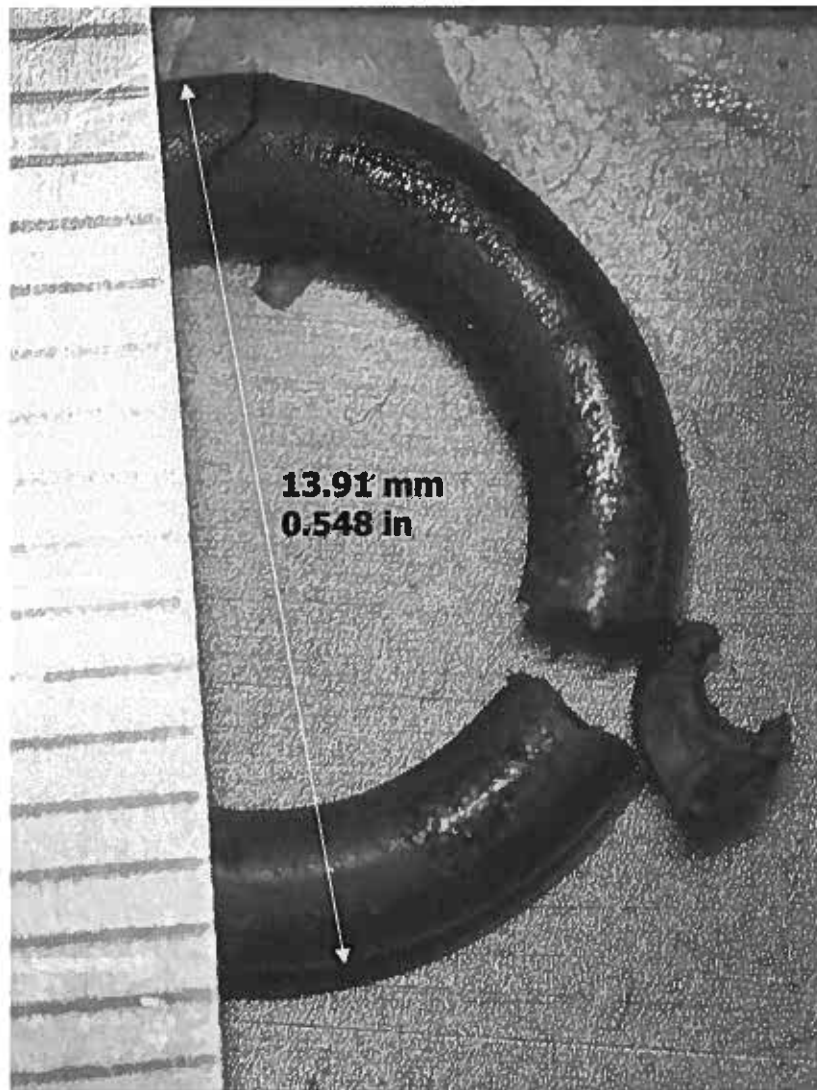
Figure 17: Reassembled O-ring. Estimation of outer diameter.

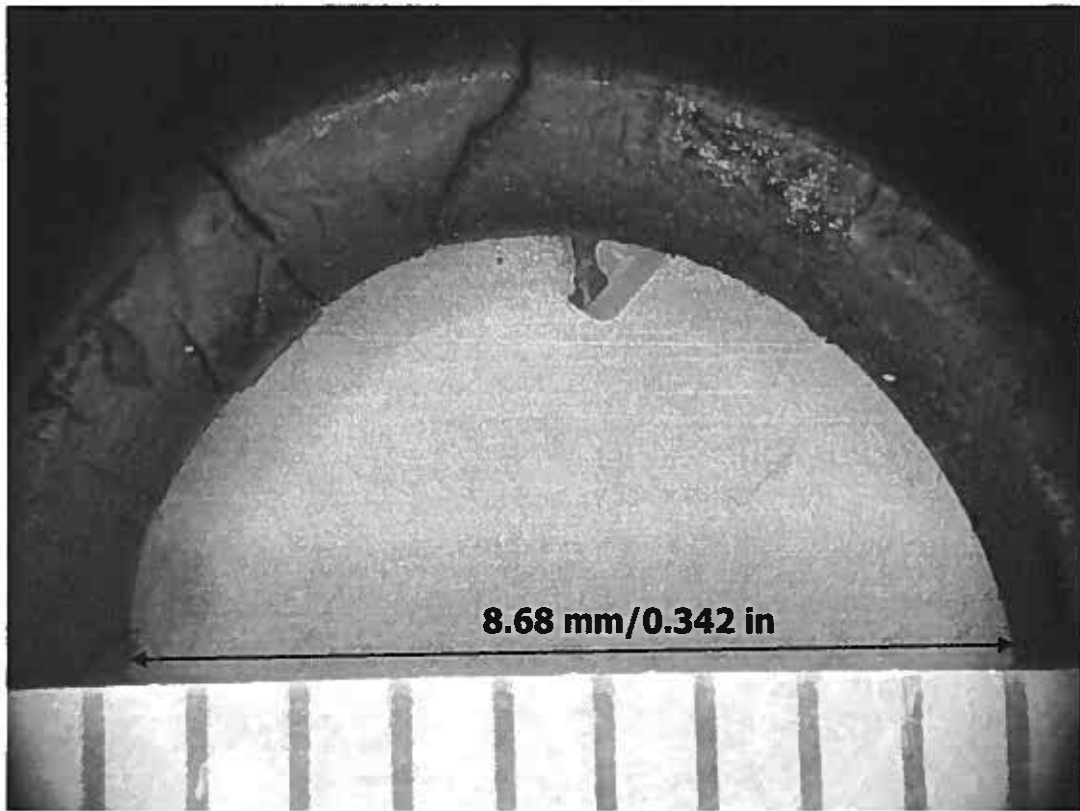
Figure 18: Reassembled O-ring. Estimation of inner diameter.

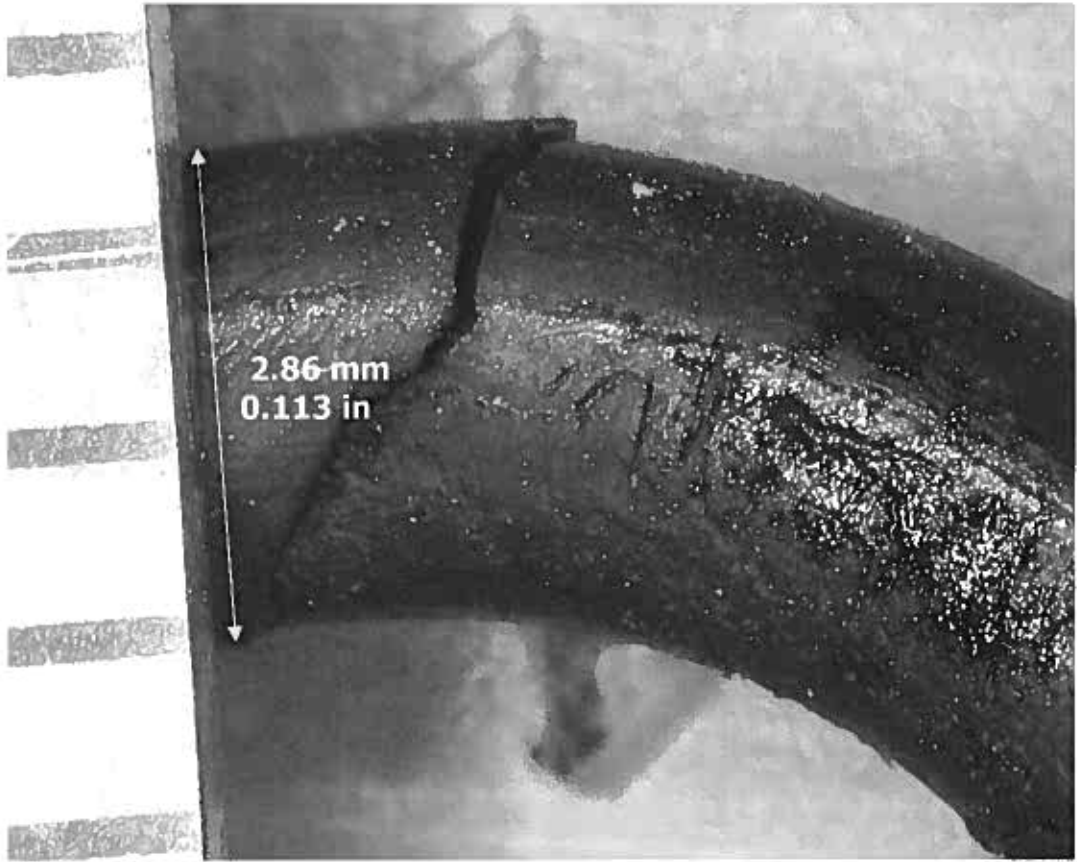
Figure 19: Reassembled O-ring. Estimation of O-ring thickness.

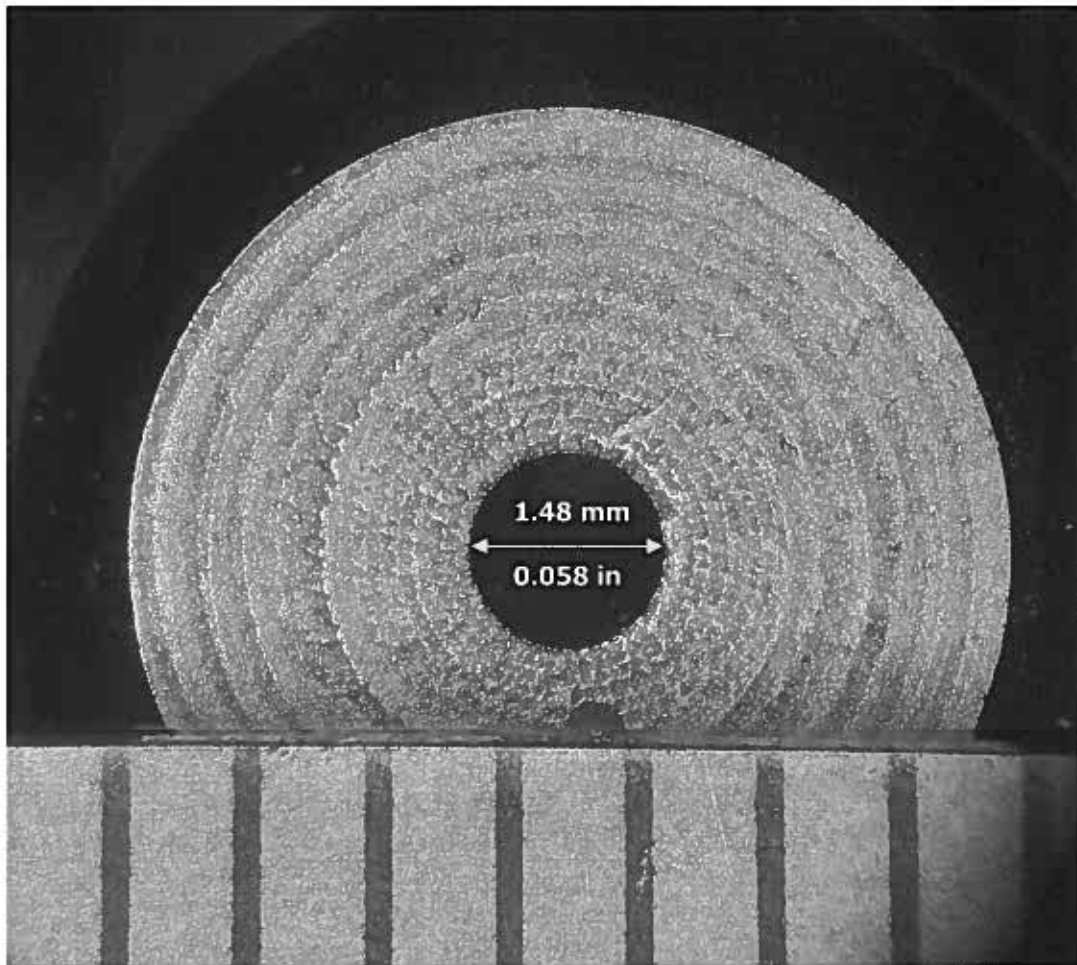
The orifice dimensions as estimated from Figures 20 and 21 are:

Figure 20: Estimation of valve cone orifice dimension.

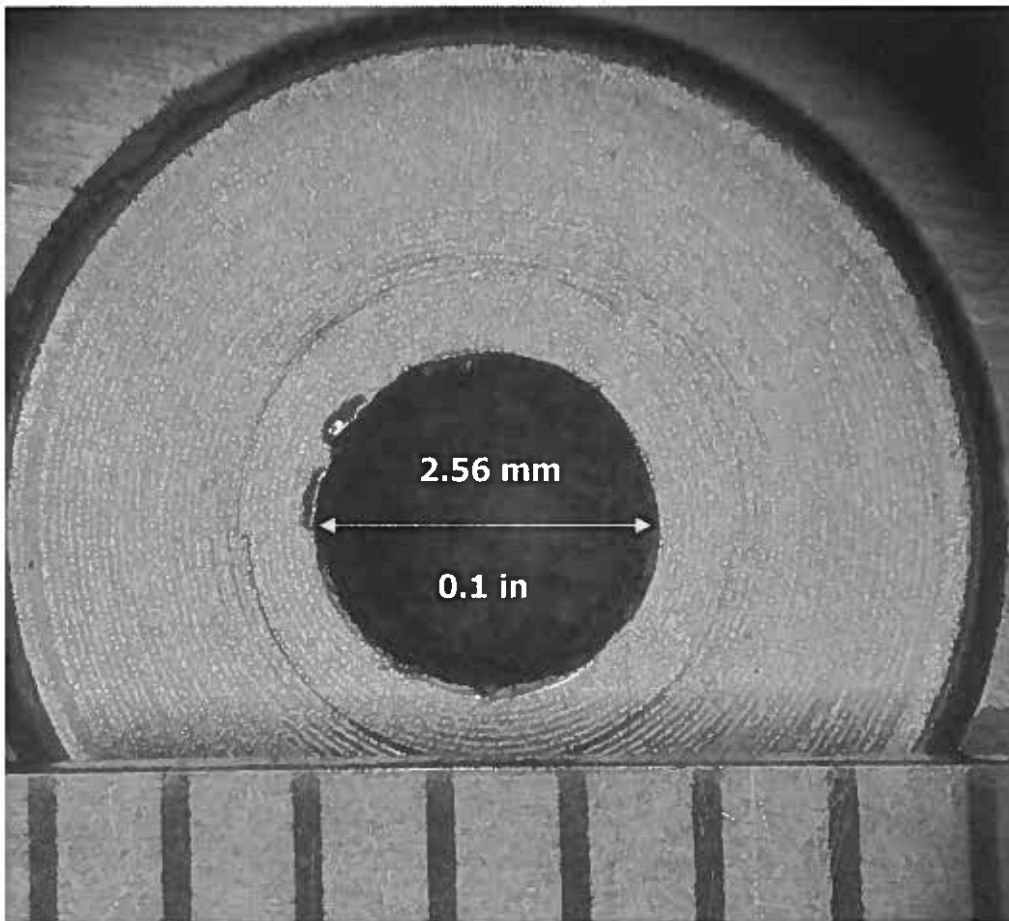
Figure 21: Estimation of A port orifice dimension.
