**Accident Investigation Board  
Denmark**

**Final Report  
HCLJ510-000449**

Accident to Bombardier DHC-8-402  
Registration LN-RDI  
At Copenhagen Airport Kastrup (Denmark)  
On 27 October 2007

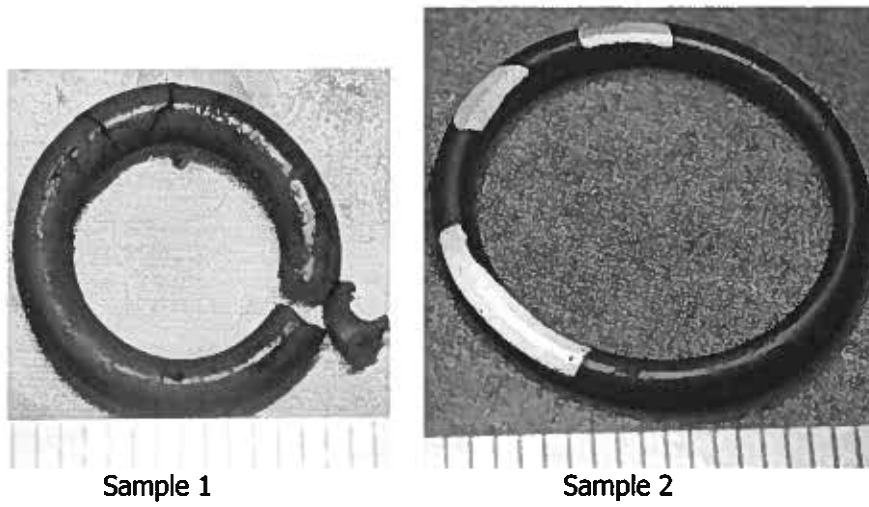
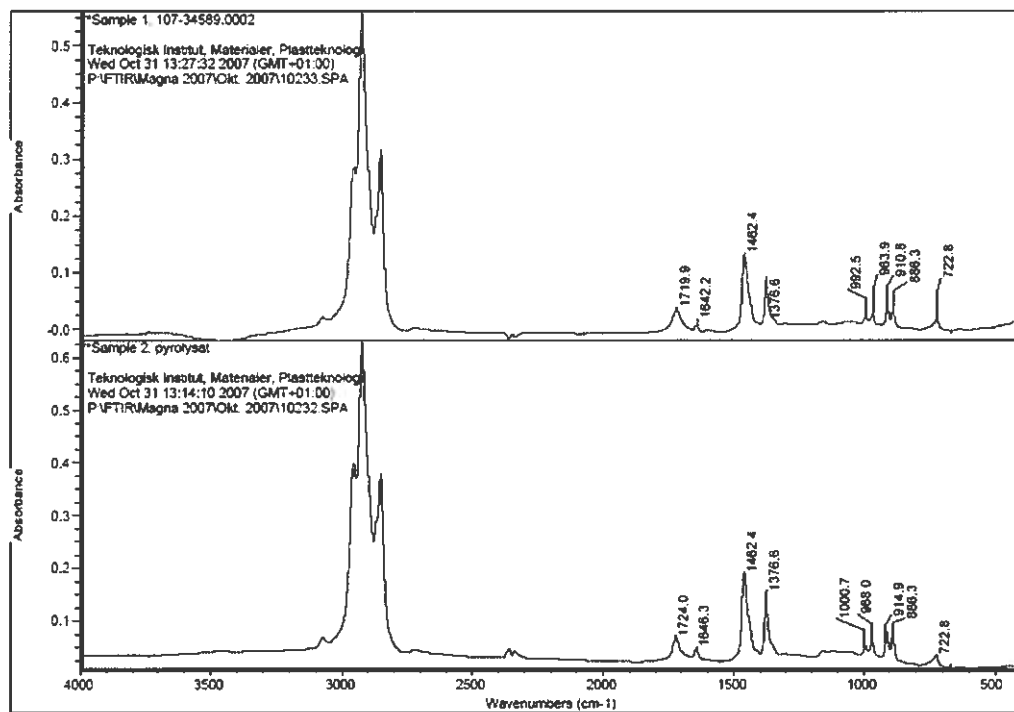
The composition of the trapped O-ring (sample 1) was checked against a reference O-ring material (sample 2), by means of Fourier Transform Infra Red spectrometry. The obtained FTIR spectra are shown in Figure 22. The spectra are quite similar and correspond to EPDM rubber (ethylene diene monomer rubber) as normally required for use in fireproof hydraulic fluids.

Figure 22: FTIR analyses of O-ring samples 1 and 2.

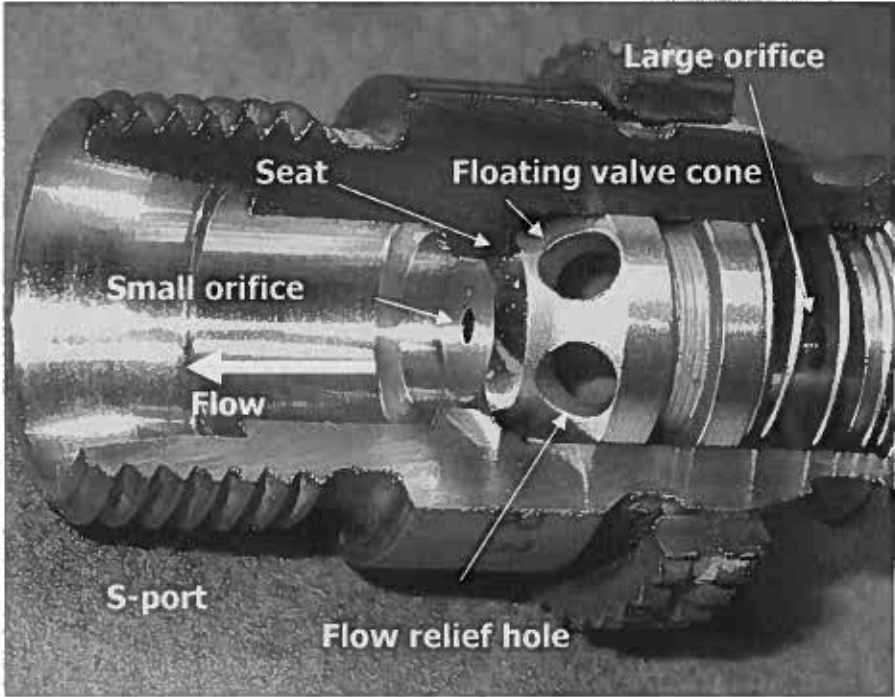
The function of the flow restrictor valve is illustrated by means of the cut-away views of a valve similar to the blocked valve, c.f. Figures 23 and 24. When pressure is applied through the A port (as during lowering of the landing gear) the floating valve cone is forced against the seal area and the flow through the restrictor is controlled by the smaller orifice. When pressure is supplied through the S port the valve cone travels away from the seal and opens up. The relief holes in the cone bypasses the smaller orifice and the flow is controlled by the large orifice in the A port end.

Figure 23: Cut-away view of back flow restrictor valve in closed position (during landing gear extension).

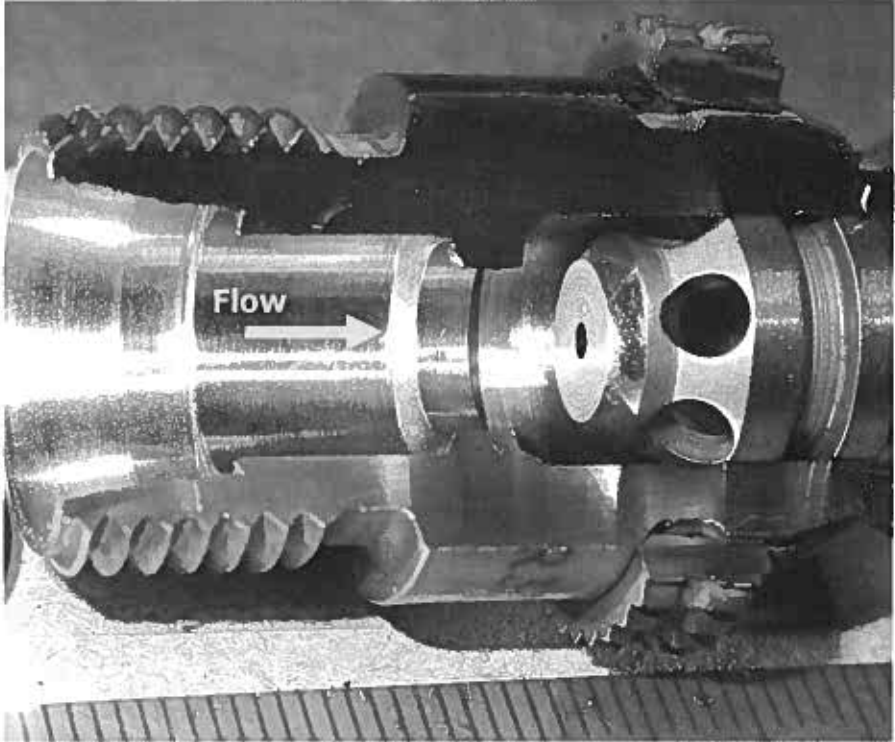
Figure 24: Cut-away view of back flow restrictor valve in open position (during landing gear retraction).

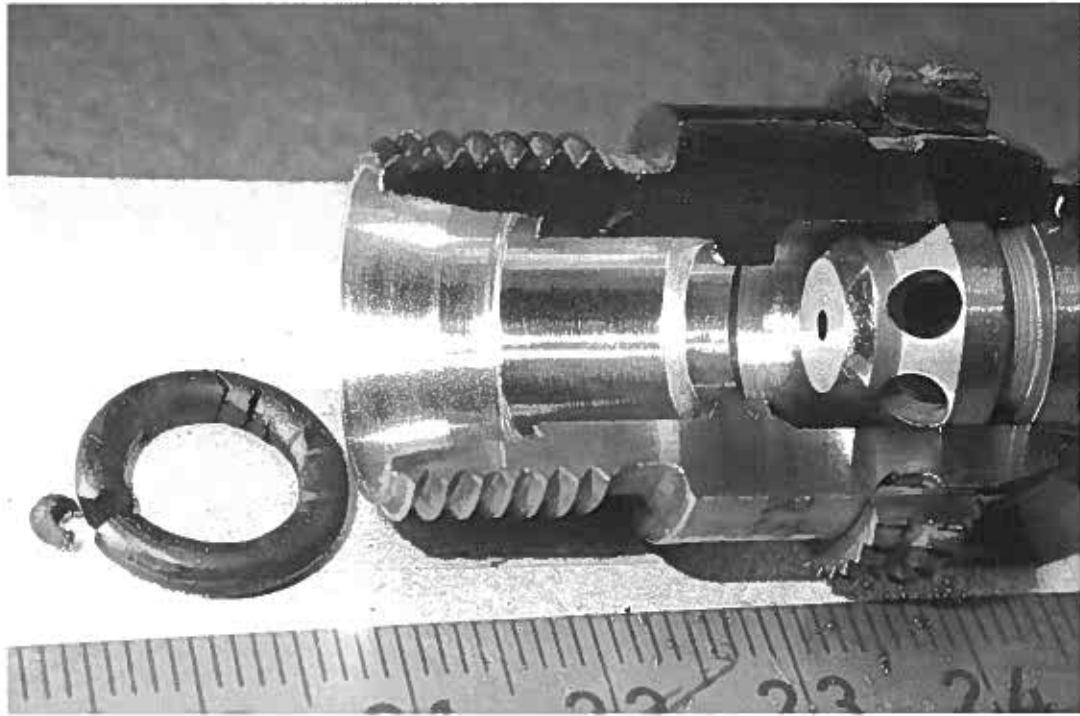
Figure 25 shows comparative sizes of the restrictor valve interior and captured O-ring. The O-ring cannot pass through either of the orifice holes. The only way it can end up where found is by travelling with the oil flow through the S port while the valve cone is open. It is not possible to determine whether the O-ring was intact but in our opinion, it arrived in one piece at least. As the valve cone closes the O-ring was caught between the valve cone and the housing. Consecutive opening and closing of the valve cone during retraction/extension of the main landing gear resulted in severe battering and chewing of the O-ring. It was partly punched through the flow relief holes in the cone and eventually some of the punch cuts resulted in division of the O-ring into 2 large and 2 small pieces. The stepwise growth of punch cuts is evidenced by the striation pattern visible in Figure 15. The smallest part of the divided O-ring was probably in the progress of being further subdivided when it made its way through one of the relief holes. Being captured in the cone interior between the two orifices the oil flow has caught the O-ring piece and forced it to block the orifice hole.

Figure 25: Comparative view of flow restrictor and O-ring.

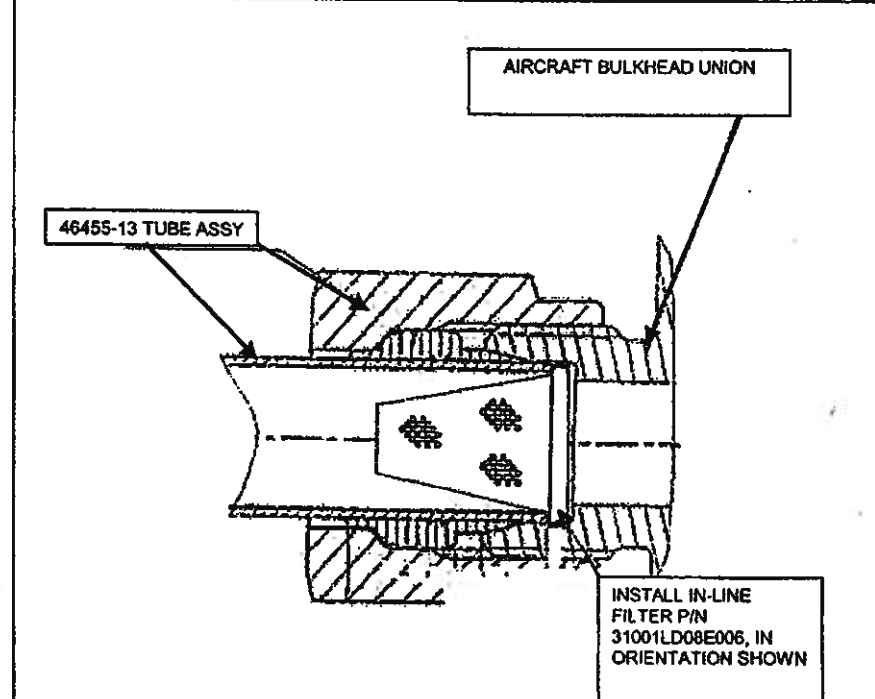
INSTRUCTIONS / CONTINUATION SHEET

ITEM	PROBLEM DESCRIPTION
1	<p>THE INTENT OF THIS SCR IS TO INTRODUCE AN IN-LINE FILTER / SCREEN TO THE MAIN LANDING GEAR HYDRAULIC SYSTEM. THIS WILL REDUCE THE POSSIBILITY OF LARGE PIECE/S OF FOD BECOMING LODGED IN ORIFICES WITHIN THE SYSTEM. THIS SCR IS APPLICABLE TO BOTH THE LEFT AND RIGHT SIDES OF THE AIRPLANE.</p> <p>THIS IS AN ADDITIONAL PRECAUTIONARY MEASURE WHICH HAS BEEN IMPLEMENTED BASED UPON PRELIMINARY FINDINGS REPORTED BY THE DAIB IN THEIR INVESTIGATION OF THE Q400 LANDING GEAR INCIDENT AT COPENHAGEN AIRPORT. OCTOBER 27/07.</p>
REPORTED CAUSE OF PROBLEM:	
ADDITIONAL INFORMATION ATTACHED <input type="checkbox"/>	
➤ SEE SHEET 2 AND SUBS FOR MORE INFORMATION ⚡	
Page 1 of 4

- Flush the hose ass'y (P/N 46455-13) with clean hydraulic fluid (Ref. AMM, Chapter 29).
- Inspect the tube and sealing surfaces for damage and rectify as necessary.
