**Accident Investigation Board
Denmark**

FINAL REPORT

HCLJ510-2011-43

Accident to De Havilland DHC 8-106
Registration TF-JMB
Nuuk Airport (BGGH), Greenland
The 4th of March 2011

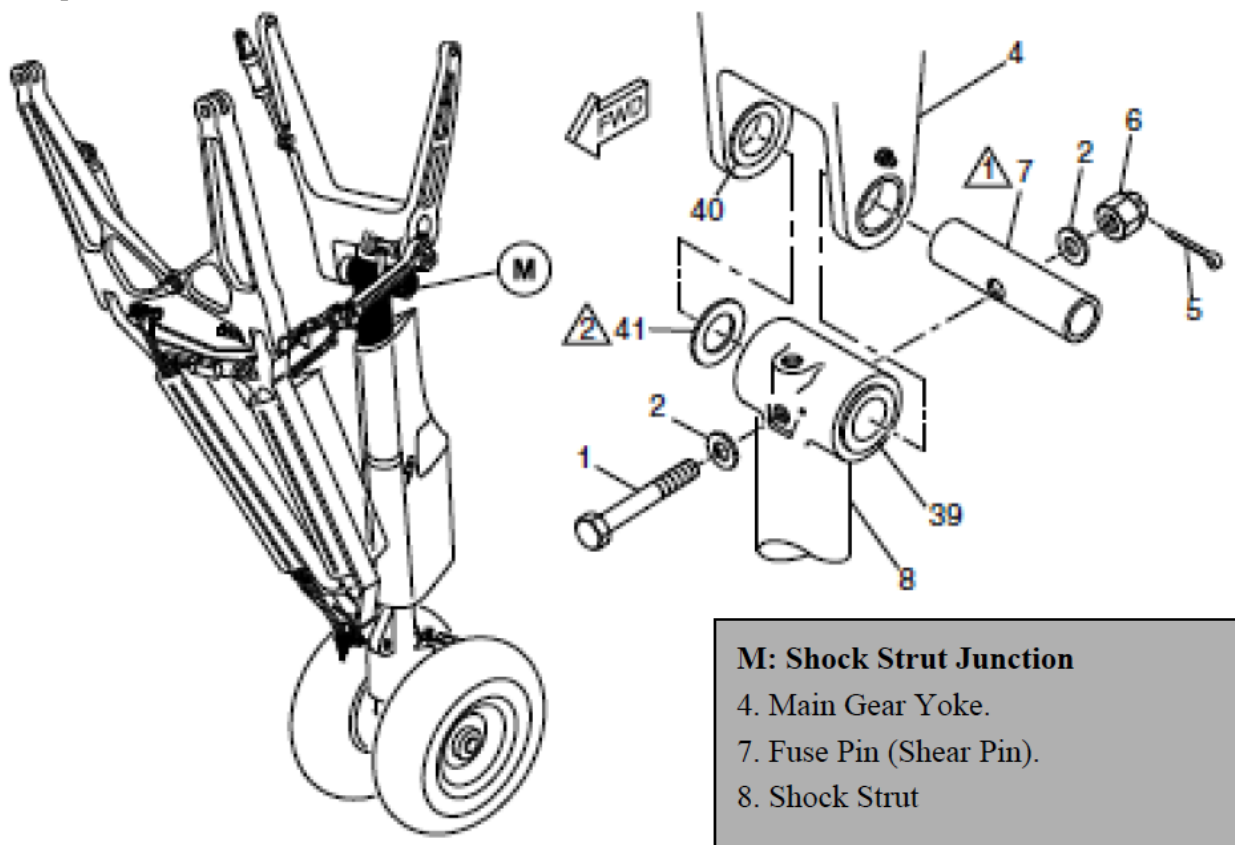
1.6.3.3 Main landing gear structural fuse pin p/n 10150-5

To prevent the gear from rupturing the fuel tanks inside the wing box during a rough landing, a fuse pin (shear pin) was installed at each main landing gear yoke to shock strut junction. This was to comply with JAR 25.721(a) and JAR 25.963(d). The purpose of those JAR requirements was to demonstrate adequate airframe strength (especially of the wing in the fuel tank zones) up until the instant where breakage of the fuse pin occurs.

The structural fuse pin was designed to shear if the aircraft touched down in level attitude at a rate of decent of more than 894 to 942 feet per minute – or if - the aircraft touched down in a tail down attitude at a rate of decent of more than 996 to 1029 feet per minute.

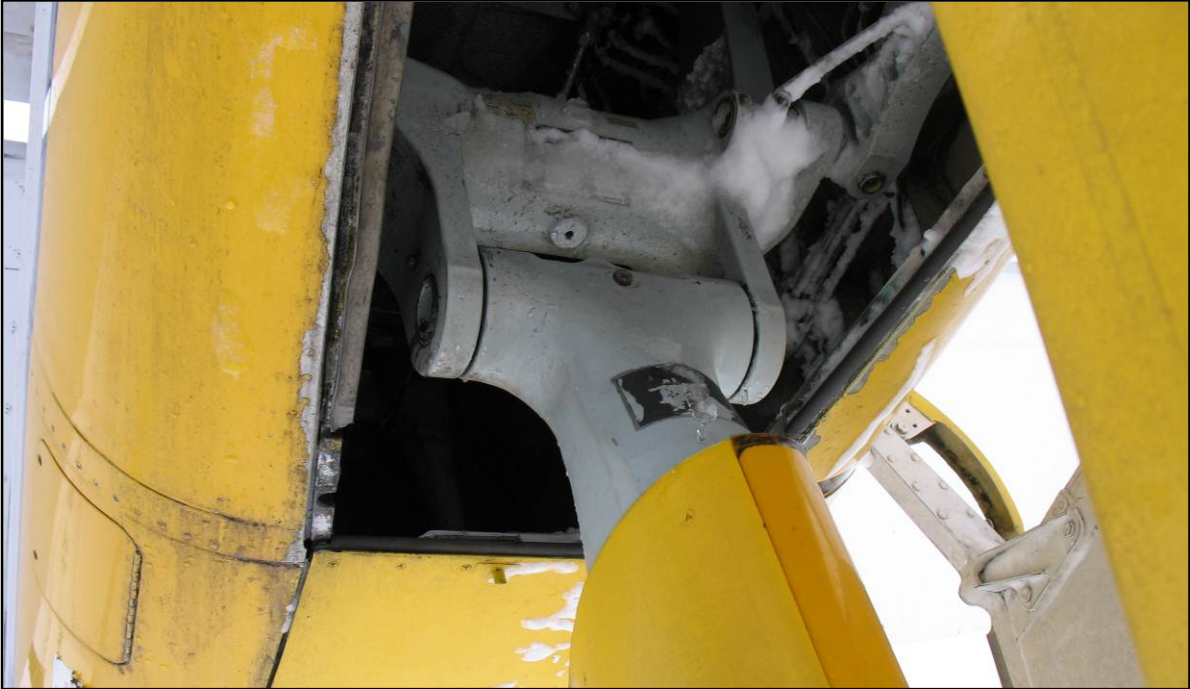
The undamaged left main landing gear – see below.

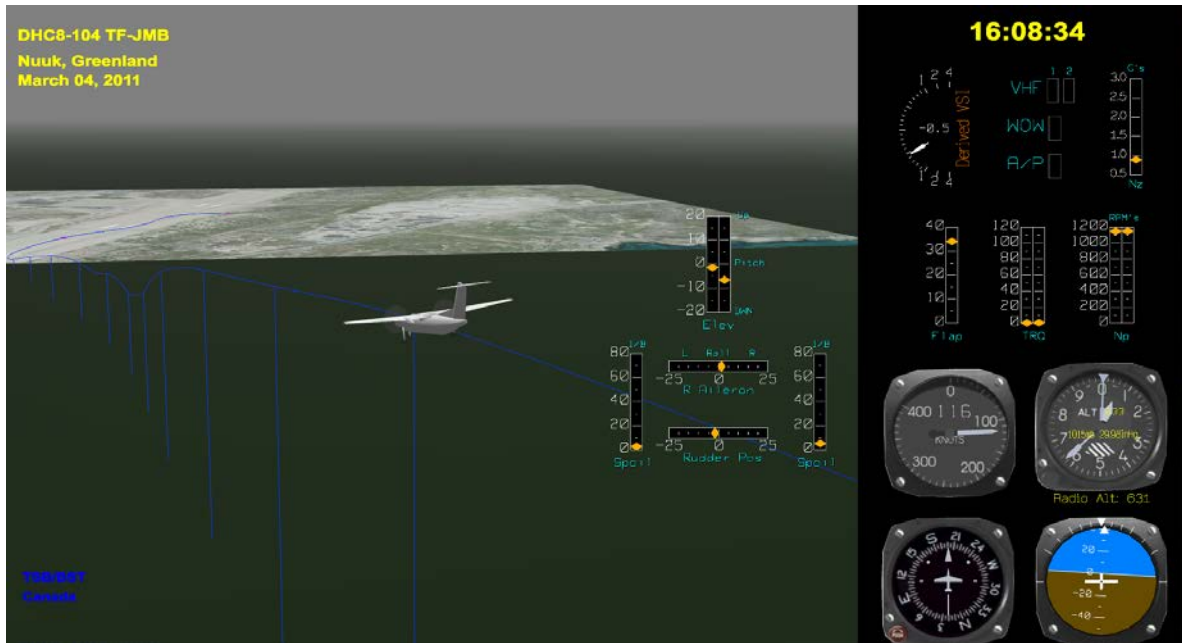
Time 16:08:34 – approximately 626 feet RA – flaps 35° set

The flaps were set at flap setting 35°.

During the flaps extension from flap setting 15° to flap setting 35°, the engine torque decreased from approximately 26% to 0% (idle power). The pitch attitude decreased to approximately -5° to -7° (nose down).

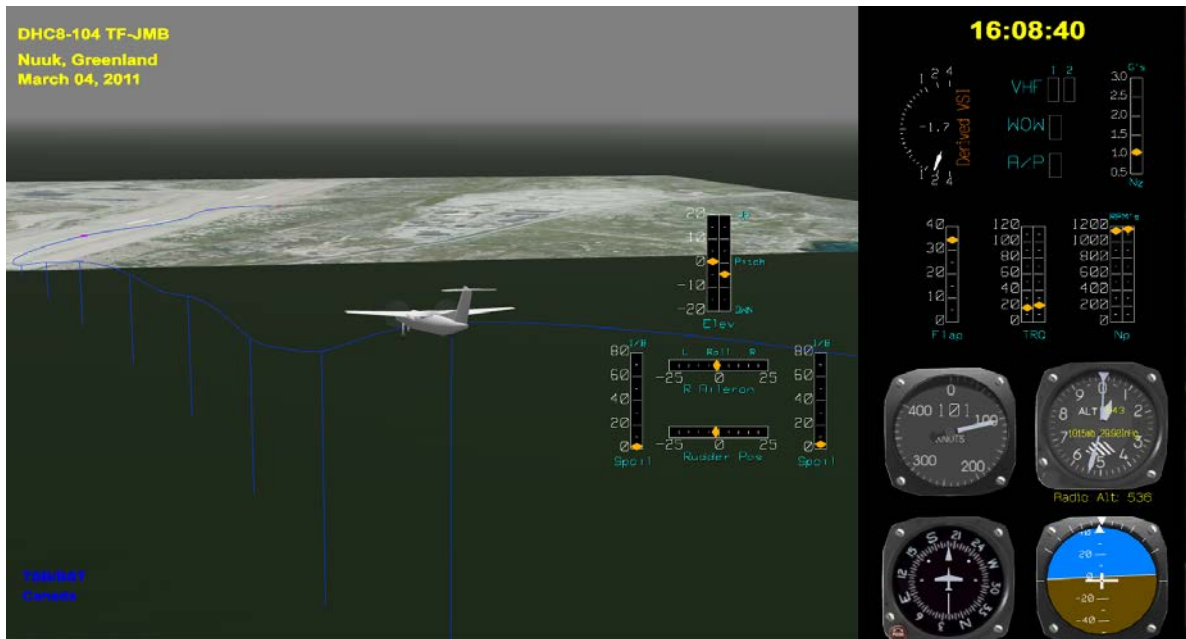
Time 16:08:40 – approximately 530 feet RA – airspeed 17 knots below Vtgt

The aircraft continued on a track towards the landing threshold runway 23 at an angle of 25° to 35°.

The Vtgt was 107 knots, and the actual CAS momentarily decreased to 90 knots.

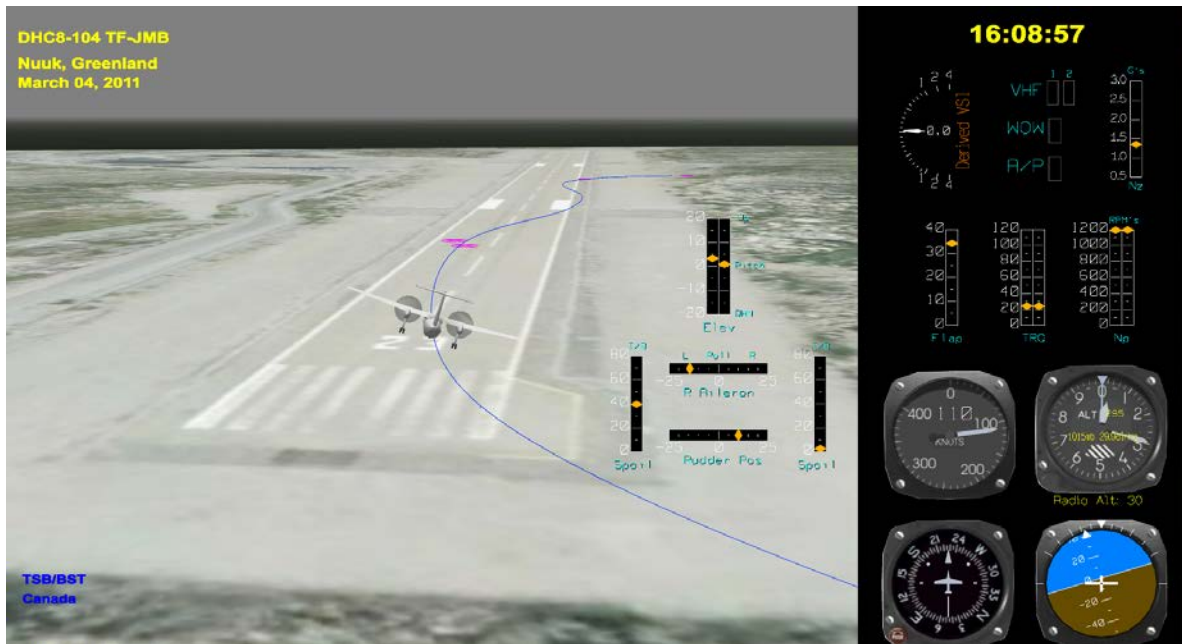
Time 16:08:57 – 30 feet above the runway – banking 18° to the right

The aircraft was banking up to 18.3° to the right but it was drifting to the left. The aircraft overshot the runway centerline to the left. The engine torque was around 24% and was about to be reduced. The RA decreased from 37.8 feet to 24.4 feet or 13.4 feet in one second (804 fpm).

The pitch attitude decreased from the previous -3° to -4° (nose down) to -5.8° (nose down).

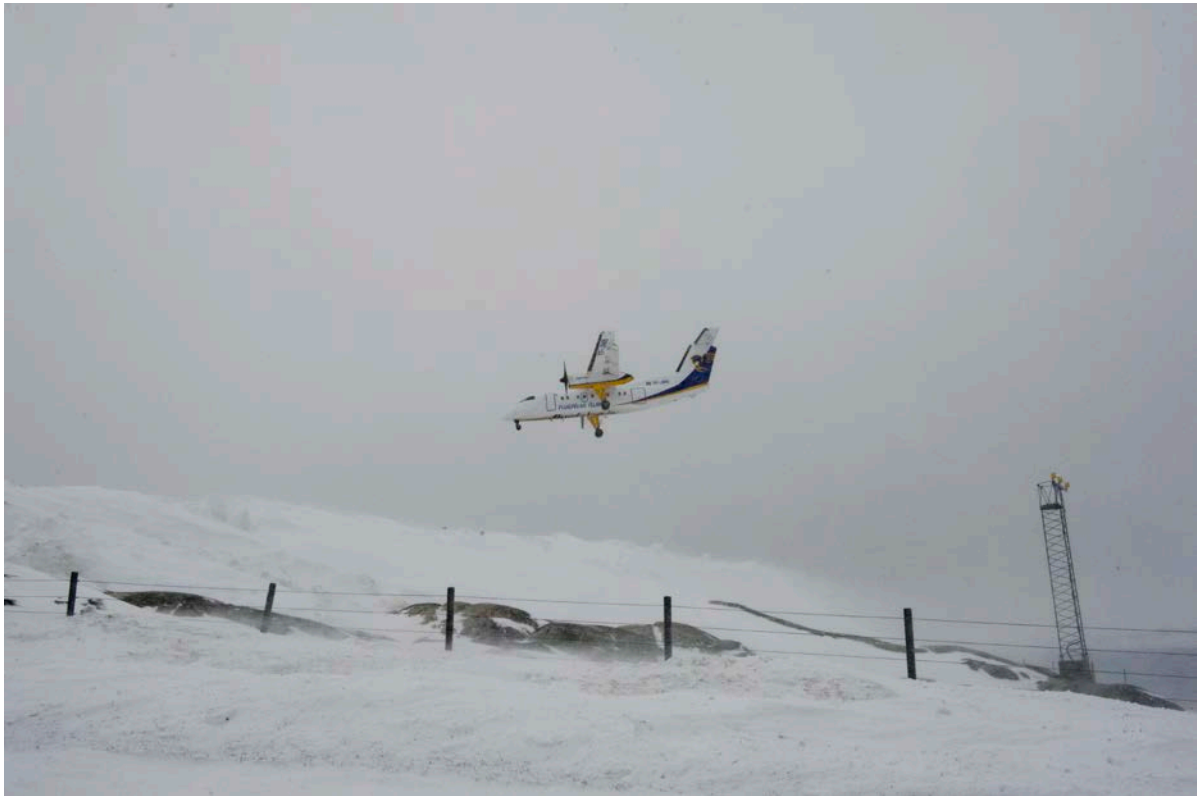
The aircraft had passed the runway threshold and descended through 30 feet above runway 23.

The picture was taken near the road to the left of runway 23 while the aircraft approached the landing threshold.

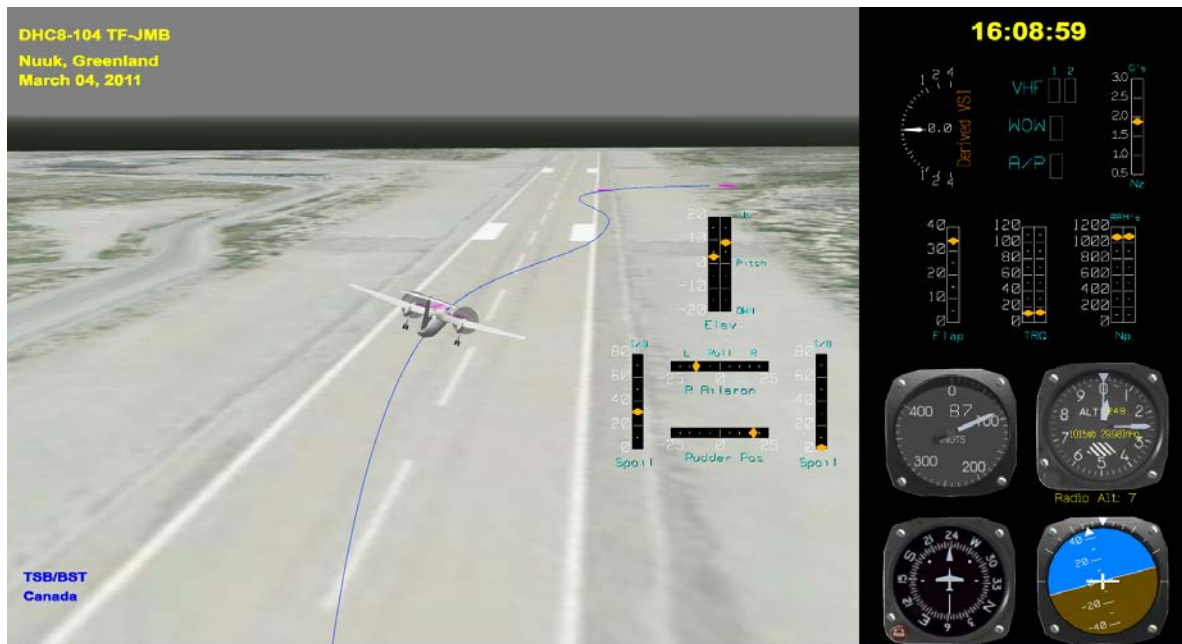
Time 16:08:59 – the flare

An excess load of the right MLG at touchdown caused the fuse pin to shear as a result of overload and consequently, the right MLG collapsed.

The aircraft was in the landing flare. The aircraft was still banking up to 17.9° to the right and the drift to the left had stopped. The aircraft was left of the runway centerline.

The right MLG fuse pin sheared and consequently, the right MLG collapsed.
