# Limfjord tunnel Assessment and retrofitting

Technical Summary Report, Version 1.0

Date 25. juni 2019

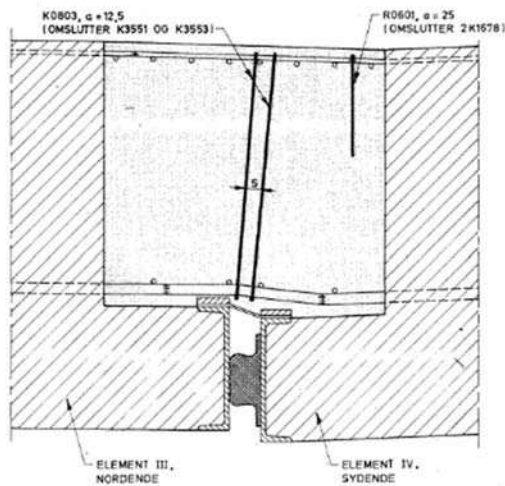
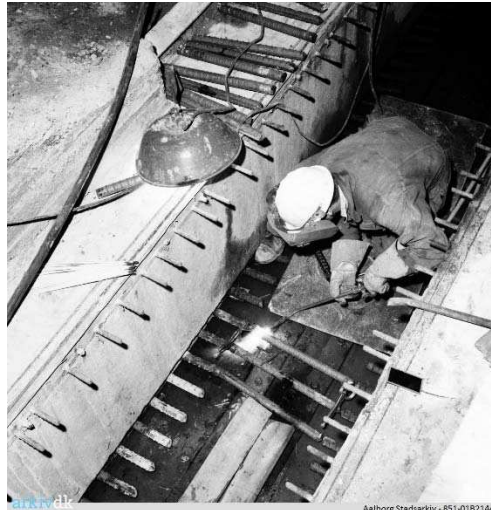
Figure 4.3-8 Immersion joint. The joint shown is between elements III and IV where additional reinforcement was installed due to the not perfect alignment.

The joints created a monolithic tunnel structure from the cast-in-situ tunnel to the northern portal building. Available information indicate that the immersion joints have all been successful as in general no water leakages have been reported in connection to the joints.

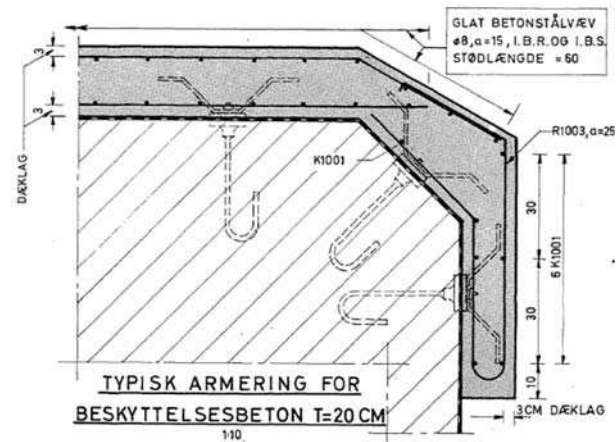
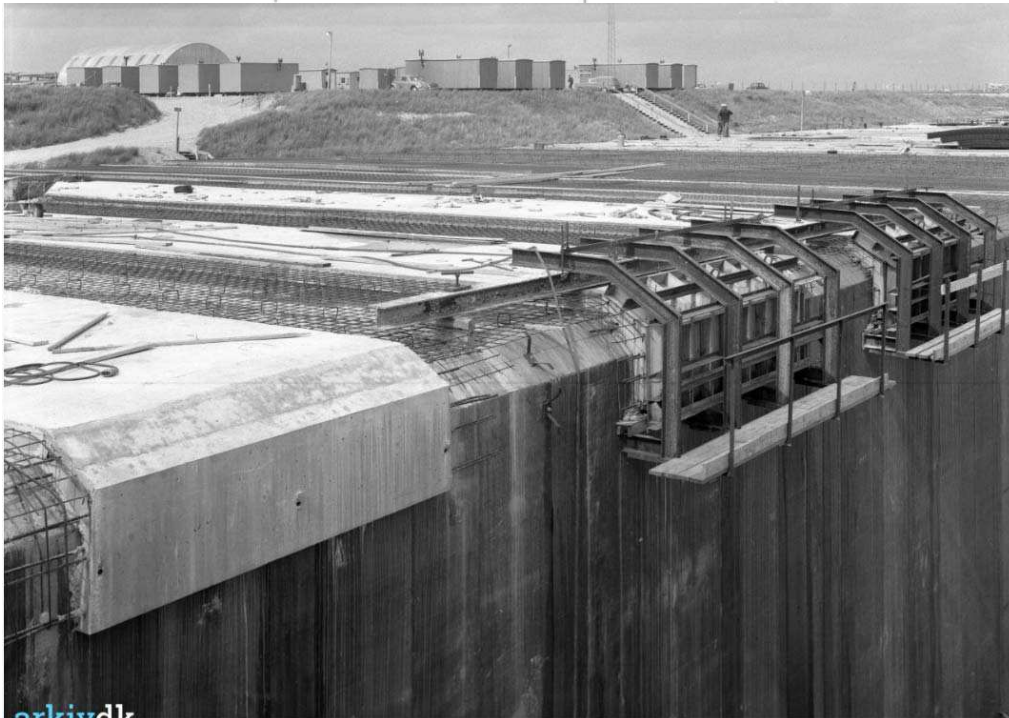
Figure 4.3-11 Protection of membrane at the top side including the top corner of tunnel elements (Dimensions are shown in cm).

On the sides of the tunnel elements there was no protection and available information indicates that already during transport and immersion some damages occurred on the unprotected membranes on tunnel sides. Further it has been indicated that the adhesion of the membrane to the structures was not perfect.

It is a fact that the membrane failed to create the watertight structure as was intended.

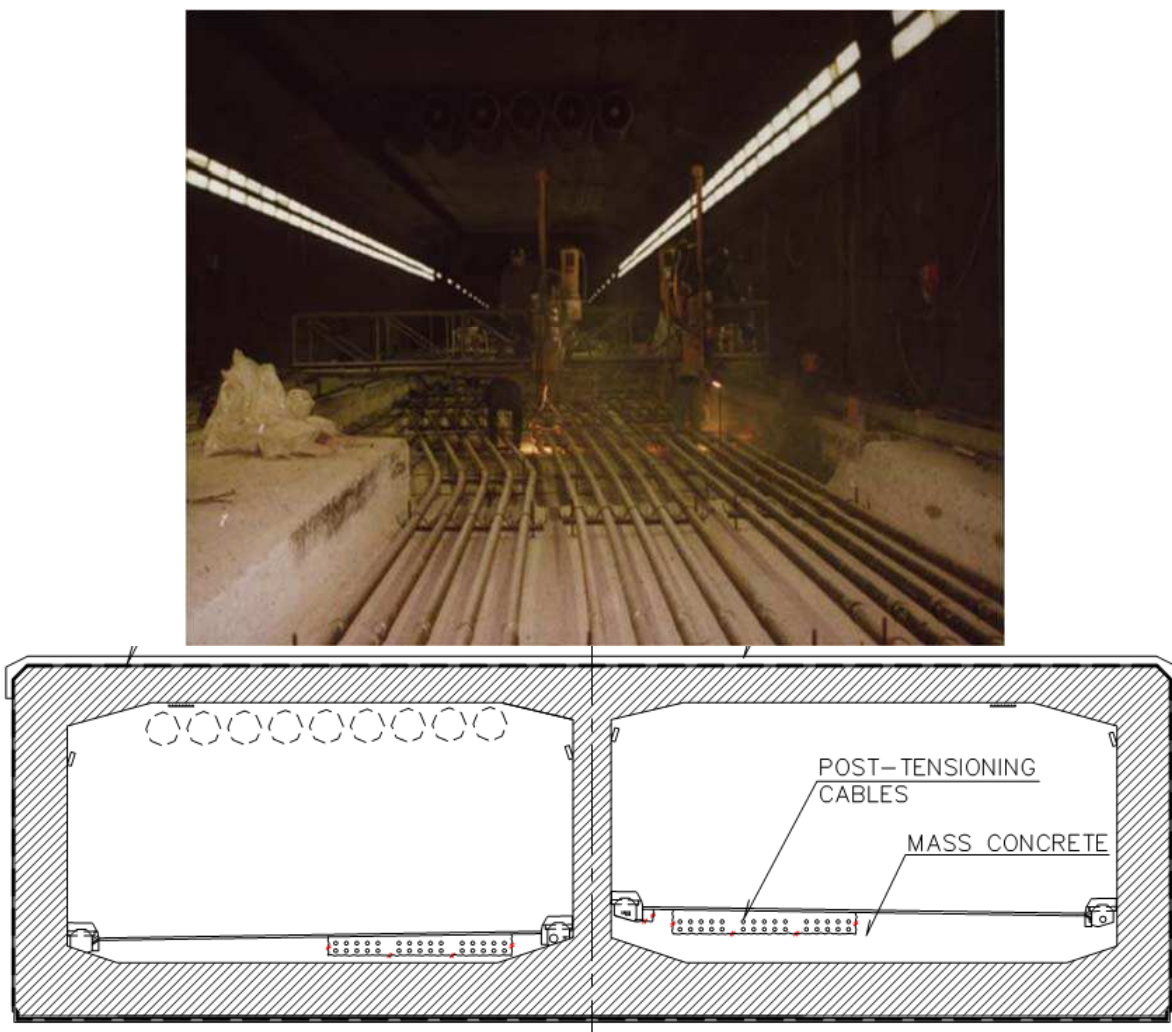
**Figure 4.5-2 Typical cross section with post tensioning cables installed in ballast concrete in 1993 – 1994.**

The tensioning of the tunnel with post tensioning cables installed in the ballast concrete in 1993-94 was carried out with the purpose to reduce the longitudinal tensile stresses and close through going cracks and thereby limit/stop water leakage. The Ultimate Limit State (ULS) structural capacity in the longitudinal direction was increased due to the additional post tensioning cables and thereby increasing the robustness of the tunnel. The location of the post tensioning cables is shown on [Figure 4.5-2](#).

The deformations of the tunnel due to the seasonal temperature variations resulted, before the tensioning of the tunnel cross section, in a slow increase of the tunnel length corresponding to approximately 1 mm per year. After the installation of the cables in 1993 – 1994 the yearly increase in length has in general been stopped.

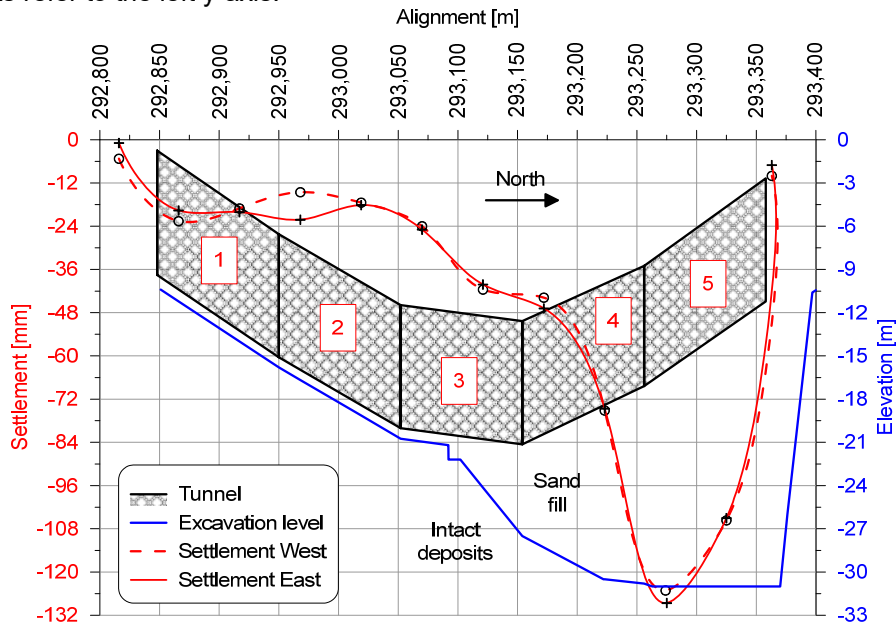
Figure 5.1-1 Tunnel elements along the alignment together with lower boundary for infilled sand.

- The location of tunnel elements along the alignment. The elevation of the tunnel elements refers to the right y-axis.
- The excavation level to which Gytija was removed and replaced by sand fill.
- Observed settlements per December 2017 are also included for both tubes. The measurements refer to the left y-axis.

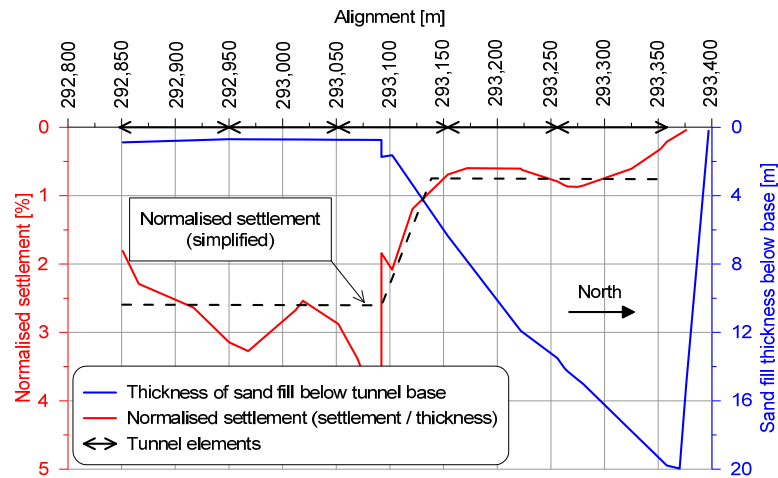
Figure 5.1-2: Thickness of sand fill below tunnel base and normalised settlement of tunnel as per December 2017.

Figure 5.1-2 is based on Figure 5.1-1. The blue curve represents the thickness of sand fill below the tunnel base (right y-axis), while the normalised settlements (red curve, left y-axis) represents the measured settlements from Figure 5.1-1 divided by the thickness of the sand fill.

Figure 5.1-2 shows that the normalised settlements are almost constant along the part of the tunnel being placed on sand fill, and this observation served as the working thesis for the geotechnical expert group during the project period.

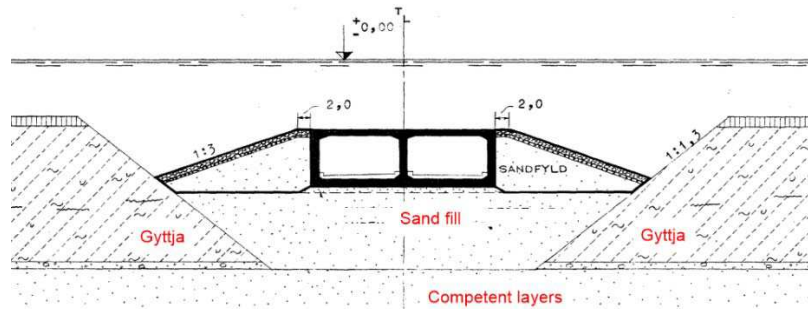
- The creep behaviour will likely be amplified as the Gytija below the sand fill adjacent to the tunnel, cf. Figure 5.1-3, will continue to consolidate in in the long term (50 years or more) causing the sand around the tunnel to continue to settle.

Figure 5.1-3 Cross-section of back-filled tunnel.

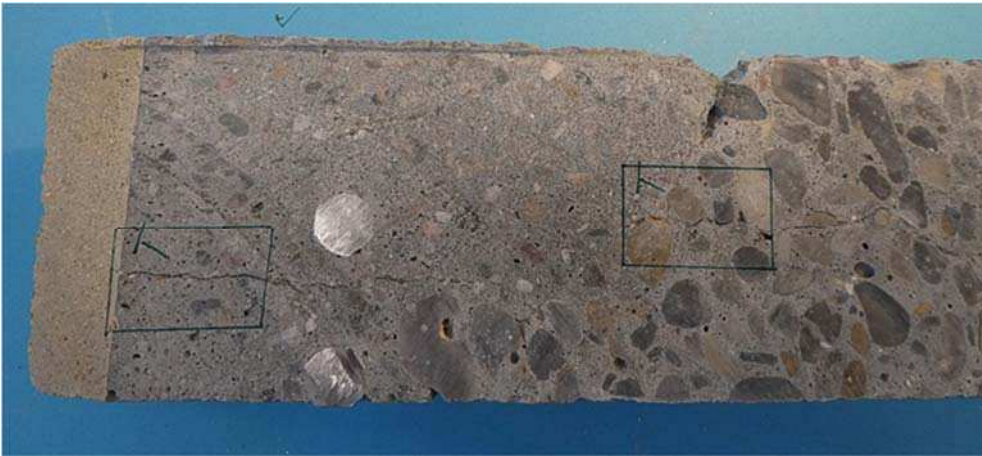
Figure 6.1-1 A concrete core from the roof has been cut in half in order to prepare for extraction of two thin sections (T).

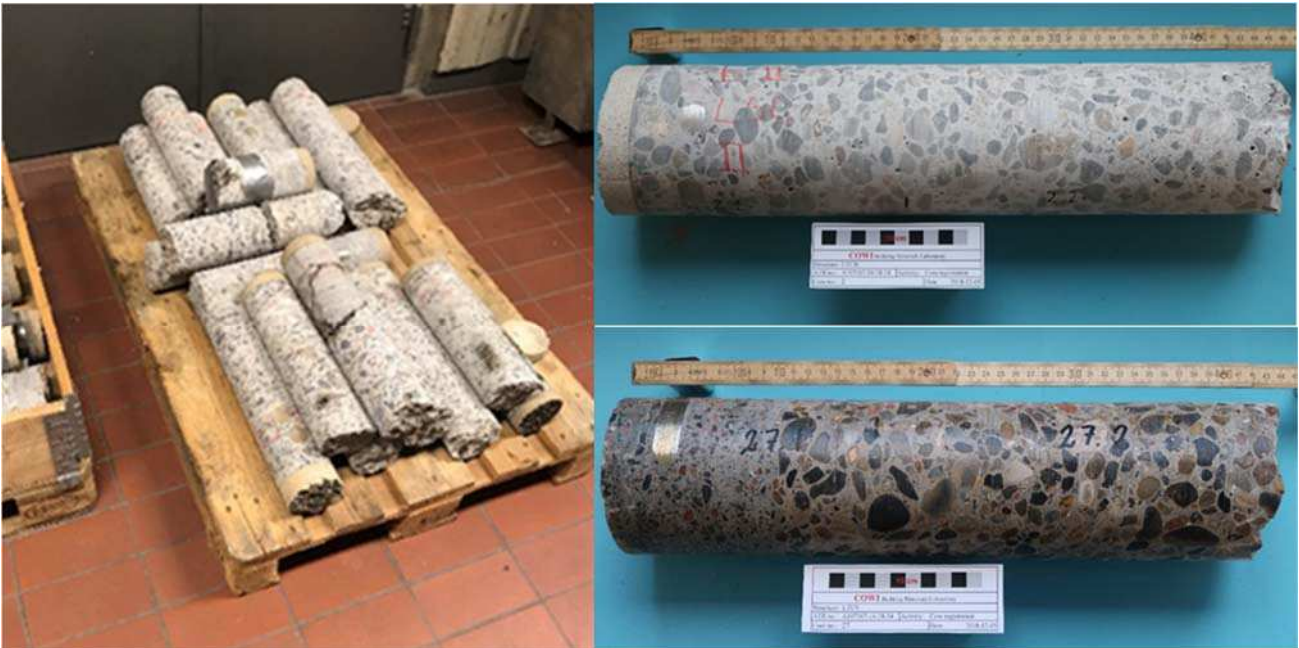
Figure 6.1-2 Cores extracted from wall (cores without fire protection) and roof (cores with fire proofing).

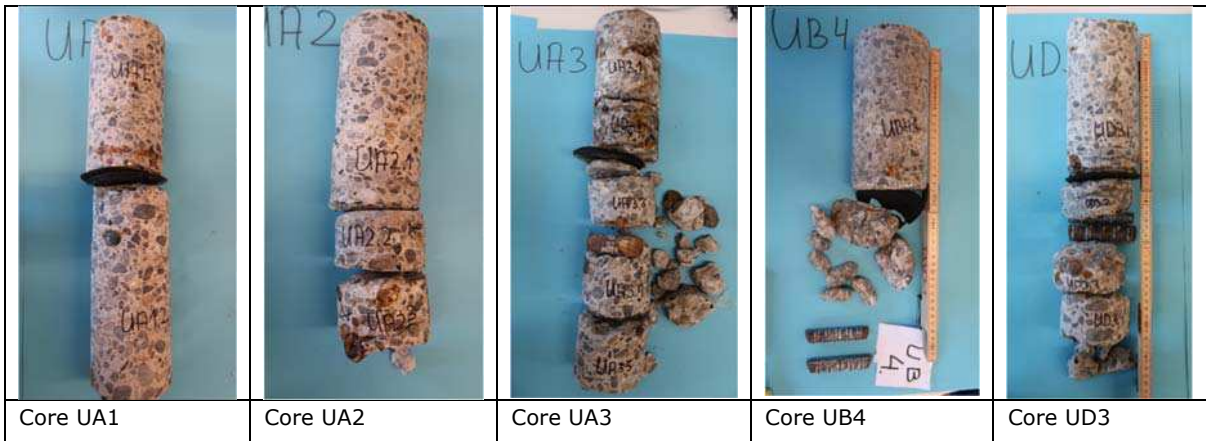
Figure 6.3-1 indicates that it was not possible to collect intact cores, which is assessed to be related to the difficult coring conditions and not the concrete quality. Generally, the protective concrete is seen at the top of the cores while the structural concrete is seen at bottom of the cores. The membrane can be seen between the two concrete layers in four of the five cores.

Protective concrete layer: The concrete generally consists of materials of good quality. Some alkali silica reactive particles have been observed but no damaging reactions have been observed.

The chloride content of the concrete is higher than 0,3 % chloride (by weight of concrete) throughout the layer. The rebars do not show any significant signs of corrosion despite the high chloride content. This is most probably due to lack of oxygen. Pitting corrosion cannot be excluded, but no signs have been observed. Generally, the risk of pitting corrosion is assessed to be low.

Figure 6.3-1 The five cores taken from the outside of the Limfjord Tunnel. The cores were taken from three different areas UA, UB and UD.

Waterproofing membrane: No signs of adhesion to either the underlying structural concrete or the protective concrete above have been observed. The membrane appears intact but has no to limited adhesion between the individual membrane layers.

Structural concrete layer: The concrete generally consists of materials of good quality, but some reactive particles have been observed. Some ASR-gel is present in cracks and voids, but no damaging reactions have been observed.

The chloride content appears high (between 0,16 and 0,78 % by weight of concrete) near the exposed surface (membrane side). A chloride content above the threshold value (0,1 % by concrete weight) is seen at reinforcement level. The rebars do not show any significant signs of corrosion despite the high chloride content. This may be due to lack of oxygen. Pitting corrosion cannot be excluded, but no signs have been observed.

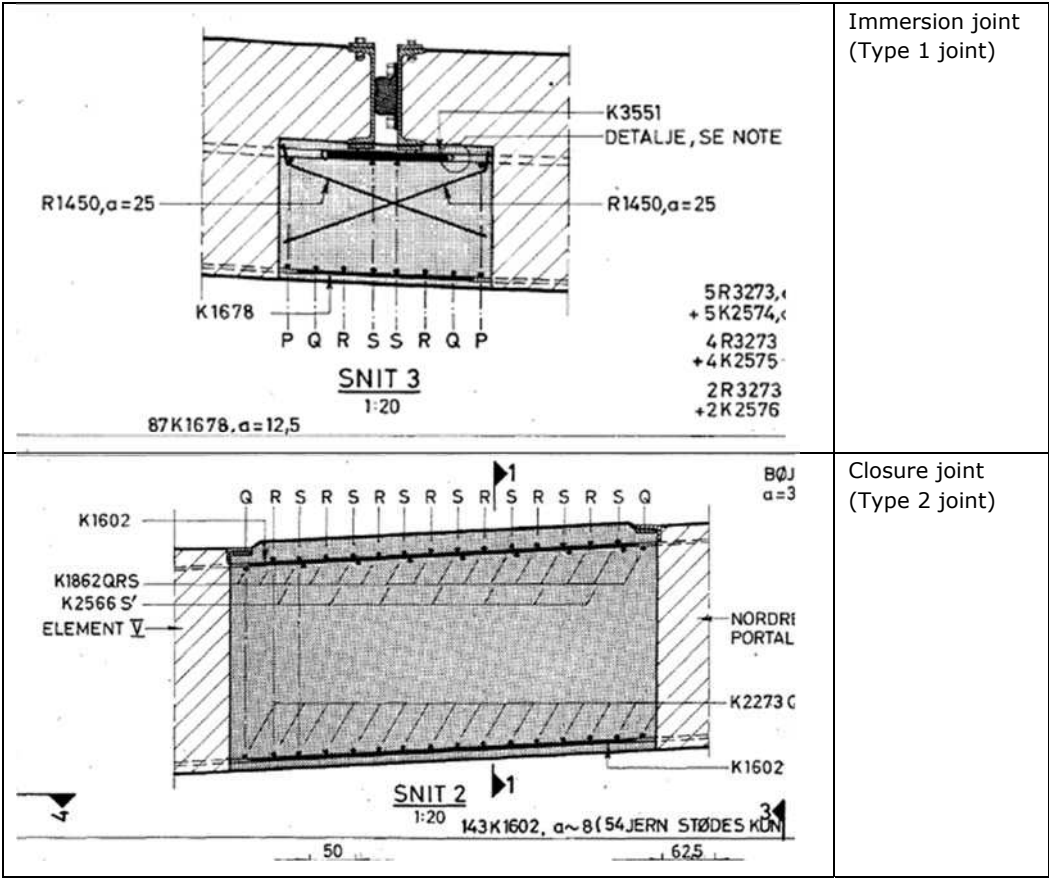
The immersion joints and closure joint have been given special attention. The main concern has been the condition of the welded connections that secures the transfer of forces in the horizontal reinforcement through the five normal immersion joints and the special closure joint between element V and the in-situ build part of the northern portal structure. The layout of the two types of joint is shown in [Figure 6.7-2](#).

Figure 6.7-2 Layout of immersion joints and closure joint.

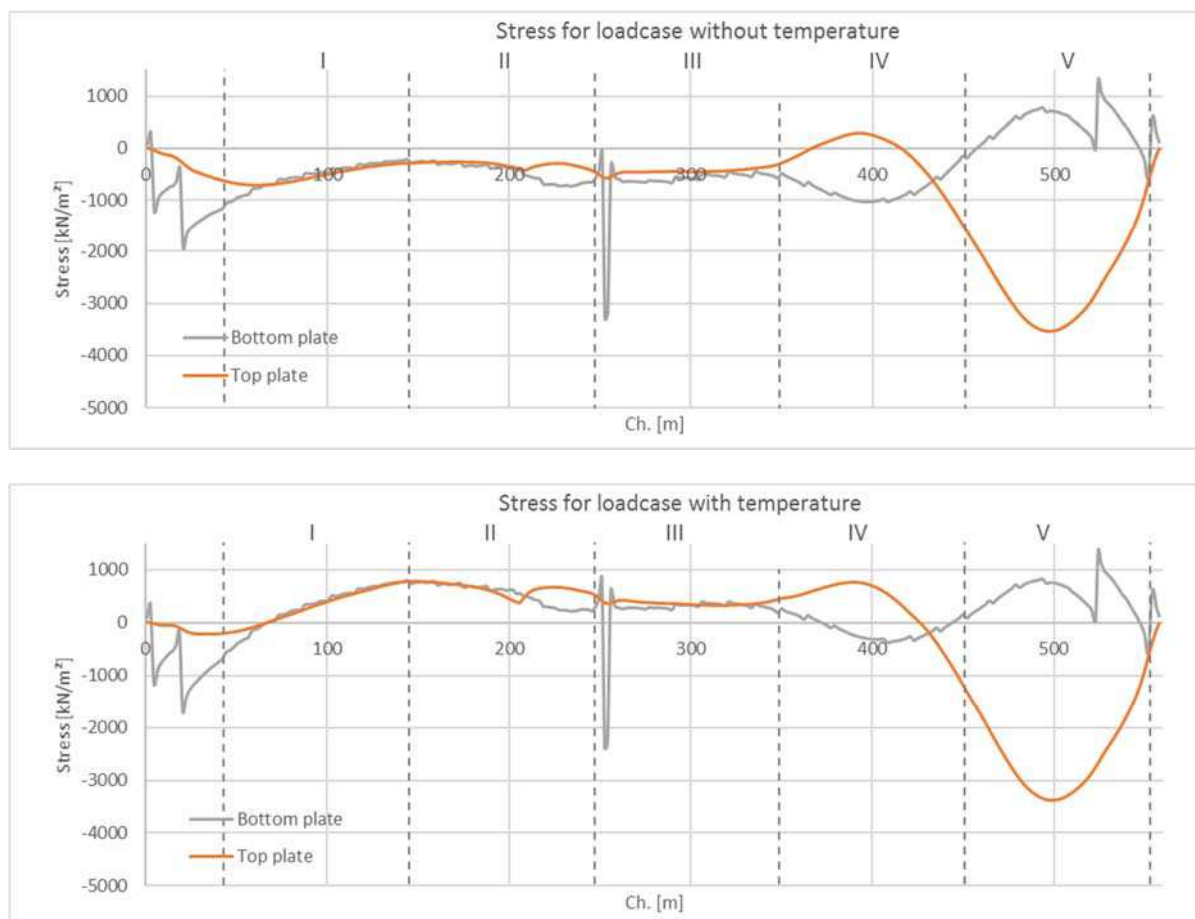
The peak stresses for tunnel element IV and V clearly reflect the significant sagging and hogging moments caused by the settlements. The discontinuous curve for the bottom slab reflects the locations where the post-tensioning forces are applied (anchorage points).

Figure 7.4-2 Model 1, Base model (year 2017). Concrete stresses in top and bottom slab, upper figure without temperature, lower figure with temperature. Alignment 0 is located at the southern expansion joint corresponding to the global alignment 292.805.

It is also clearly seen how the temperature contribution (contraction) increases the tensile stresses significantly and brings the main part of top slab / roof into tension, although post-tensioning has been installed. This means that post-tensioning is not fully efficient with regards to closing the cracks and keeping the cross-sections permanently under compression. Hence, the water is still able to penetrate the existing cracks caused by early age thermal effect / shrinkage and further developed by axial tension from temperature effects before prestressing was applied. That is why leakages are still seen every year, although the tensile stresses are generally lower than the tensile strength. In other words, the cross-sections are not able to satisfy the crack width criteria to ensure a watertight structure (SLS).

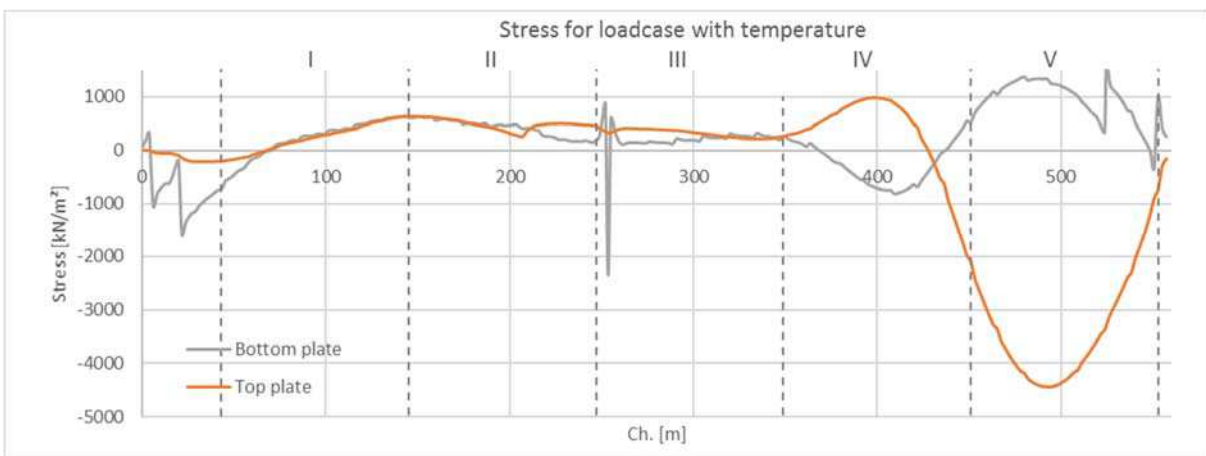
Figure 7.4-3 Model 4, Future scenario (year 2069), increased settlements, Stresses in top and bottom slab including temperature

In Figure 7.4-3 the similar stresses are shown for the future situation in year 2069 with increased settlements. Obviously, the tensile stresses both in the top slab and the bottom slab are increased, but the corresponding reinforcement stresses are well below the design yielding strength when applying safety factors in Ultimate Limit State (ULS). However, with regards to leakages, an increase might be expected in the future because of an increase of the tensile stresses mainly in tunnel element IV and V.

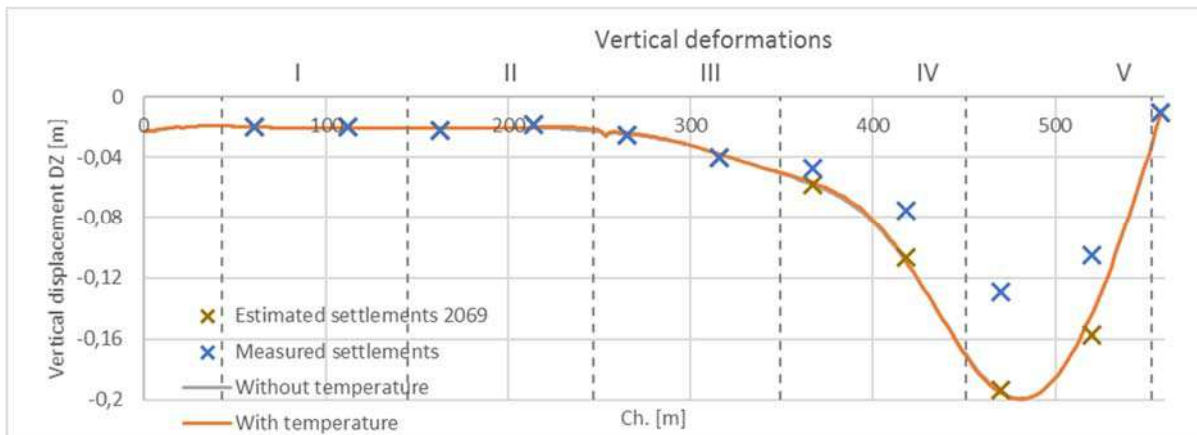
The future scenario of differential settlements shown on Figure 7.4-4 is based on a conservative extrapolation of the current settlements with increase of approx. 60 mm (at point of max) in the next 50 years. An additional 30 mm is added in the verifications, see Section 7.4.6.

Figure 7.4-4 Model 4, Future scenario (year 2069), increased settlements

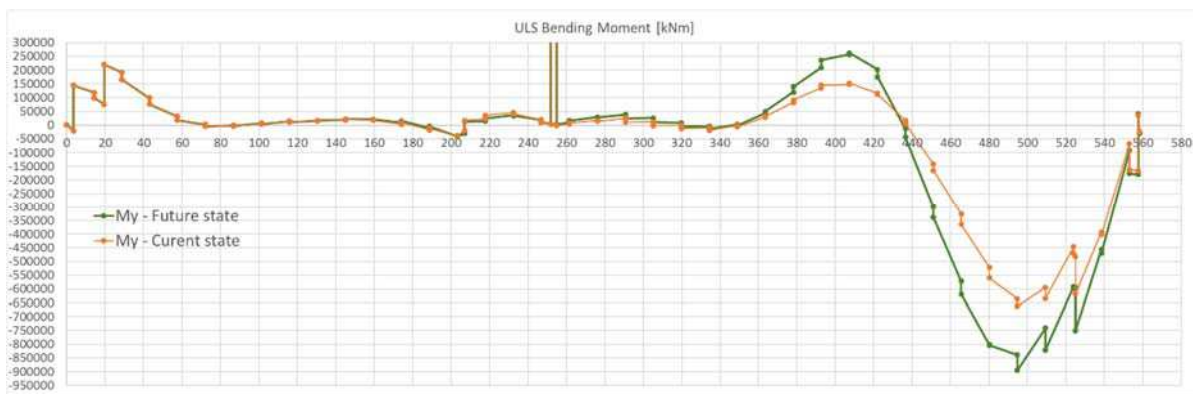
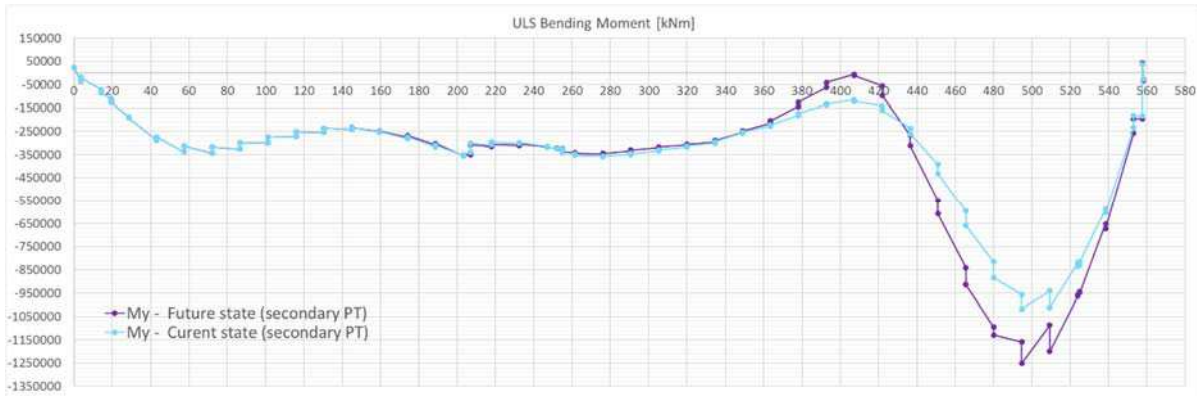
The design bending moment diagrams are shown in [Figure 7.4-5](#) and [Figure 7.4-6](#) for both the future and current state. The difference between the diagrams in the two figures is the first one considers the post-tensioning on the load effect side only, while the other one considers only the secondary effects of post-tensioning on load effect side. The most critical of the values from the two figures have been used for calculating the utilization ratios.

The bending moment capacities have been calculated assuming fully embedded prestressing cables, which is actually not the case. The cables are only structurally connected to the tunnel in the anchorage zones and where the deviators are placed. Therefore, reduced bending capacities corresponding to the yield strength ( $f_{p0,1k}$ ) have been calculated as well, see [Table 7.4-1](#). And the utilization ratios are determined based on the latter. For more details reference is made to Appendix 3 of Longitudinal indicative analyses [9].

Figure 7.4-5 Bending moment in longitudinal direction, ULS combination values (total PT), current and 2069 state

Figure 7.4-6 Bending moment in longitudinal direction, ULS combination values (Secondary PT), current and 2069 state

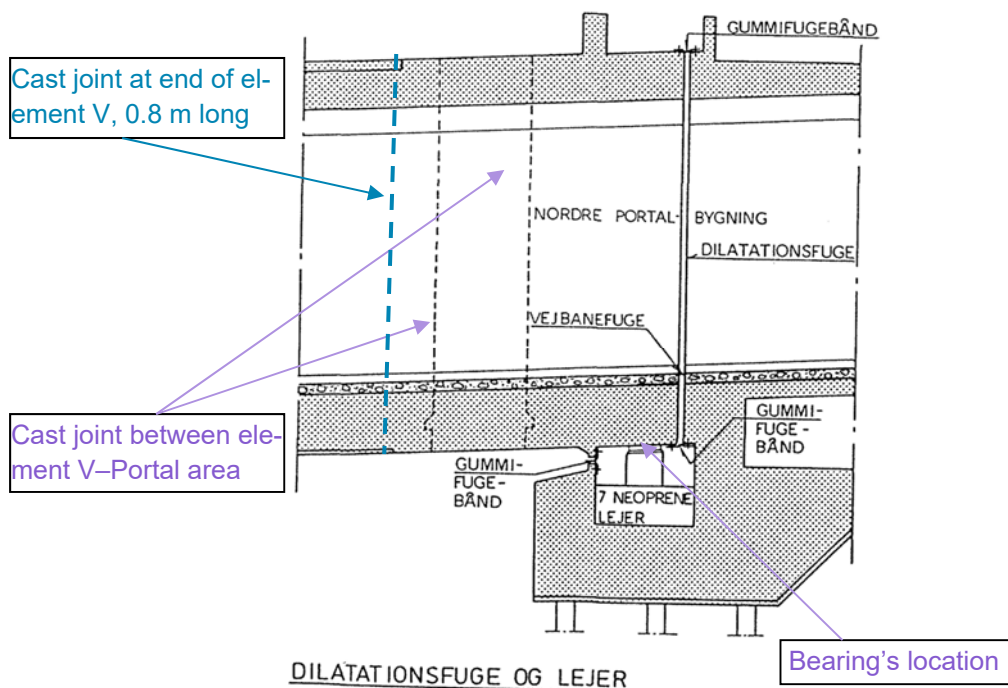
The utilization ratios for the shear capacity verifications for construction joints are shown in Table 7.4-2. The most critical vertical construction joint with regards to shear capacity is the closure joint type 2 connecting tunnel element V and the last part of the tunnel that was constructed together with northern portal building, see Figure 7.4-7. For more details, reference is made to section 6 in Appendix 3 of Longitudinal indicative analyses [9].

Figure 7.4-7 Geometry of northern end of the tunnel (Closure Joint type 2)

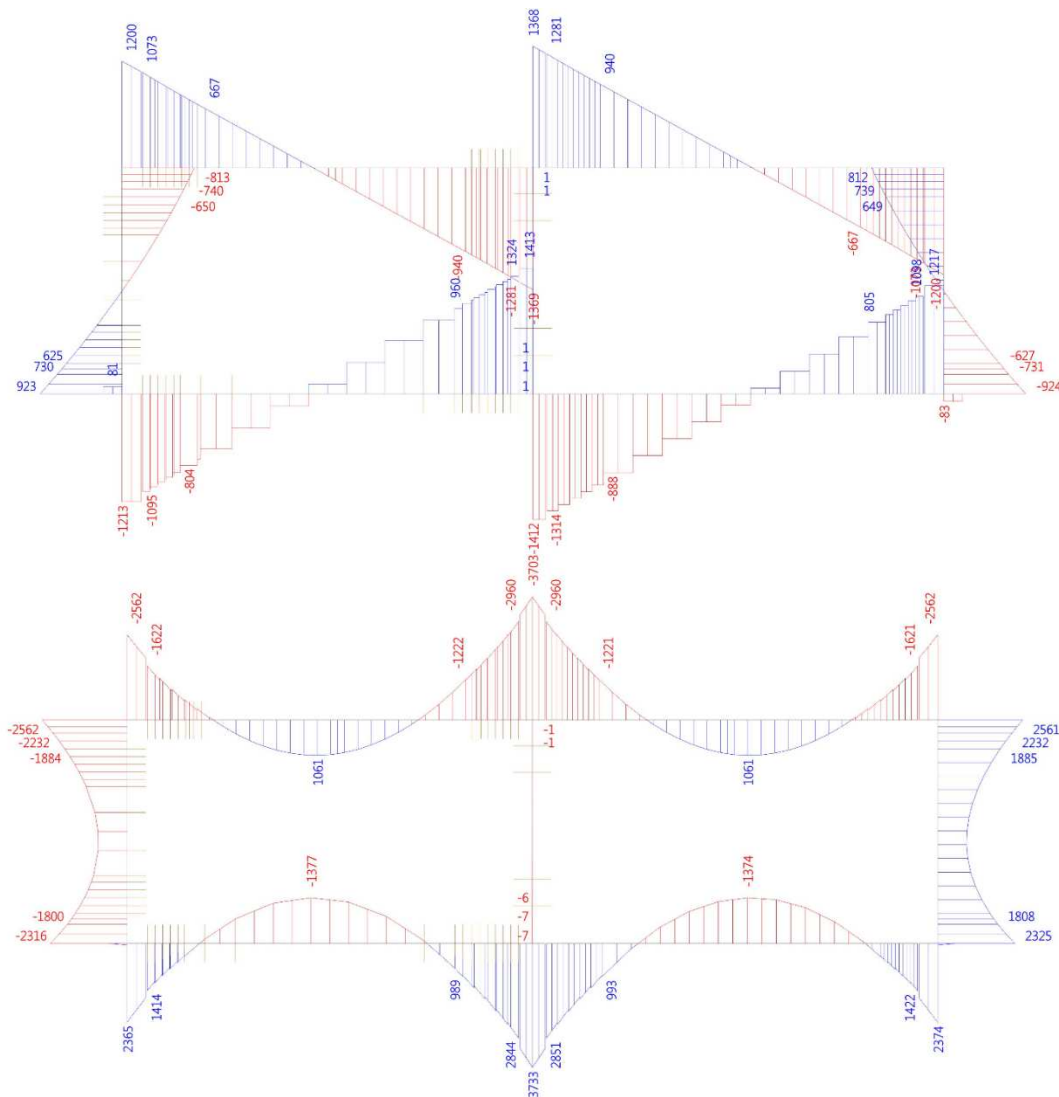
The shear and bending moment diagrams for ultimate limit state, ULS, are shown for the most critical section (293060) in [Figure 7.5-3](#). The location of the section is shown on [Figure 7.5-1](#).

**Figure 7.5-3** Shear force and bending moment diagrams, ULS, section 293060

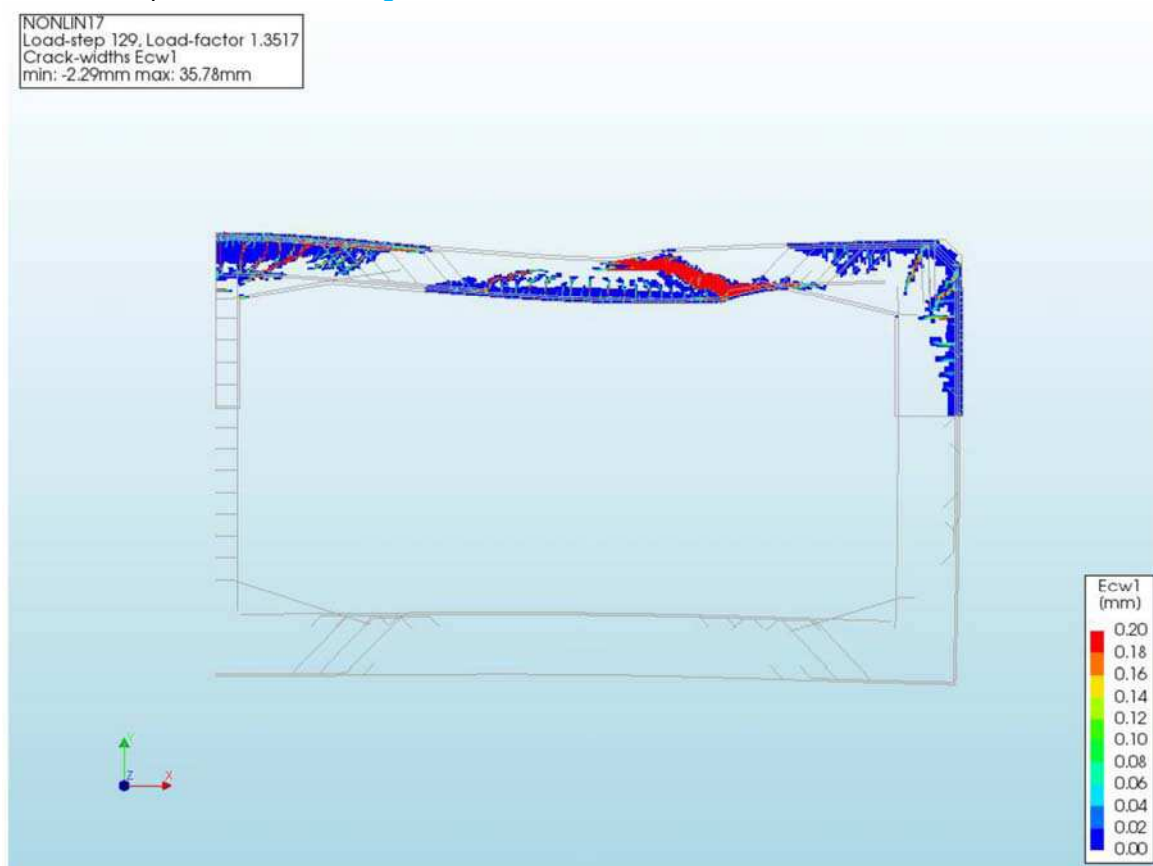
The analyses have been carried out after the material models have been validated based upon back analysis of real experiments and after sufficient testing the FE model for the tunnel cross section. For the Base Case the load factor is calculated to 1,35. This is in fact additional to the Ultimate Limit State and actually represents a “safety level” of  $1,38 \times 1,35 = 1,86$ . The corresponding crack patterns and deformation plot are shown in Figure 7.5-7.

Figure 7.5-7 Base case. Crack patterns at max load level

It is seen that the critical section is close to the outer wall, where the haunched section and bent-up rebars start, and not as expected from the previous calculations the non-shear reinforced sections closest to the central wall. It should be noted though, that the crack patterns indicate that this section is close to be critical as well.

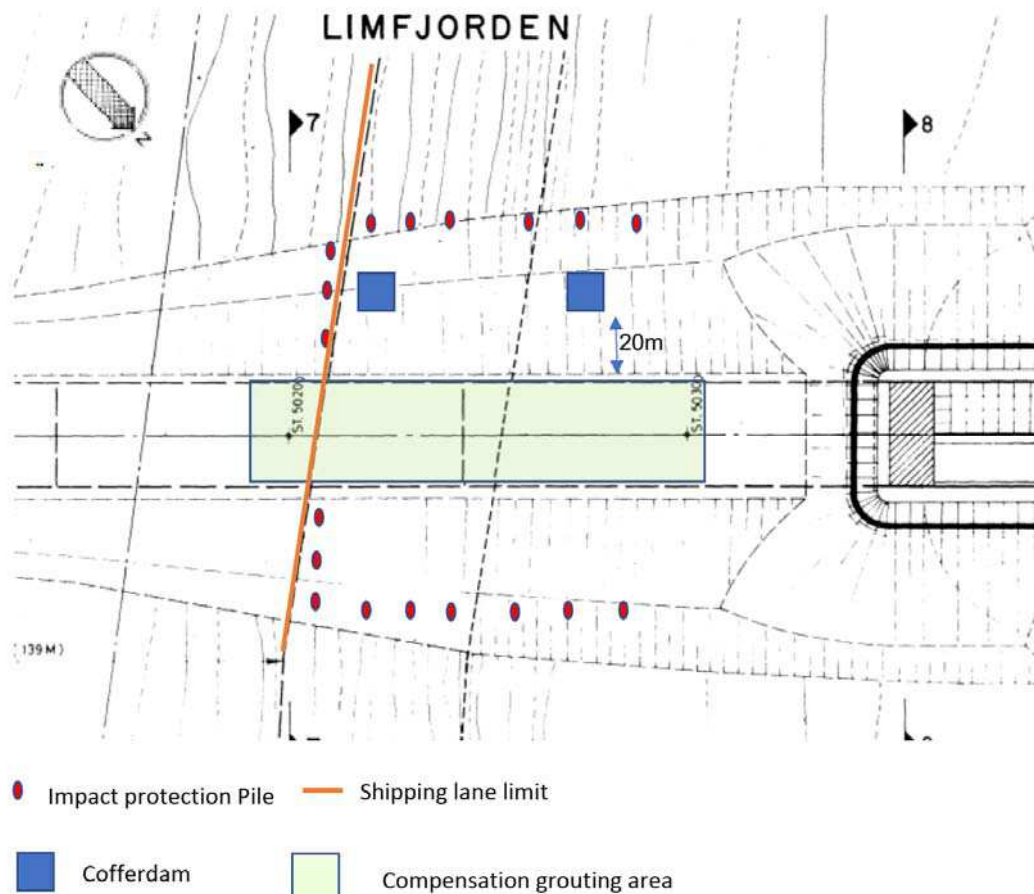
Figure 9.2-1 Indicative plan showing cofferdams and ship protection piles.

Control of the grouting can be very selective inducing very small level changes of varying amounts to reduce the risk of inducing further stress in the tunnel structure. The compensation grouting treatment would be installed from the midpoint of element IV to approximately 25m from the Northern Portal (i.e. 125m long over the full width over the tunnel) as shown in [Figure 9.2-1](#) and [Figure 9.2-2](#).

3. Installing ship impact protection piles to provide protection to the cofferdams during the grouting process. See [Figure 9.2-1](#)
4. Installing two levels of horizontal grout injection tubes to a pre-determined pattern under the structure. See [Figure 9.2-2](#) and [Figure 9.2-3](#). The drilling techniques to be adopted will address the high water pressures and poor ground conditions that will be present at this level.

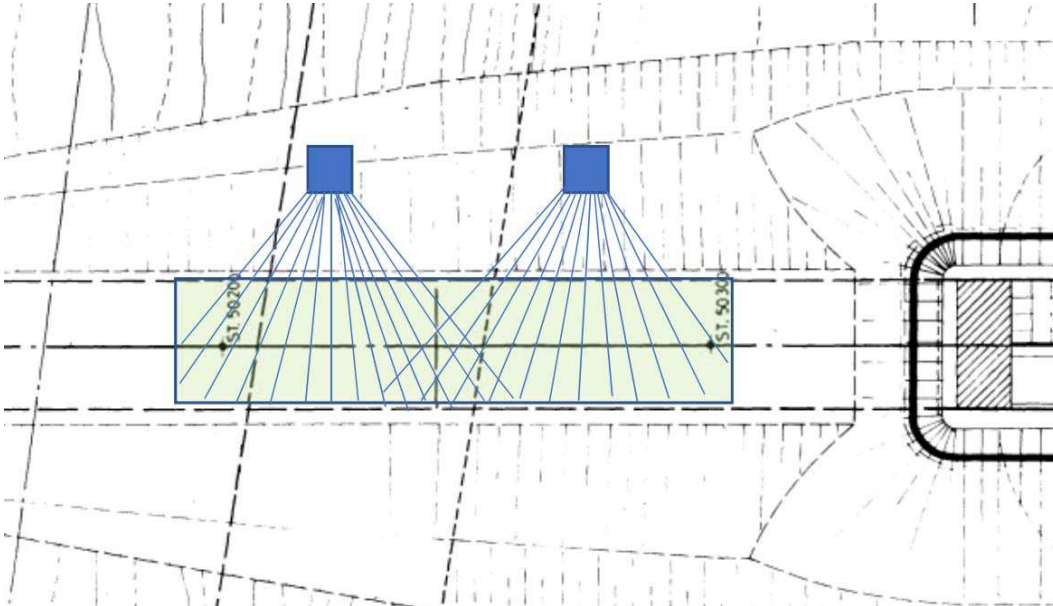
Figure 9.2-2 Plan showing indicative layout of grout injection tubes.

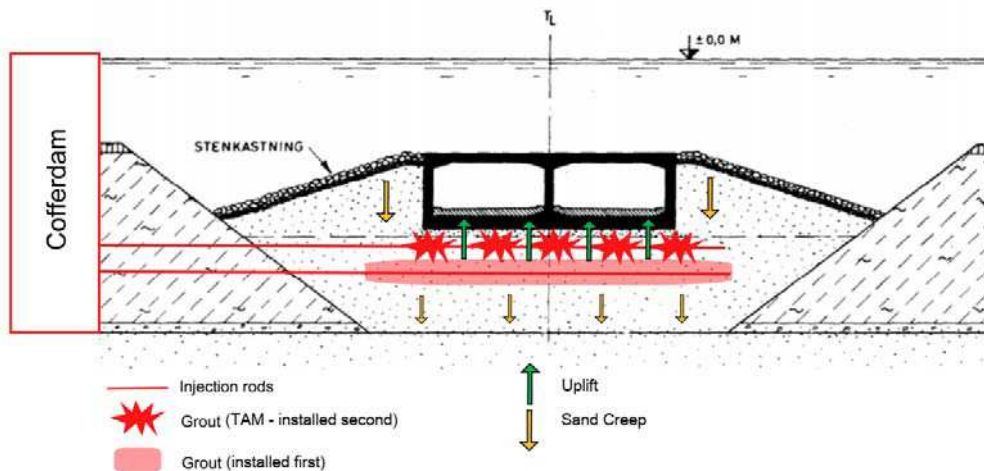
Figure 9.2-3 Section showing indicative pre-treatment and compensation grout injection tubes.

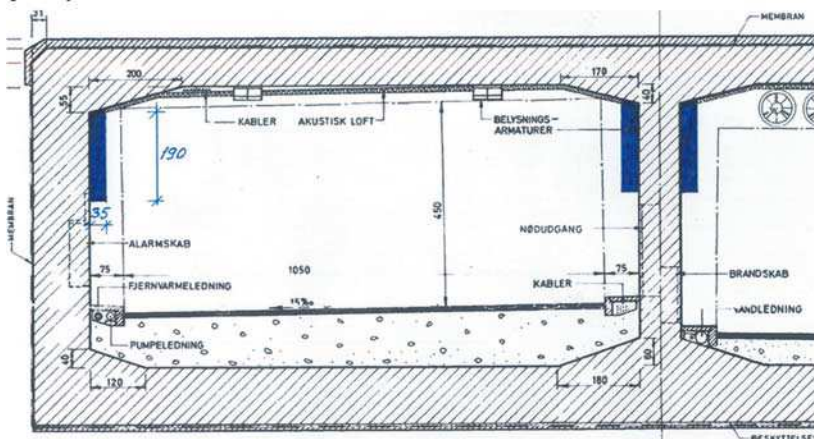
Figure 9.3-1 Spaces available for installations such as external post tensioning cables (blue colour) along upper part of all wall surfaces.

It was chosen to develop a solution which will have minimum disturbance on the traffic in the tunnel and accordingly a solution was developed where additional cables were not placed inside the ballast concrete. Under the tunnel ceiling the space is varying depending on location. In some locations, e.g. where jet fans are located, there is plenty of space, but in other locations there is nearly no space. It has been concluded that cables cannot be accommodated under the ceiling. The only space available for additional cables is along the walls above the diminutive sidewalks. Figure 9.3-1 shows the allowable space for cables with an acceptable distance from any traffic. In the 0.35 m wide and 1.90 m high spaces indicated (blue colour) installations are accepted according to UK regulation (DMRB) and German regulation (RABT). The Danish Road Directorate DRD has confirmed that installations in these spaces are also accepted in Denmark. There will be no interference with (blocking of) any of the emergency doors in the middle wall and cabinets in all the walls.

The available spaces are assumed used for placing a number of external post tensioning cables. External cables are often used for strengthening of existing structures and the solution is considered well proven technology even though the use in an immersed tunnel may be unusual.

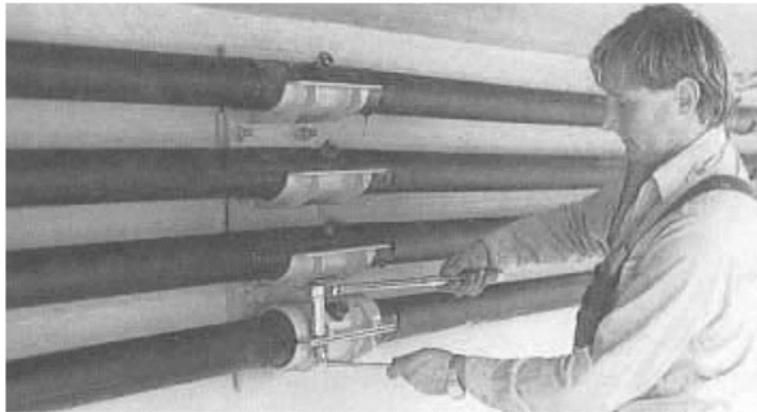
Figure 9.3-2 External post tensioning cables – intermediate tendon supports (VSL system shown).

In the Limfjord tunnel the deviators will only be controlling very small angle changes and friction losses will be very small. Considering the circumstances for installation, the anchorage and deviator blocks could be considered as tailor-made steel structures fixed to the existing structure by use of (a large number) of drilled and glued-in anchor bolts. At the middle wall it could be considered to use prestressed bolts and shear blocks or profiles passing through the wall. Anchor and deviator blocks can also be constructed as reinforced concrete structures, but such will probably slightly limit the number of cables compared to a steel solution. The concrete solution can in general benefit from standard components and is therefore not depending on the design of a number of special tailor-made items necessary for the steel solution. Concrete anchor and deviator blocks also depends on a large number of drilled and glued-in anchor bolts and the distribution of forces to the many anchor bolts is more simple in a concrete block compared to a steel bracket type of anchor block.

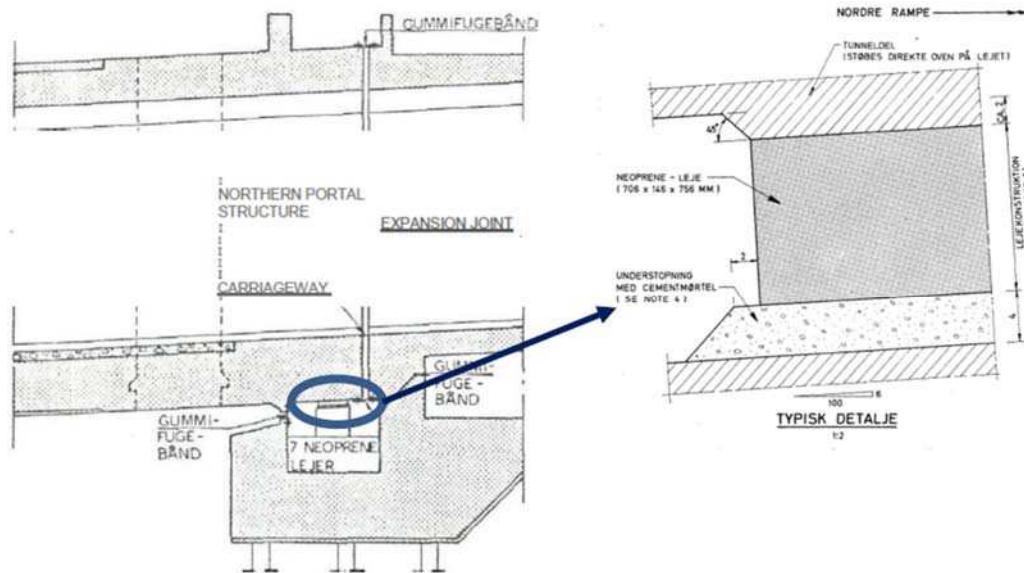
The bearing blocks located in the northern portal building are dimensions 706 x 756 x 146 mm<sup>3</sup>. The thickness of the grout pad under the bearing blocks is approximately 40 mm.

Figure 9.3-3 Existing bearing blocks in northern portal building.

These bearing blocks can be replaced with new bearing blocks with less height and with a Teflon layer included. The possible reduction in height may not be more than approx. 20 mm, but more lowering can be achieved by a small reduction in the height of the plinths below the bearing blocks. The height of the grout pad can also be reduced from 40 mm to approximately 20 mm. The possible lowering of the northern end of tunnel element V is thus at least say 90 - 100 mm (but circumstances as explained in the following may prevent such a big vertical displacement unless some special measures are introduced).

The use of bearing blocks with a reduced height would close the potential gap under the northern end of the tunnel to some extent. Thereby more ground support could be mobilised and forces/stresses in the tunnel in the longitudinal direction could be reduced. If the capacity of the cross section in the longitudinal direction was exceeded in the remaining lifetime (not assumed) this could be a relevant remedial proposal. But the proposal will also have some beneficial effect on limiting the crack width or closing the cracks (by decreasing tensile stresses) to reduce future leakages, improve durability and limit the extent of the injection campaigns. The new bearing blocks could be installed with load cells providing current information regarding the load transfer and thereby be an important element in the future monitoring of the tunnel structure (trigger values).

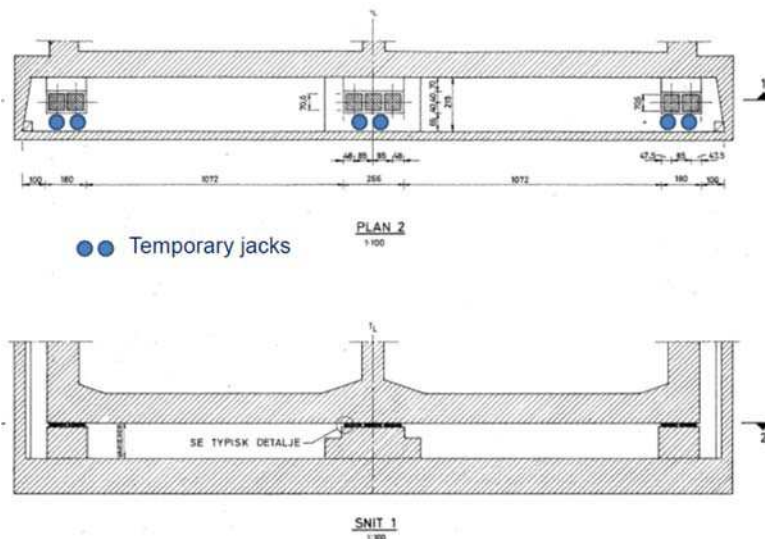
Figure 9.3-4 Location of temporary jacks during replacement of bearing blocks.

The temporary jacks can only be placed south of the bearings in the gap between the small front wall with the Omega seal expansion joint and the plinths. It means that the loads on the piles will be applied eccentrically.

Temporary jacks would be used to exchange the bearing blocks and during this operation to provide information regarding the current load and indirectly regarding the potential gap and the foundation bed mobilization. The jacks could also be used as part of the monitoring system.

Replacement of bearings by use of temporary jacks is often used, however mainly on bridges. It must be regarded as well proven technology even if it is not common practice in case of an immersed tube tunnel.
